# Errata Sheet

August 8, 2003 / Release 1.6

<b>Device:</b>	<b>SAB-C161PI-LM, -L25M SAF-C161PI-LM, -L25M SAB-C161PI-LM3V SAF-C161PI-LM3V  SAB-C161PI-LF, -L25F SAF-C161PI-LF, -L25F SAB-C161PI-LF3V SAF-C161PI-LF3V</b>
<b>Stepping Code / Marking:</b>	<b>ES-AA, AA ES-BA-H, BA-H</b>
<b>Package:</b>	<b>P-MQFP-100-2, P-TQFP-100-1</b>

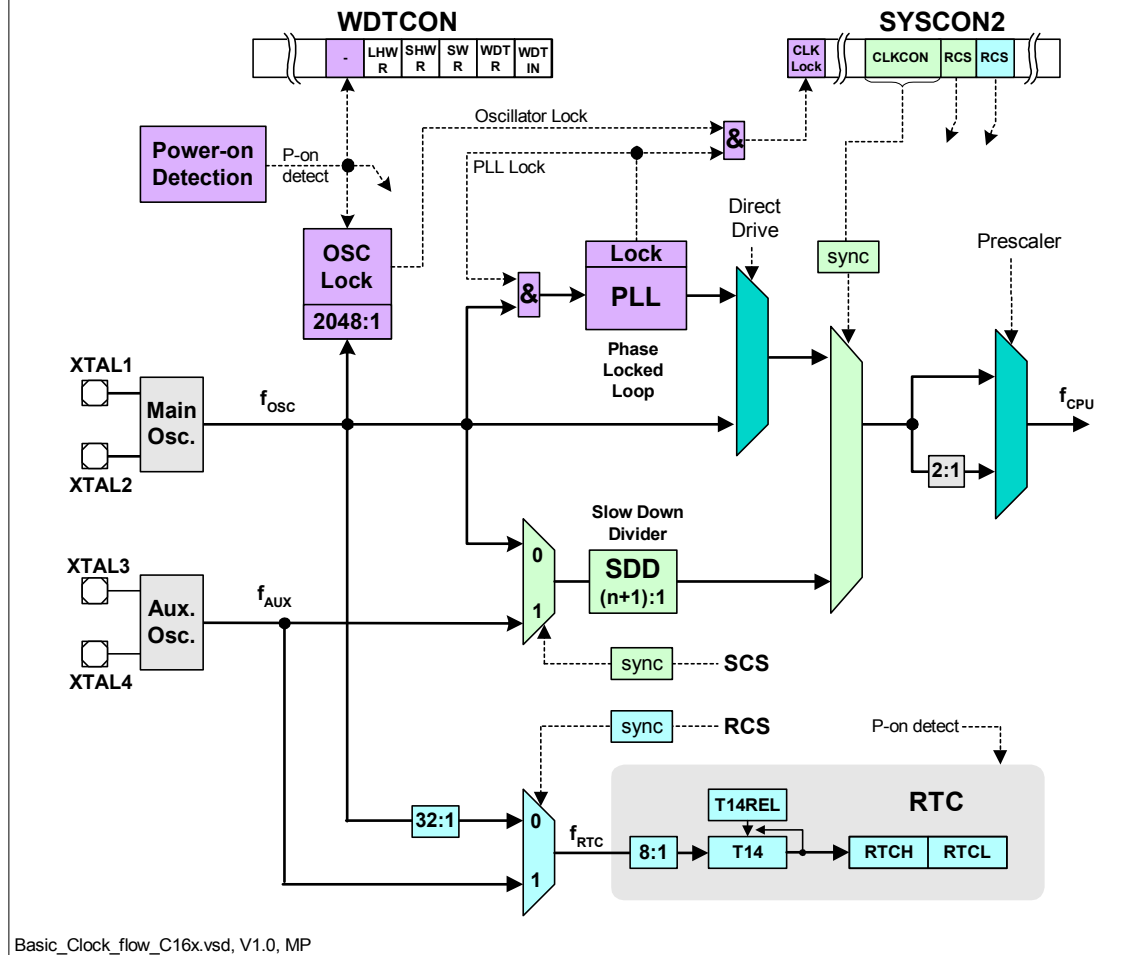
## C16x Family Clock Configuration

Note: The C161PI includes no auxiliary oscillator. Bits SCS and RCS are set to zero.

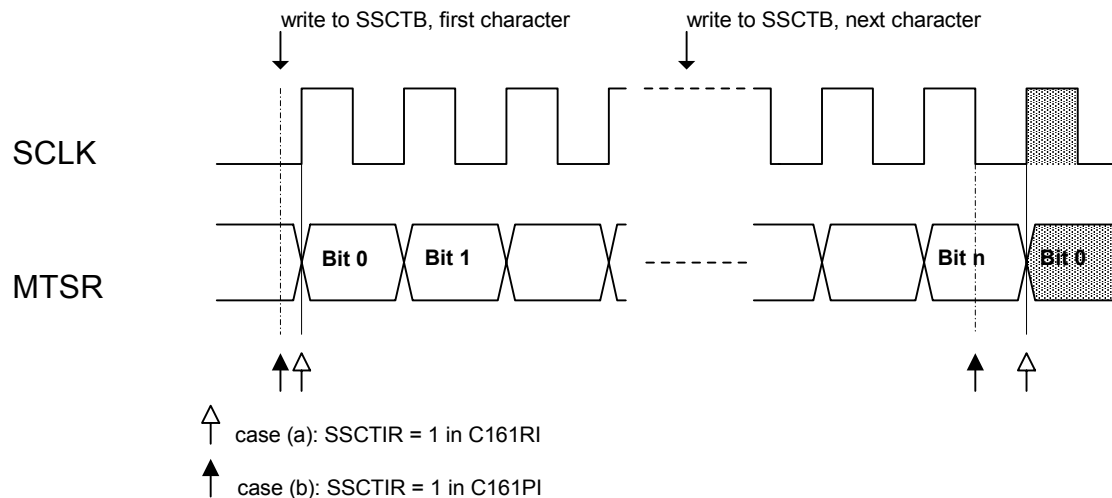
- in the **C161RI**, flag SSCTIR is set to '1' synchronous to the shift clock SCLK 1/2 bit time before the first latching edge (= first shifting clock edge when SSCPH = 0). When SSCTB is written while the shift register is empty, the maximum delay between the time SSCTB has been written and flag SSCTIR=1 is up to 1/2 bit time.
- in the **C161PI**, when SSCTB has been written while the transmit shift register was empty (and the SSC is enabled), flag SSCTIR is set to '1' directly after completion of the write operation, independent of the selected baud rate. When the transmit shift register is not empty when SSCTB was written, SSCTIR is set to '1' after the last latching edge of SCLK (= 1/2 bit time before the first shifting edge of the next character). See also e.g. C167CR User's Manual V3.1, p. 12-5.

The following diagram shows these relations in an example for a data transfer in master mode with SSCPO = 0 and SSCPH = 0. It is assumed that the transmit shift register is empty at the time the first character is written to SSCTB:

Typically, in interrupt driven systems, no problems are expected from the modified timing of flag SSCTIR. However, when flag SSCTIR is polled by software in combination with other flags which are set/cleared at the end or at the beginning of a transfer (e.g. SSCBSY), the modified timing may have an effect.
