Device	C164CI-8EM, C164CI-8E25M
Marking/Step	Step ES-DB, DB
Package	P-MQFP-80

This Errata Sheet describes the deviations from the current user documentation.

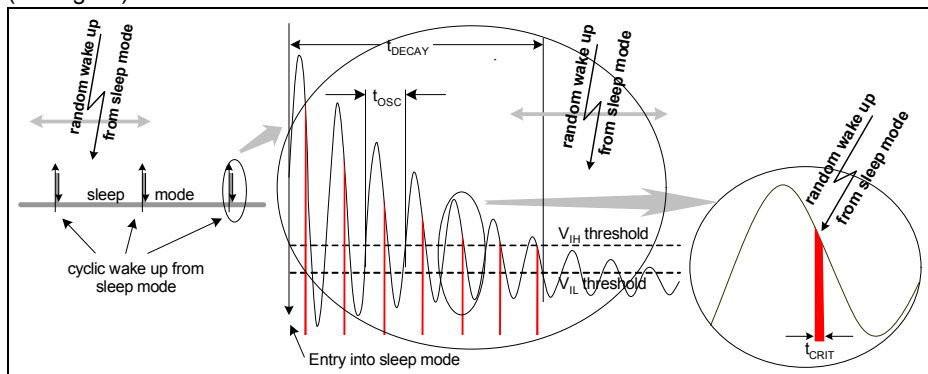
Figure 1 Critical Event

Due to a synchronization problem, the device may not correctly wake up from sleep mode if an asynchronous external wake up trigger occurs already in the oscillator decay time, i.e. in a particular time window before the device has actually entered sleep mode (see figure)

- the external wake up trigger signal (fast external interrupt or signal on pin $\overline{\text{NMI}}$) coincides with the critical time window (t_{CRIT}) of each oscillator cycle during the decay time of the clock signal at pin XTAL1 (critical times shown in red in figure)

The problem occurs only in the decay time of the main oscillator and in a very small window around the clock edge at XTAL1 (t_{CRIT} is about 5 ps wide).

- Select RTC on in sleep mode ($\text{SYSCON1.SLEEPCON} = 01_{\text{B}}$).
For devices with auxiliary oscillator (e.g. C161CS), select main oscillator as clock source ($\text{SYSCON2.RCS} = 0$).
- Avoid a wake up during the main oscillator decay time

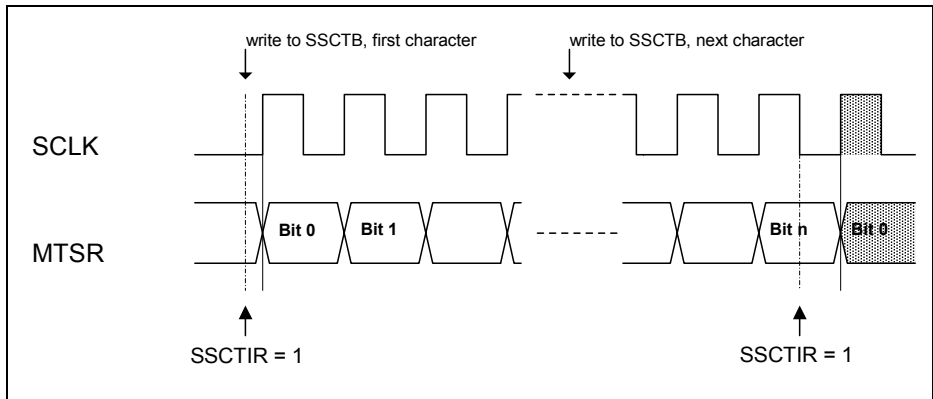
Figure 2 SSCTB Timing

When SSCTB has been written while the transmit shift register was empty (and the SSC is enabled), flag SSCTIR is set to '1' directly after completion of the write operation, independent of the selected baud rate. When the transmit shift register is not empty when SSCTB was written, SSCTIR is set to '1' after the last latching edge of SCLK (= 1/2 bit time before the first shifting edge of the next character). See also e.g. C167CR User's Manual V3.1, p. 12-5.

Typically, in interrupt driven systems, no problems are expected from the modified timing of flag SSCTIR. However, when flag SSCTIR is polled by software in combination with other flags which are set/cleared at the end or at the beginning of a transfer (e.g. SSCBSY), the modified timing may have an effect.

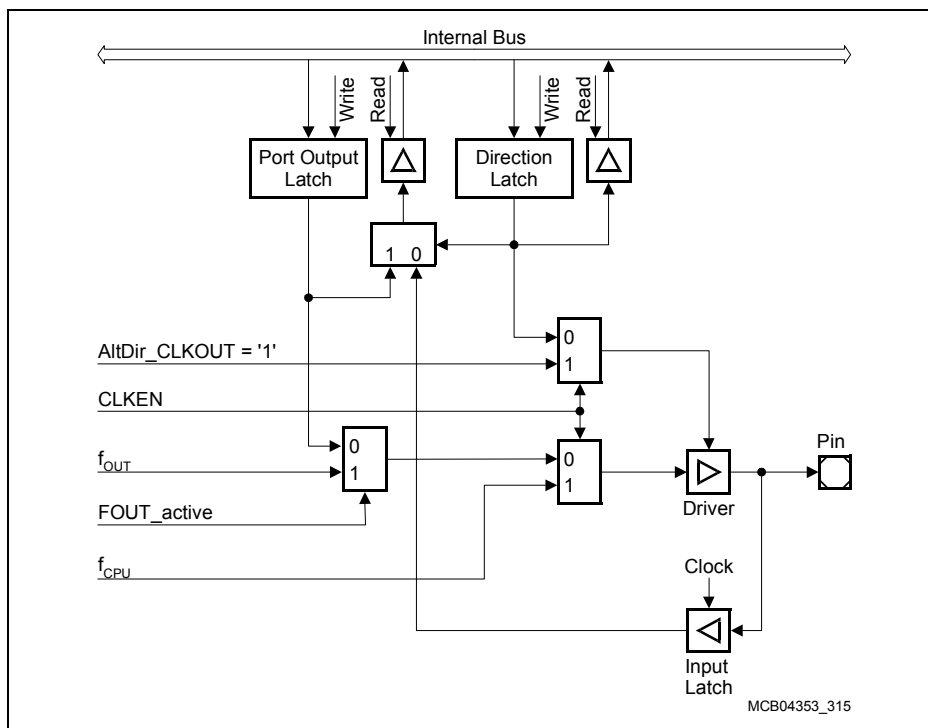
To enable the frequency output signal f_{OUT} bit CLKEN in register SYSCON must be cleared (before EINIT) and f_{OUT} must be enabled in register FOCON. In contrast to signal CLKOUT the direction latch has to be set by software to enable f_{OUT} .
