# Errata Sheet

October 16, 2001 / Release 1.0

**Device:** SAB-C167CS-L16M 3V  
SAF-C167CS-L16M 3V

**Stepping Code / Marking:** ES-BA, BA 6

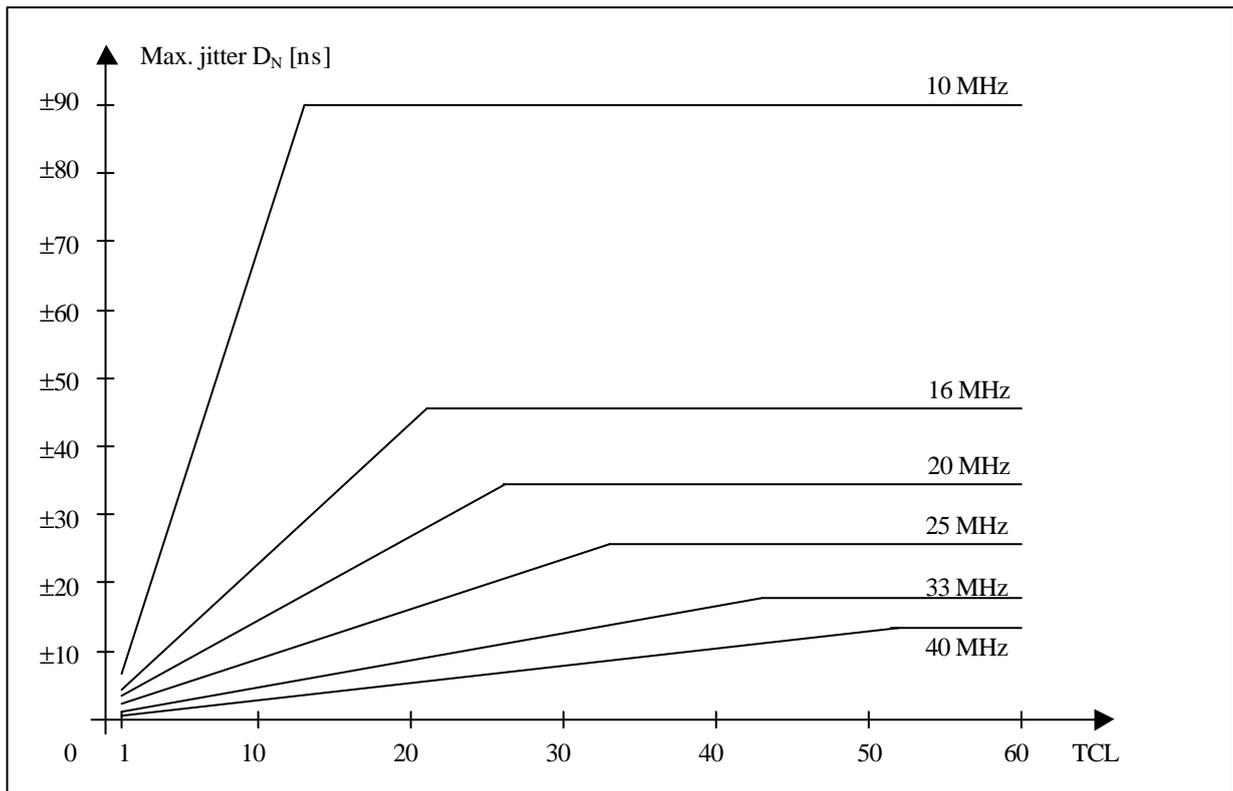
In systems where the PLL is used for generation of the CPU clock frequency, the PLL jitter can increase under certain circumstances and exceed the specified value.

The value of the additional jitter is not a fixed one but it depends on the kind of activity on the external bus or output pins. The additional jitter increases with the number of output/bus pins which are switched at the same time to a new voltage level because the problem is caused by noise on the on-chip power supply.

The capacitive load of the used pins has also an influence to the additional jitter. A high capacitive load can increase the additional jitter.

All PLL factors are affected (PLL factor 1.5 / 2 / 2.5 / 3 / 4 / 5). The PLL jitter increases when access to the external bus or output pins is performed. This phenomenon has no influence to direct drive-, prescaler-, and SDD mode.

This approximated formula is valid for a CPU frequency  $10 \text{ MHz} \leq f_{\text{CPU}} \leq 40 \text{ MHz}$  with the conditions:

$$\begin{aligned} T_m &= f_{\text{CPU}} * 1.3 && \text{for } N \leq T_m \\ T_m &= N && \text{for } N > T_m \end{aligned}$$

In the case that the additional jitter causes problems in the system which cannot be relaxed with software adapted timing parameters the following workarounds are possible:
