# Errata Sheet

October 16, 2001 / Release 1.0

| <b>Device:</b> | <b>SAB-C167CS-L16M 3V</b><br><b>SAF-C167CS-L16M 3V</b> |
| <b>Stepping Code / Marking:</b> | <b>ES-BA, BA 6</b> |

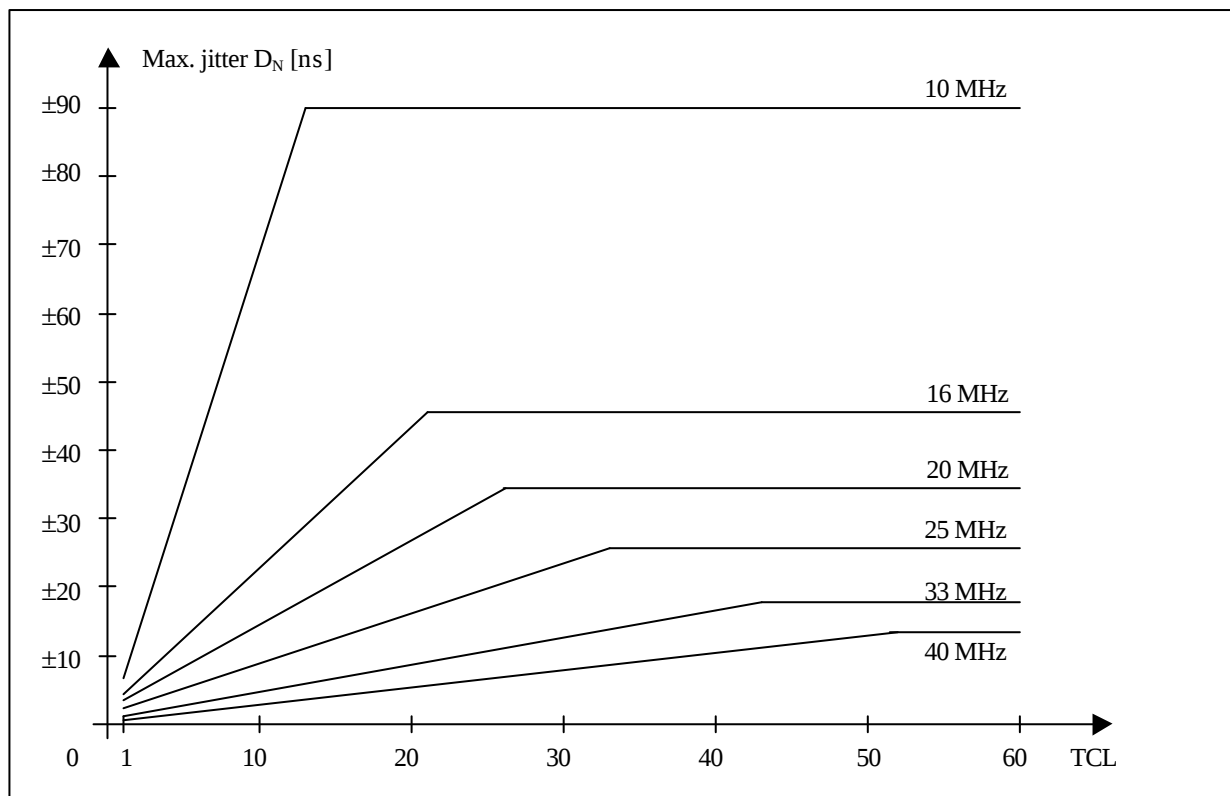
### **PLL.3.3: Increased PLL Jitter caused by external Access**

In systems where the PLL is used for generation of the CPU clock frequency, the PLL jitter can increase under certain circumstances and exceed the specified value.

The value of the additional jitter is not a fixed one but it depends on the kind of activity on the external bus or output pins. The additional jitter increases with the number of output/bus pins which are switched at the same time to a new voltage level because the problem is caused by noise on the on-chip power supply.

The capacitive load of the used pins has also an influence to the additional jitter. A high capacitive load can increase the additional jitter.

This approximated formula is valid for a CPU frequency  $10 \text{ MHz} \leq f_{\text{CPU}} \leq 40 \text{ MHz}$  with the conditions:

$$\begin{aligned} T_m &= f_{\text{CPU}} * 1.3 & \text{for } N \leq T_m \\ T_m &= N & \text{for } N > T_m \end{aligned}$$

### Workaround:

In the case that the additional jitter causes problems in the system which cannot be relaxed with software adapted timing parameters the following workarounds are possible:
