# Errata Sheet

October 16, 2001 / Release 1.5

| <b>Device:</b> | <b>SAK-C167CS-LM</b><br><b>SAK-C167CS-4RM</b> |
| <b>Stepping Code / Marking:</b> | <b>ES-AB, AB</b> |

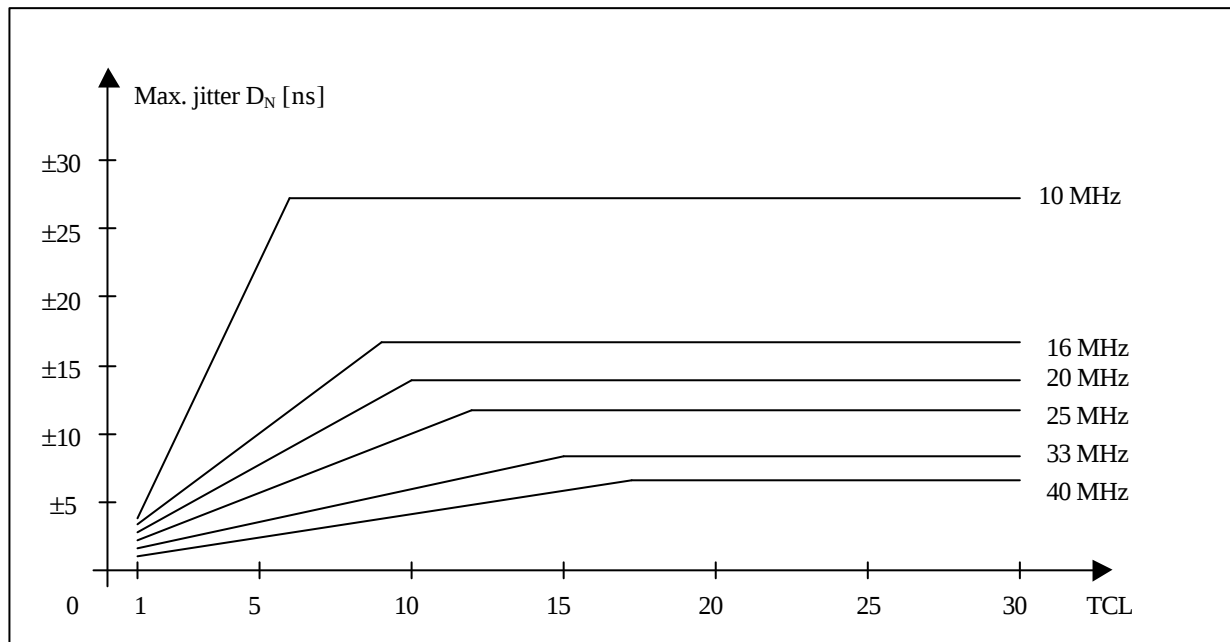
### **PLL.3.4: Increased PLL Jitter caused by external Access**

The value of the additional jitter is not a fixed one but it depends on the kind of activity on the external bus or output pins. The additional jitter increases with the number of output/bus pins which are switched at the same time to a new voltage level because the problem is caused by noise on the on-chip power supply.

Where  $N$  = number of consecutive  $T_{CL}$ ,  $f_{\text{CPU}}$  = CPU frequency in MHz and  $T_m = f_{\text{CPU}} * 0.35 + 2.5$ .  
This approximated formula is valid for a CPU frequency  $10 \text{ MHz} \leq f_{\text{CPU}} \leq 40 \text{ MHz}$  with the conditions:

$$\begin{aligned} T_m &= f_{\text{CPU}} * 0.35 + 2.5 & \text{for } N \leq T_m \\ T_m &= N & \text{for } N > T_m \end{aligned}$$

### Workaround:

In the case that the additional jitter causes problems in the system which cannot be relaxed with software adapted timing parameters the following workarounds are possible:
