# Errata Sheet

July 7, 2003 / Release 1.2

| <b>Device:</b> | SAK-C167CS-LM<br>SAK-C167CS-L33M<br>SAK-C167CS-L40M<br>SAK-C167CS-4RM<br>SAK-C167CS-4R33M<br>SAK-C167CS-4R40M |
| <b>Stepping Code / Marking:</b> | ES-BA, BA, BA 6 |

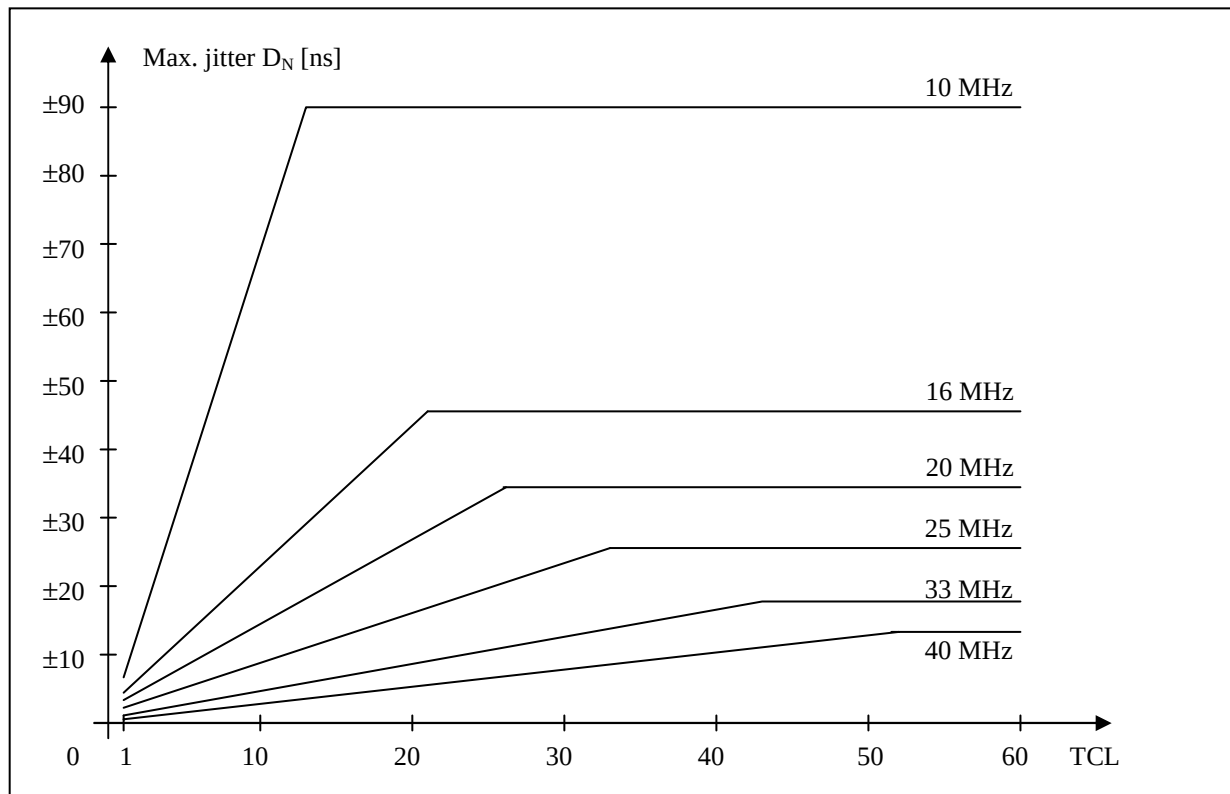
### PLL.3.3: Increased PLL Jitter caused by external Access

The value of the additional jitter is not a fixed one but it depends on the kind of activity on the external bus or output pins. The additional jitter increases with the number of output/bus pins which are switched at the same time to a new voltage level because the problem is caused by noise on the on-chip power supply.

This approximated formula is valid for a CPU frequency  $10 \text{ MHz} \leq f_{\text{CPU}} \leq 40 \text{ MHz}$  with the conditions:

$$\begin{aligned} T_m &= f_{\text{CPU}} * 1.3 & \text{for } N \leq T_m \\ T_m &= N & \text{for } N > T_m \end{aligned}$$

#### Workaround:

In the case that the additional jitter causes problems in the system which cannot be relaxed with software adapted timing parameters the following workarounds are possible:
