Device TC1782
Marking/Step BA
Package see Data Sheet

04074AERRA

This Errata Sheet describes the deviations from the current user documentation.

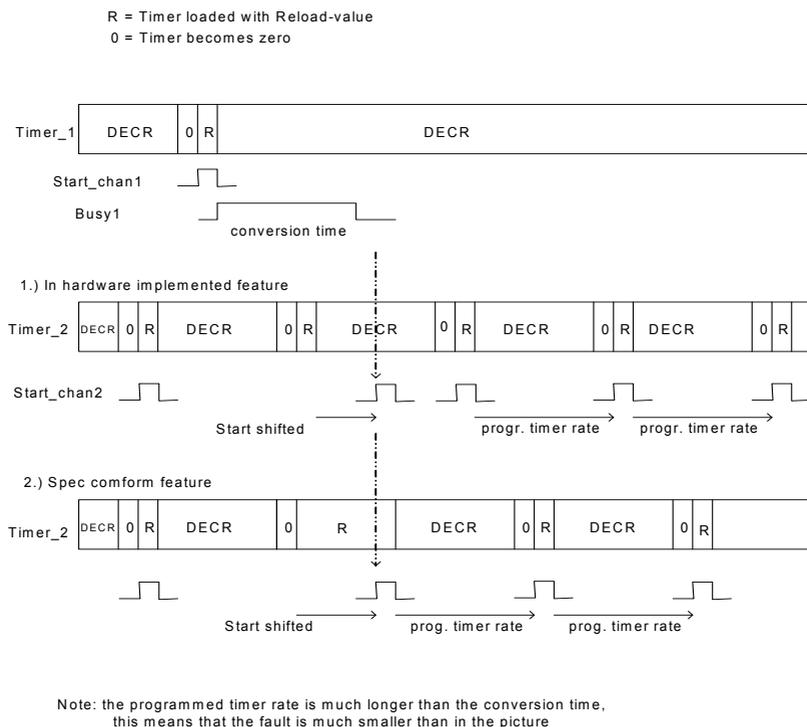
Figure 1 Timing concerning equidistant multiple timers

The correct behavior would be a reload when the requested conversion (of channel_2) is started.

Therefore the start of conversion for channel_2 is delayed by maximum one conversion-time. After this delay it will be continued with equidistant conversion-starts. Please refer to the following figure.

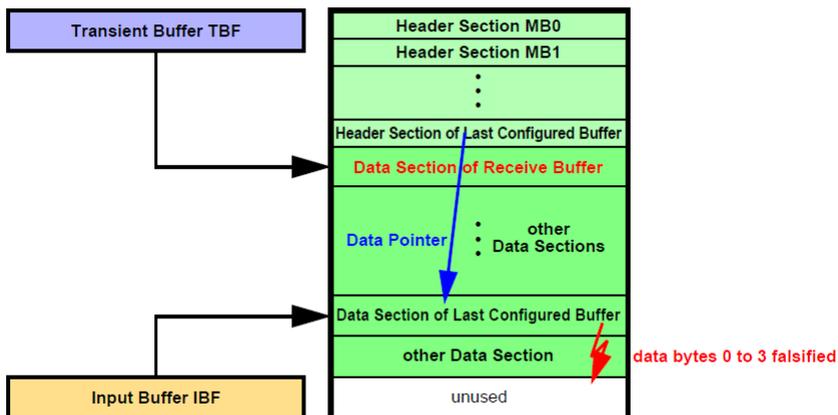
Figure 3 Message buffer transfer from IBF to Message RAM

b) Message buffer transfer from IBF to Message RAM

After the Data Section of the selected message buffer in the Message RAM has been written, one additional write access overwrites the following word in the Message RAM which might be the first word of the next Data Section.
