Device	XMC1200
Marking/Step	EES-AA, ES-AA, AA
Package	PG-TSSOP-16/28/38, PG-VQFN-24/40

This “Errata Sheet” describes product deviations with respect to the user documentation listed below.

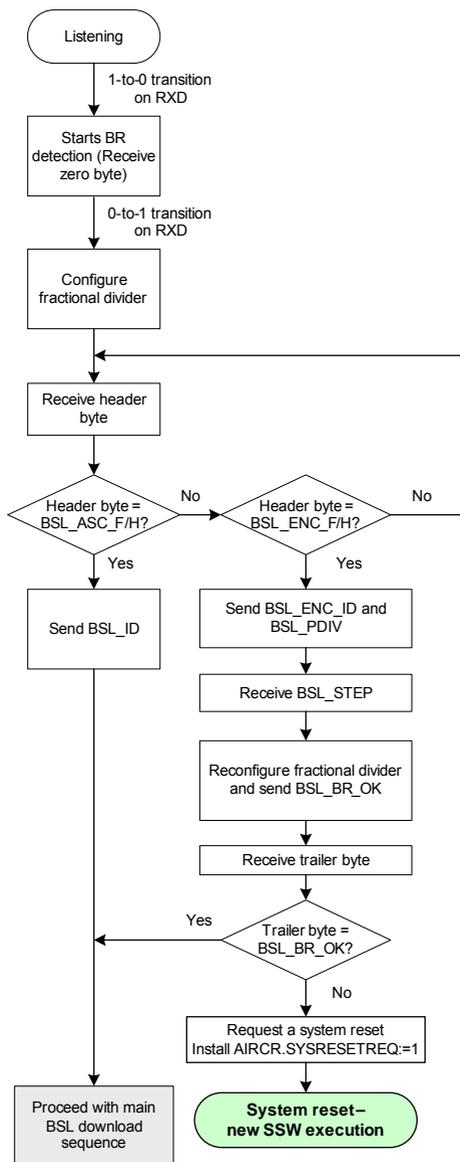
Figure 2 Baud Rate configuration sequence during ASC BSL entry

With the current implementation (refer to the “Bootstrap Loaders and User Routines” chapter in Reference Manual) the host device (e.g. a PC) may have problem to switch the baudrate fast enough after sending the request (BSL_STEP as of [Figure 2](#)) and is not able to receive the device acknowledge (BSL_BR_OK) correctly with the changed ASC channel speed. If this happens, the host will get some error condition - wrong response, start bit not detected, etc. In such a case the host has to ignore the error and send the trailer Byte (BSL_BR_OK) with the new baudrate. The correctness of the communication speed settings will be then decided by the host upon the response from the device after sending the length of code for downloading (refer to [Figure 3](#)).
