Device	XMC4100/XMC4200
Marking/Step	EES-AA, ES-AA
Package	PG-VQFN-48, PG-LQFP-64

Document ID is **02530AERRA**.

This “Errata Sheet” describes product deviations with respect to the user documentation listed below.

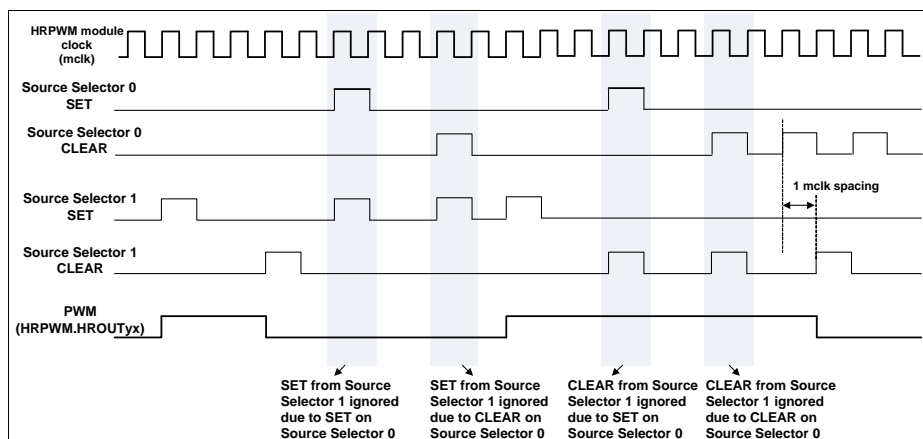
Figure 11 Collision between signals of the two Source Selectors - valid

- at the same module clock time frame Source Selector 0 and Source Selector 1 both decode a signal (a PWM set or PWM clear).

If the described condition occurs, then the signal generated by Source Selector 1 is lost and the PWM signal is not handled properly - **Figure 11**.

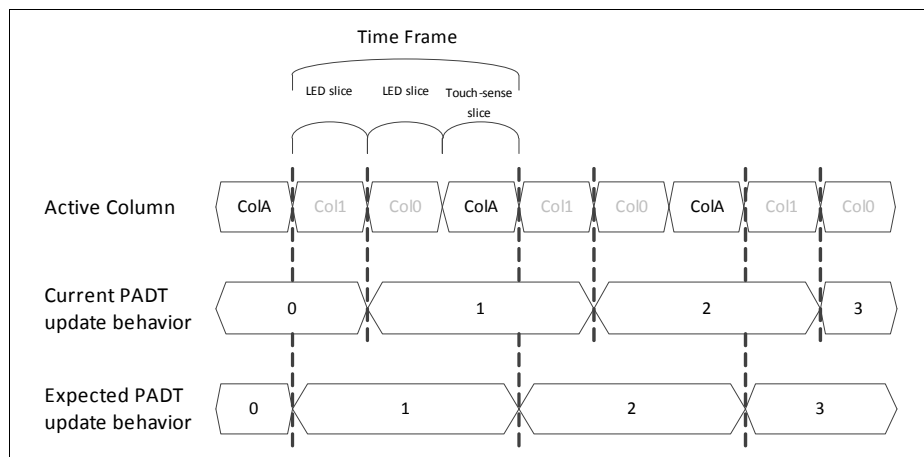
Figure 14 PADT update behavior

The touch-sense pad turn (PADT) value is updated, not at the end of the touch-sense time slice (ColA), but one time slice later ([Figure 14](#)).

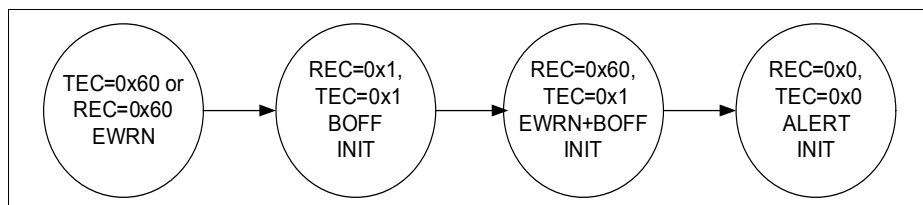
Figure 22 Alert Interrupt Behavior in case of Bus-Off

When the threshold for error warning (EWRN) is reached (default value of Error Warning Level EWRN = 0x60), then the EWRN interrupt is issued. The bus-off (BOFF) status is reached if $TEC > 255$ according to CAN specification, changing the MultiCAN module with REC and TEC to the same value 0x1, setting the INIT bit to 1_B, and issuing the BOFF interrupt. The bus-off recovery phase starts automatically. Every time an idle time is seen, REC is incremented. If REC = 0x60, a combined status EWRN+BOFF is reached. The corresponding interrupt can also be seen as a pre-warning interrupt, that the bus-off recovery phase will be finished soon. When the bus-off recovery phase has finished (128 times idle time have been seen on the bus), EWRN and BOFF are cleared, the ALERT interrupt bit is set and the INIT bit is still set.

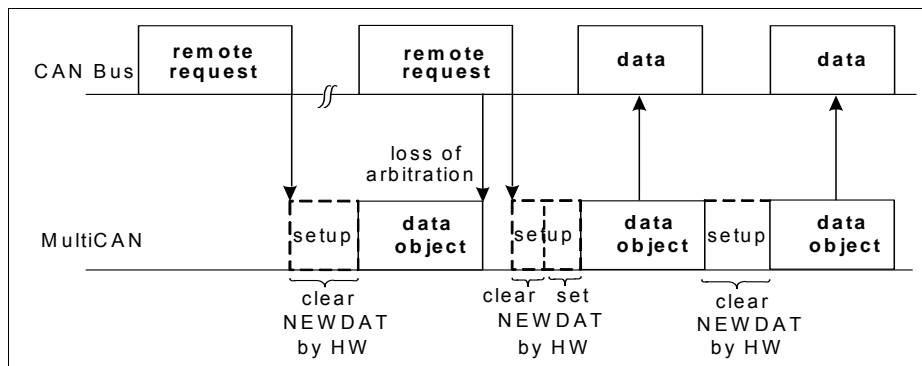
Figure 23 Loss of Arbitration

When the appropriate message object (data frame) triggered by the first remote frame wins the arbitration, it will be sent out and `NEWDAT` is not reset. This leads to an additional data frame, that will be sent by this message object (clearing `NEWDAT`).

There will, however, not be more data frames than there are corresponding remote requests.
