Device	XMC4400
Marking/Step	ES-BA, BA
Package	PG-LQFP-64/100

Document ID is **118/17**.

This “Errata Sheet” describes product deviations with respect to the user documentation listed below.

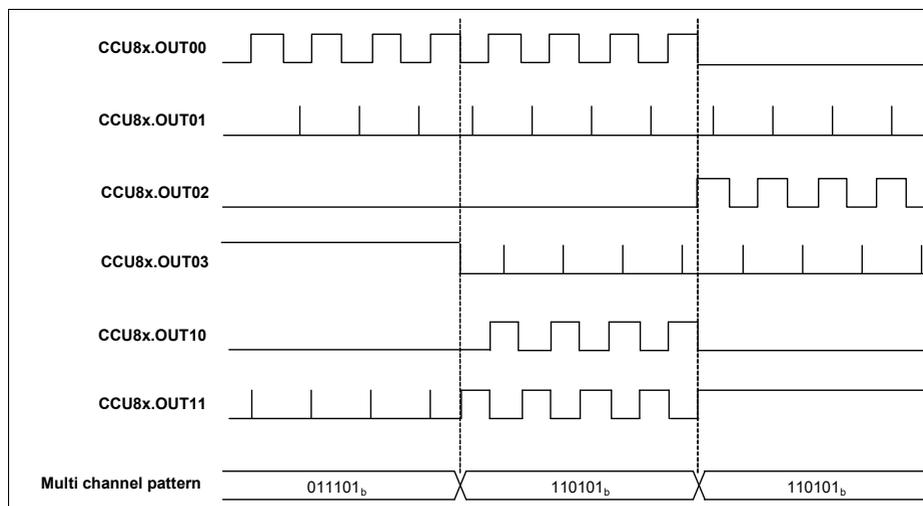
Figure 5 PWM output glitch

A glitch is present at the PWM outputs whenever the dead time of the specific compare channel is enabled - CC8yDTC.DTE1 and/or CC8yDTC.DTE2 set to 1_B (each compare channel has a separate dead time function) - and the specific multi channel pattern for the channel is 01_B or 10_B.

This glitch only affects the PWM output that is linked to the inverting ST path of each compare channel (non inverting outputs are not affected).

The effect of this glitch can be seen in Figure 3. The duration of the PWM glitch has the same length has the dead time value programmed into the CC8yDC1R.DT1F field (for compare channel 1) or into the CC8yDC1R.DT2F.

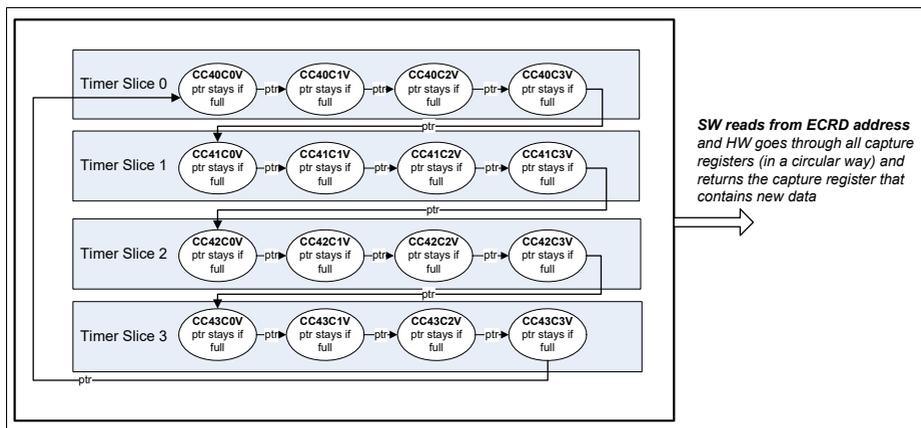
Figure 7 Extended Read Back access - example for CCU4 (CCU8 structure is the same)

- Timer X has 4 capture registers and is the only Timer set with ECM = 1_B . At the moment that the software starts reading the capture registers via the ECRD address, we have already captured two values. The ECRD read back will output CC4xC2V -> CC4xC2V (CC4xC3V value is lost)

- Timer X and Timer Y have 4 capture registers each and they are both configured with ECM = 1_B . At the moment that the software starts reading the capture registers via the ECRD address, we have already captured two values on Timer X and 4 on Timer Y. The ECRD read back will output CC4xC0V -> CC4xC1V -> CC4xC2V -> CC4xC3V -> CC4yC2V -> CC4yC2V (CC4yC3V value is lost)

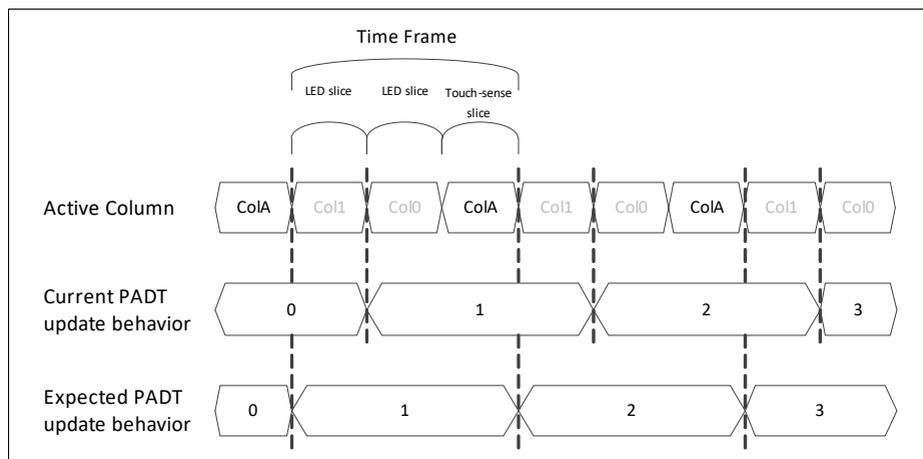
Figure 9 PADT update behavior

The touch-sense pad turn (PADT) value is updated, not at the end of the touch-sense time slice (ColA), but one time slice later ([Figure 9](#)).

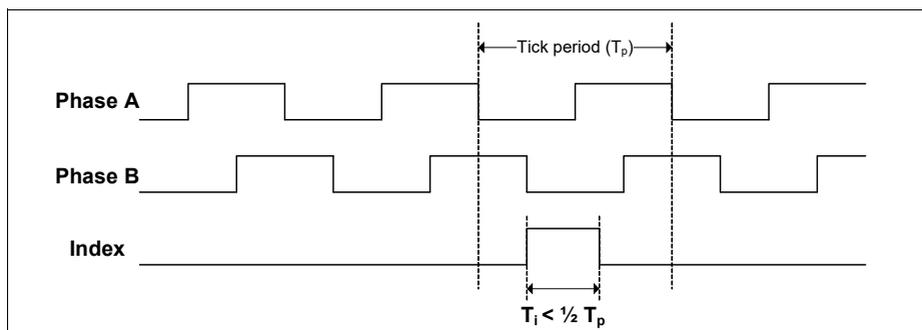
Figure 15 Different index signal types

When the index signal is smaller than 1/2 of the tick period, the POSIF module is not able to decode this signal properly, Figure 2 - notice that the reference edge of the index generation in this figure is the falling of Phase B, nevertheless this is an example and depending on the encoder type, this edge may be one of the other three.

Due to this fact it is not possible to use the POSIF to decode these type of signals (index with duration below 1/2 of the tick period).
