Device	TC1762
Marking/Step	EES-AA, ES-AA, AA
Package	PG-LQFP-176-2

## 01742AERRA

This Errata Sheet describes the deviations from the current user documentation.

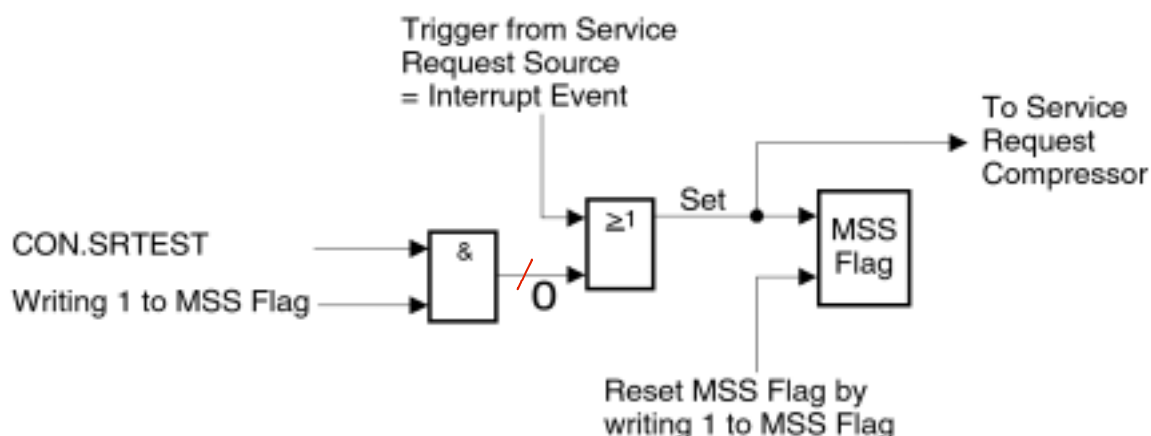
**Figure 1**

### **ADC\_TC.023 Setting the MSS-flag doesn't generate an interrupt in TEST-MODE**

It is possible to generate a software triggered interrupt event in TESTMODE (ADCx\_CON.SRTEST=1) by setting one of the bitflags in register ADCx\_MSS0/1. Due to the fact, that this mechanism is not working, it is not possible to generate a corresponding interrupt by software.

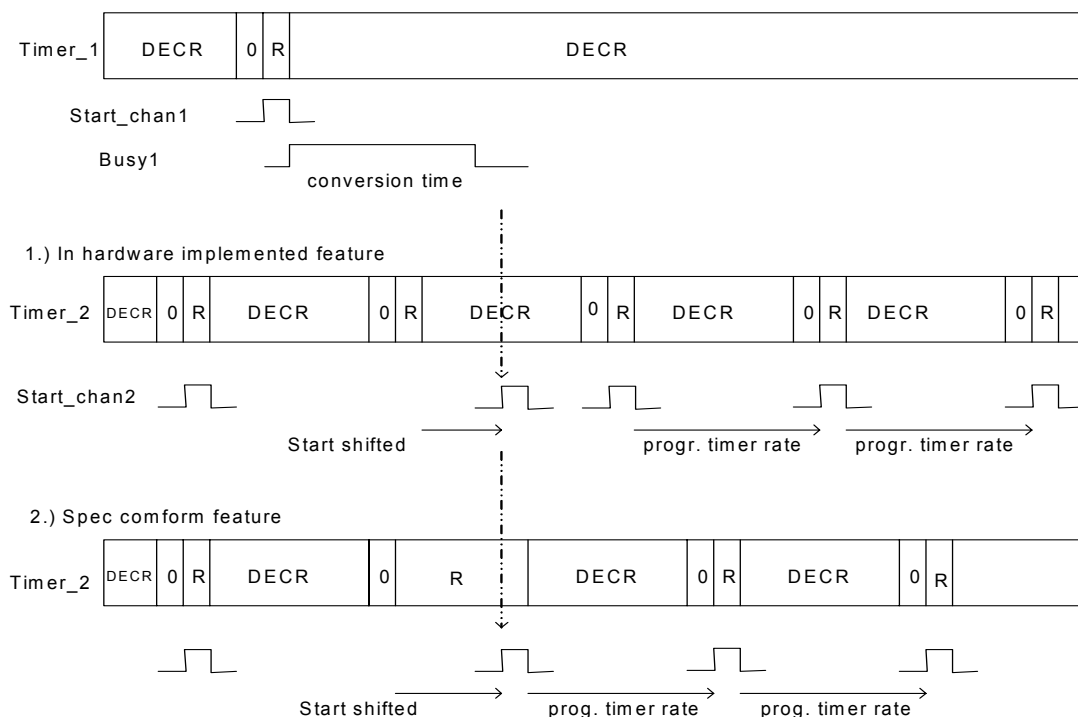
Therefore the start of conversion for `channel_2` is delayed by maximum one conversion-time. After this delay it will be continued with equidistant conversion-starts. Please refer to the following figure.

Note: the programmed timer rate is much longer than the conversion time, this means that the fault is much smaller than in the picture

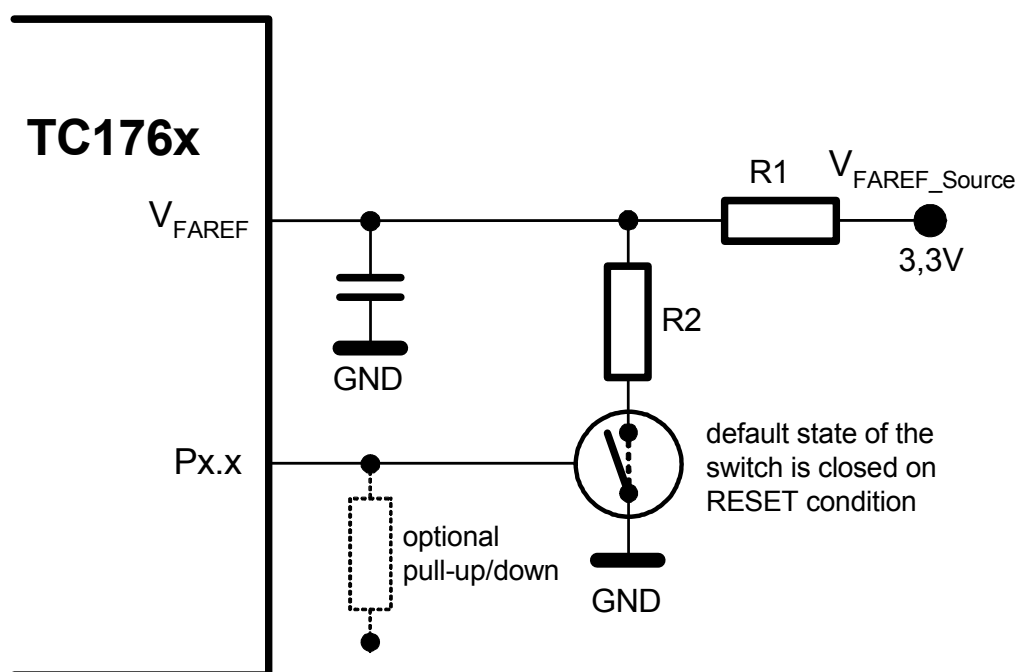
Stress minimization over lifetime can be achieved by the introduction of a small external circuitry applied to the  $V_{\text{FAREF}}$  pin. The circuitry might consist e.g. out of a switchable voltage divider applied to  $V_{\text{FAREF}}$  pin, which as default in any reset condition of the device assures voltage levels between 0 V to 1.65V.

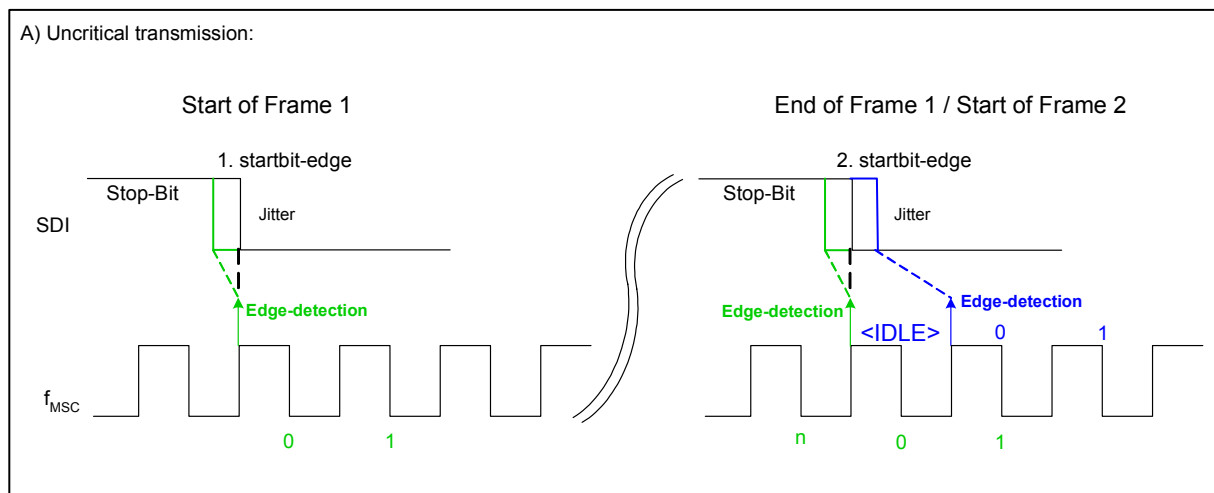
**Figure 4**      **Uncritical transmission**

As the falling startbit edge is shifted to the left of the rising clock edge (**Figure 4** left), there occurs a secure detection of the next start-bit edge in the last cycle of the previous frame (here cycle n, **Figure 4** right) independent from the applied jitter to this edge.

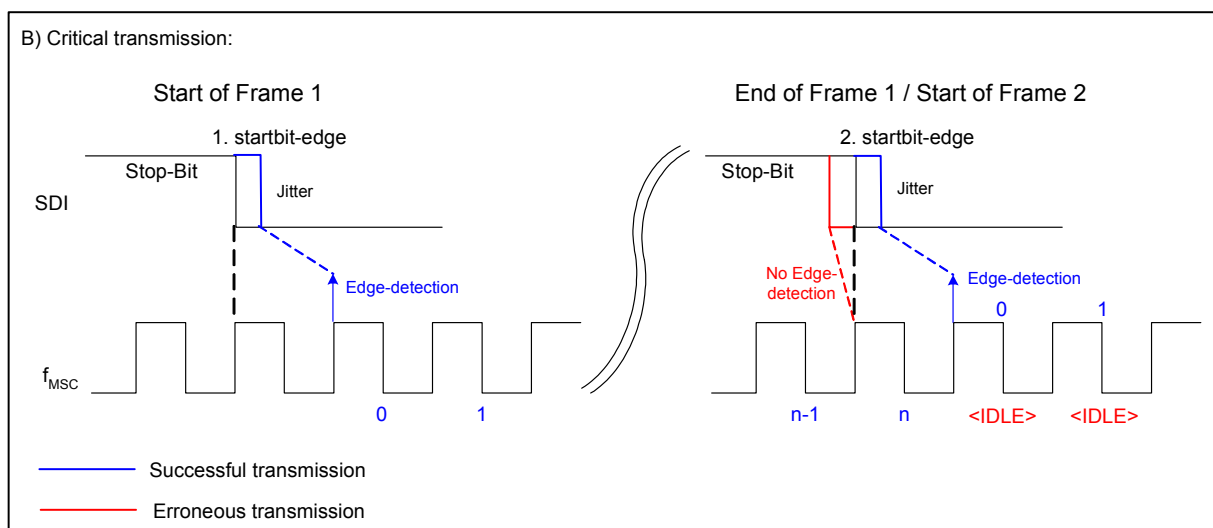
**Figure 5**      **Critical transmission**

If the high-low edge of the start-bit in the first frame is just not detected by the near clock-edge (**Figure 5** - left) and the start-bit edge of the second frame is jittering to cycle  $n-1$  (**Figure 5** - right, red coloured), then an erroneous transmission will take place. In this case the state-machine switches to IDLE after the last state  $n$  and wakes up on the next falling edge that may be a data-bit recognized as a start-bit. If the start-bit of the second frame is jittering to cycle  $n$  (**Figure 5** - right, blue colored), then the state-machine will not switch to IDLE but will start receiving the next frame correctly.

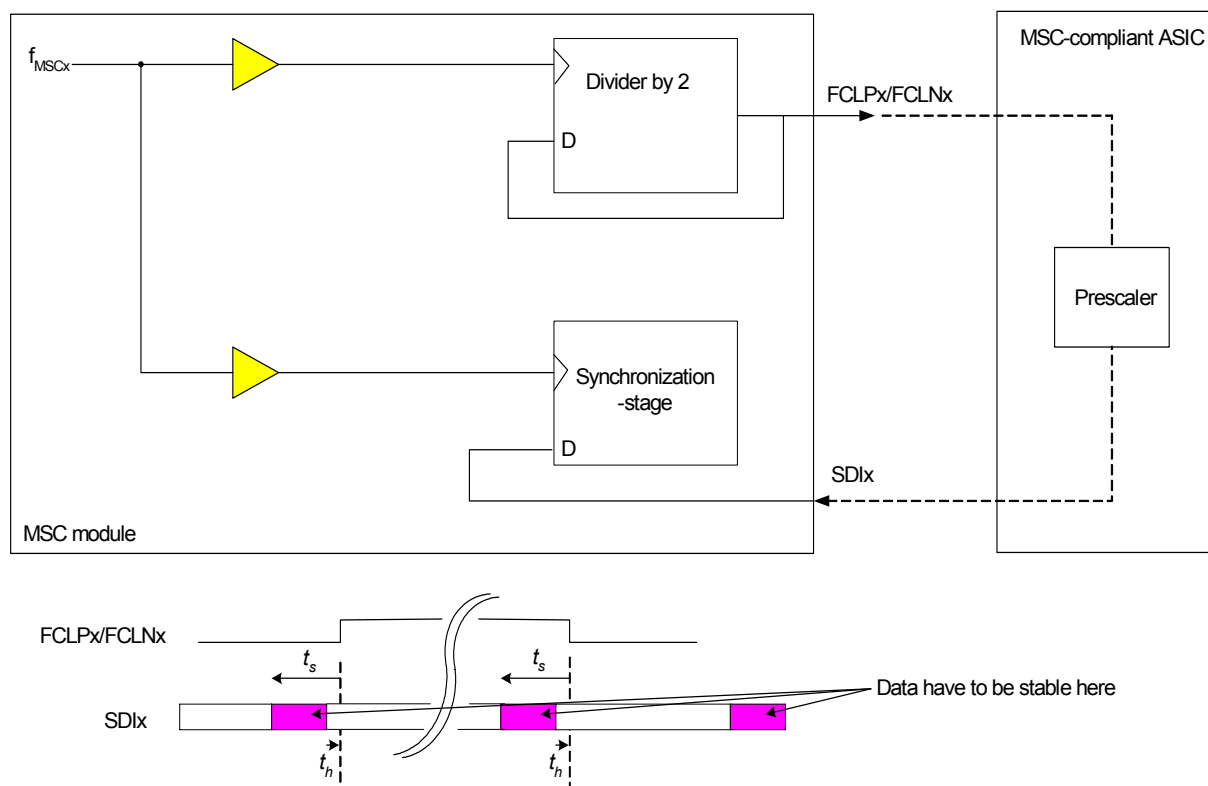
**Figure 6 Delay adjustment relative to the module clock**

**Figure 6** shows the principle blockdiagram of the input synchronization stage of the MSC module.

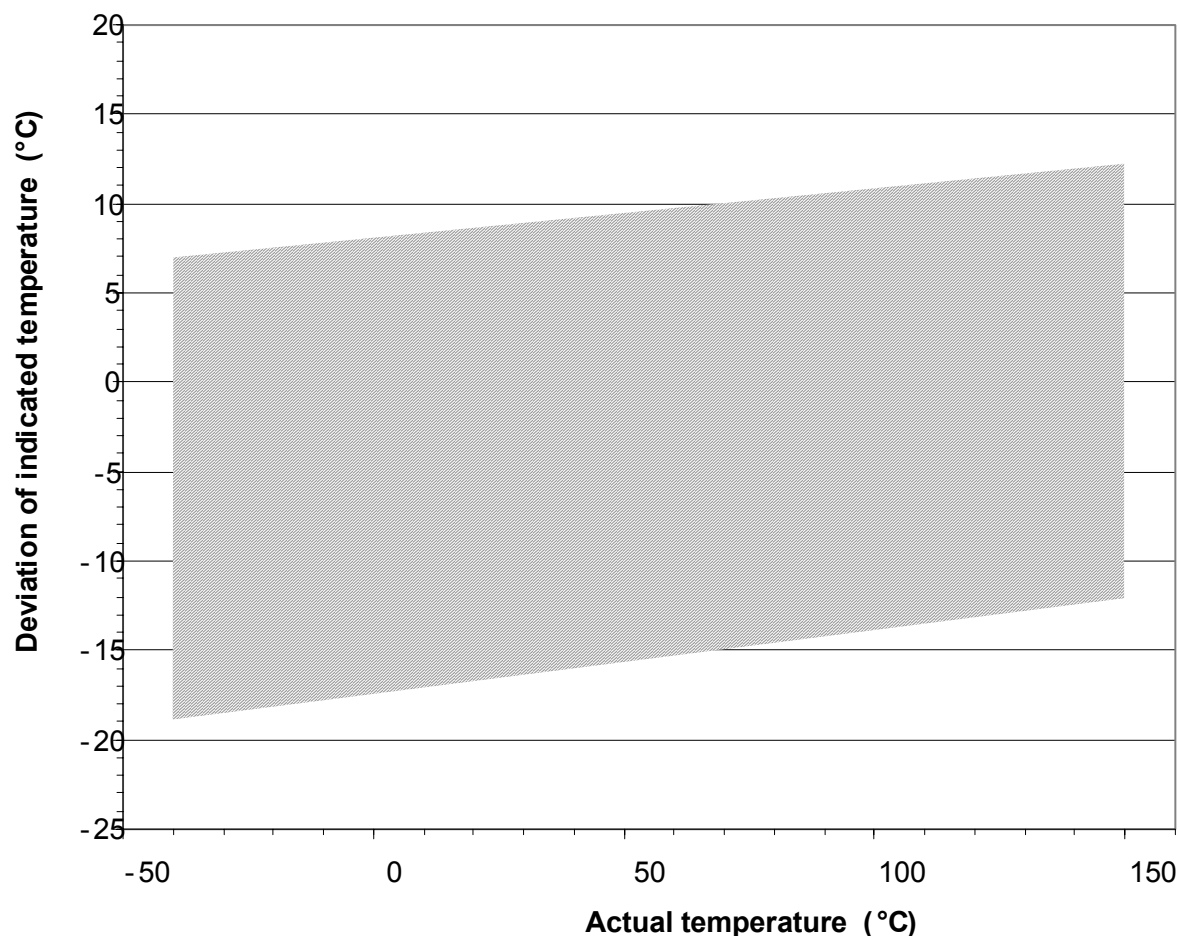
**Figure 10 Current accuracy range**

The deviation using these formulas is:

- $\pm 12^{\circ}\text{C}$  at  $T_J = 150^{\circ}\text{C}$
- $\pm 9/-17^{\circ}\text{C}$  at  $T_J = 25^{\circ}\text{C}$
- $\pm 7/-19^{\circ}\text{C}$  at  $T_J = -40^{\circ}\text{C}$

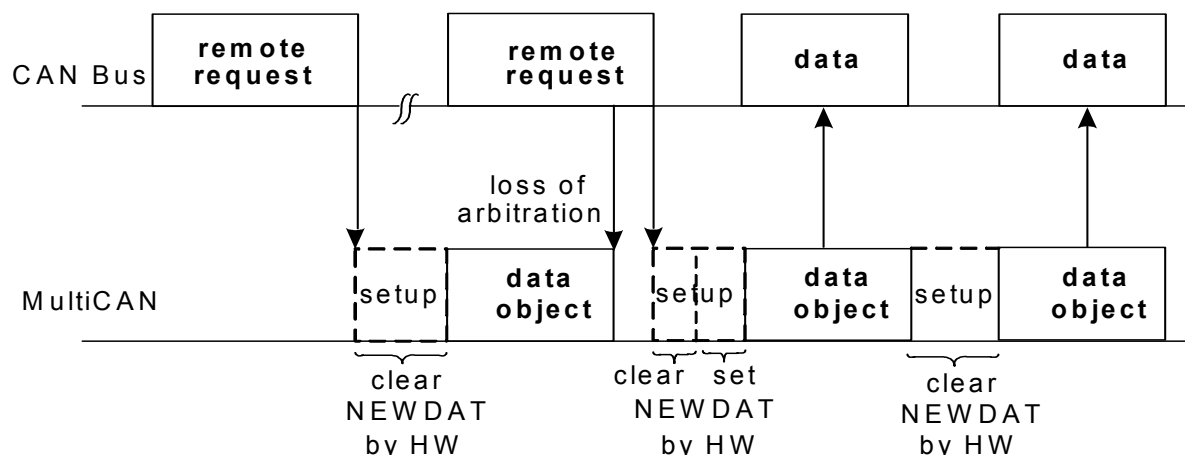
**Figure 12 Loss of Arbitration**

When the appropriate message object (data frame) triggered by the first remote frame wins the arbitration, it will be sent out and `NEWDAT` is not reset. This leads to an additional data frame, that will be sent by this message object (clearing `NEWDAT`).

There will, however, not be more data frames than there are corresponding remote requests.
