Device	TC1762
Marking/Step	EES-AB, ES-AB, AB
Package	PG-LQFP-176-2

This Errata Sheet describes the deviations from the current user documentation. The module oriented classification and numbering system uses an ascending sequence over several derivatives, including already solved deviations. So gaps inside this enumeration can occur.

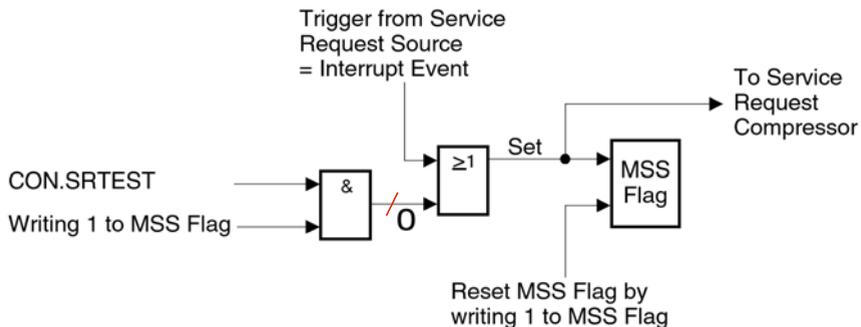
Figure 1

ADC_TC.023 Setting the MSS-flag doesn't generate an interrupt in TEST-MODE

It is possible to generate a software triggered interrupt event in TESTMODE (ADCx_CON.SRTEST=1) by setting one of the bitflags in register ADCx_MSS0/1. Due to the fact, that this mechanism is not working, it is not possible to generate a corresponding interrupt by software.

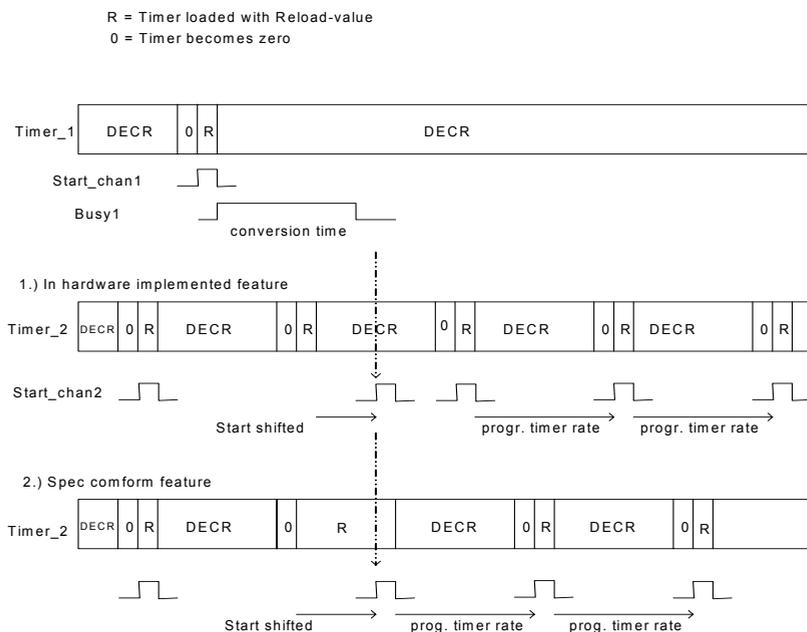
Figure 2 Timing concerning equidistant multiple timers

The correct behavior would be a reload when the requested conversion (of channel_2) is started.

Therefore the start of conversion for channel_2 is delayed by maximum one conversion-time. After this delay it will be continued with equidistant conversion-starts. Please refer to figure 1.

Note: the programmed timer rate is much longer than the conversion time, this means that the fault is much smaller than in the picture

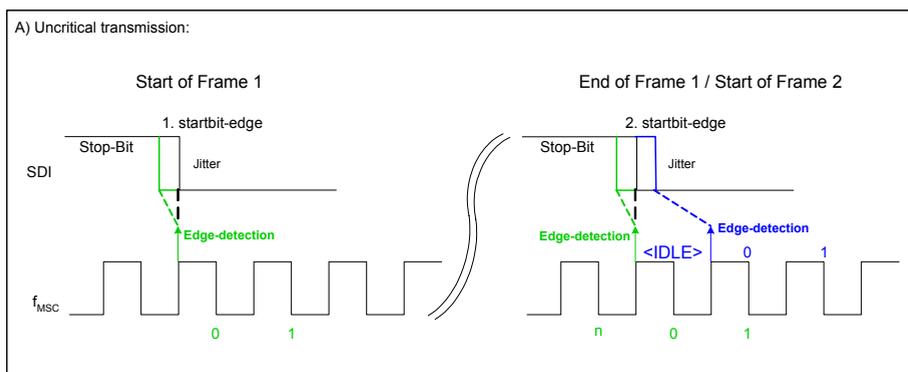
Figure 3 Uncritical transmission

As the falling startbit edge is shifted to the left of the rising clock edge (**Figure 3** left), there occurs a secure detection of the next startbit edge in the last cycle of the previous frame (here cycle n, **Figure 3** right) independent from the applied jitter to this edge.

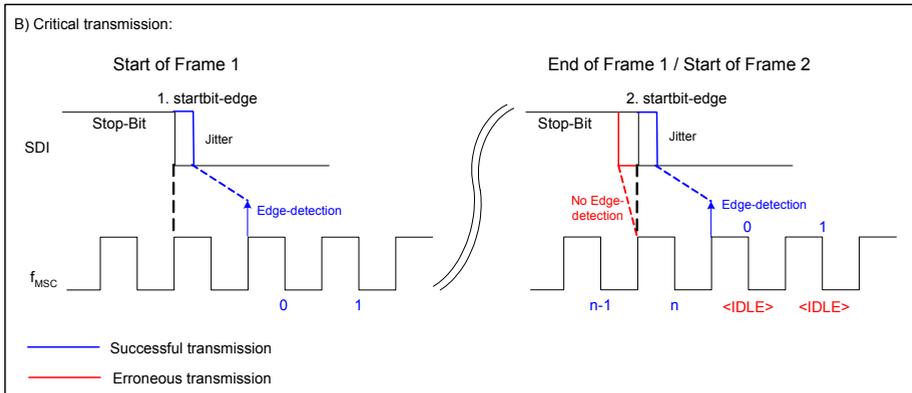
Figure 4 Critical transmission

If the high-low edge of the start-bit in the first frame is just not detected by the near clock-edge (**Figure 4** - left) and the start-bit edge of the second frame is jittering to cycle n-1 (**Figure 4** - right, red coloured), then an erroneous transmission will take place. In this case the state-machine switches to IDLE after the last state n and wakes up on the next falling edge that may be a data-bit recognized as a start-bit. If the start-bit of the second frame is jittering to cycle n (**Figure 4** - right, blue colored), then the state-machine will not switch to IDLE but will start receiving the next frame correctly.

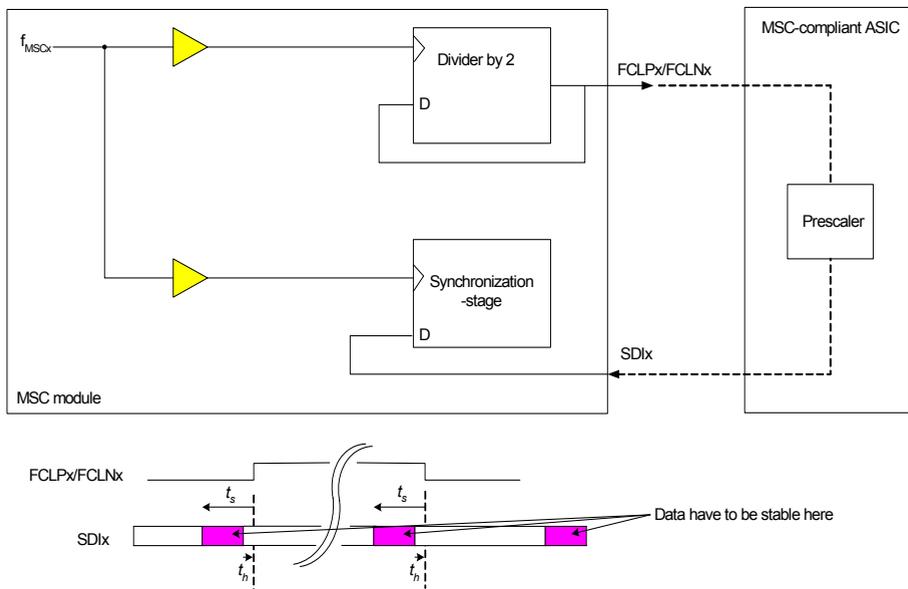
Figure 5 Delay adjustment relative to the module clock

Figure 5 shows the principle blockdiagram of the input synchronization stage of the MSC module.

The values for setup- and hold-times are listed in the following table. They were taken out of the timing analysis tool of the microcontroller device and apply to both, the rising and the falling edge.

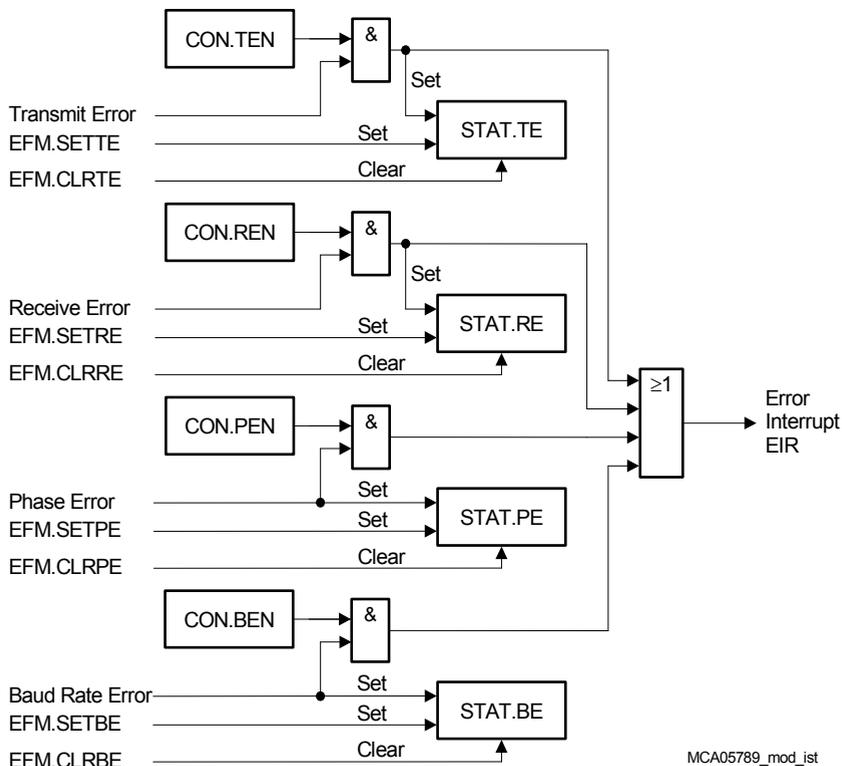
Figure 8 SSC Error Interrupt Control

A **Receive Error** (Master or Slave Mode) is detected when a new data frame is completely received, but the previous data was not read out of the receive buffer register `RB`. If enabled via `CON.REN`, this condition sets the error flag `STAT.RE` and activates the error interrupt request line `EIR`. The old data in the receive buffer `RB` will be overwritten with the new value and is unretrievably lost.

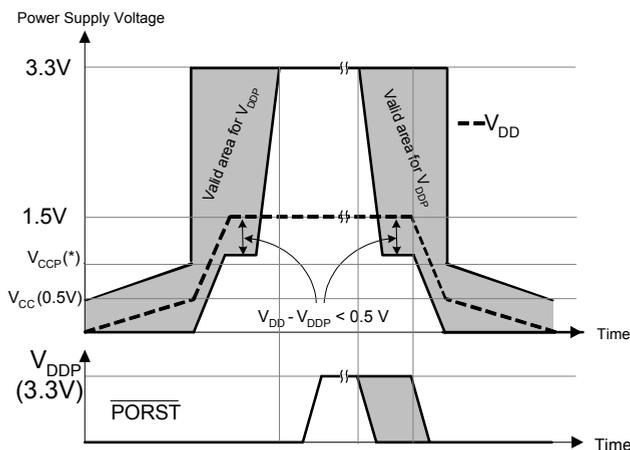
Figure 9 Exemplary power up sequence
Reliability risk

The violation of the parallel power sequencing for any supply is allowed for a maximum of 4% of the operational lifetime, before encountering a reliability risk. Additionally, for a maximum of 4% of the operational lifetime it is allowed to have V_{AREF} supplied while the 1.5V supplies have not reached a value as defined in the operating conditions.

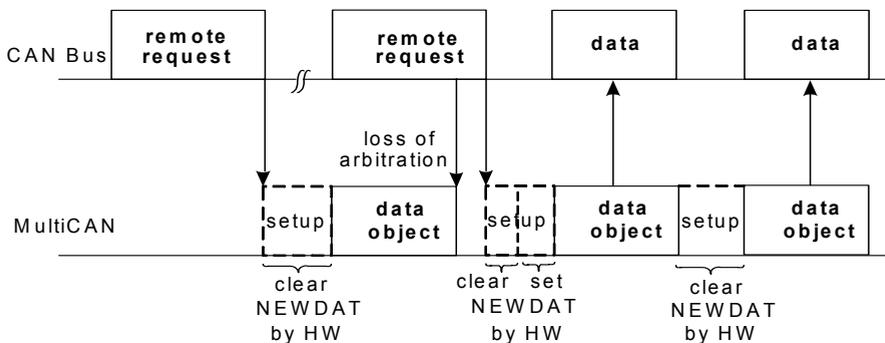
Figure 10 loss of arbitration

When the appropriate message object (data frame) triggered by the first remote frame wins the arbitration, it will be sent out and `NEWDAT` is not reset. This leads to an additional data frame, that will be sent by this message object (clearing `NEWDAT`).

There will, however, not be more data frames than there are corresponding remote requests.
