Device TC1766
Marking/Step ES-BD, BD
Package PG-LQFP-176-2

02967AERRA

This Errata Sheet describes the deviations from the current user documentation.

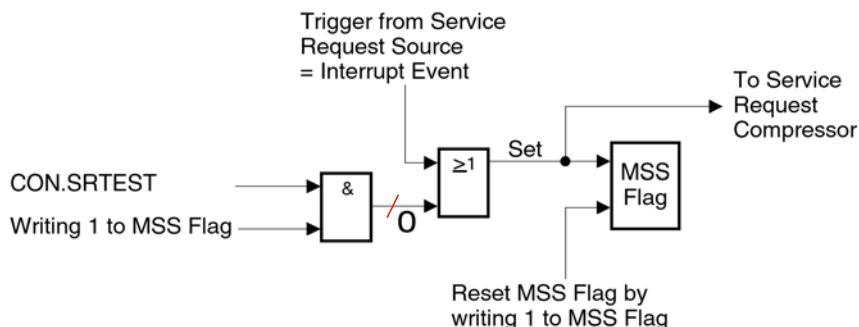
Figure 1

ADC_TC.023 Setting the MSS-flag doesn't generate an interrupt in TEST-MODE

It is possible to generate a software triggered interrupt event in TESTMODE (ADCx_CON.SRTEST=1) by setting one of the bitflags in register ADCx_MSS0/1. Due to the fact, that this mechanism is not working, it is not possible to generate a corresponding interrupt by software.

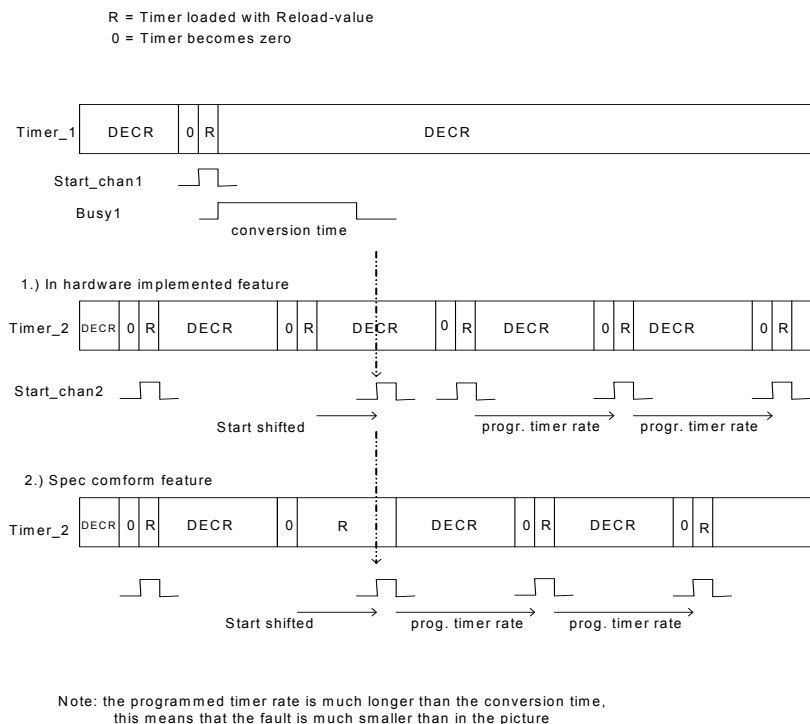
Figure 2 Timing concerning equidistant multiple timers

The correct behavior would be a reload when the requested conversion (of channel_2) is started.

Therefore the start of conversion for channel_2 is delayed by maximum one conversion-time. After this delay it will be continued with equidistant conversion-starts. Please refer to the following figure.

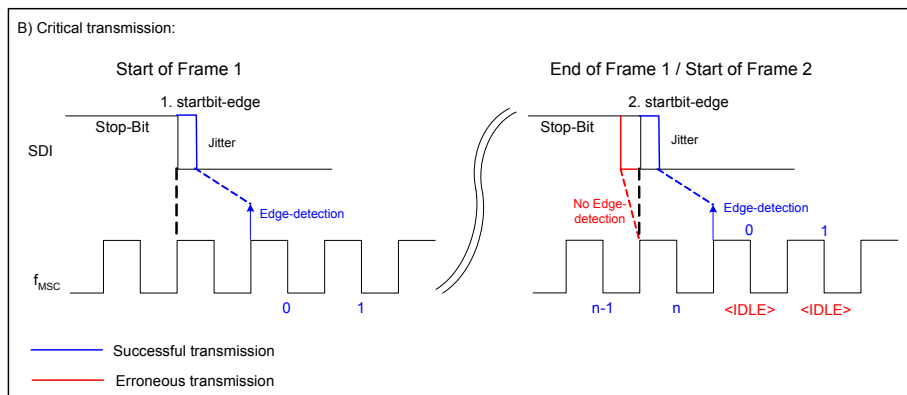
Figure 4 Critical transmission

If the high-low edge of the start-bit in the first frame is just not detected by the near clock-edge (**Figure 4** - left) and the start-bit edge of the second frame is jittering to cycle $n-1$ (**Figure 4** - right, red coloured), then an erroneous transmission will take place. In this case the state-machine switches to IDLE after the last state n and wakes up on the next falling edge that may be a data-bit recognized as a start-bit. If the start-bit of the second frame is jittering to cycle n (**Figure 4** - right, blue colored), then the state-machine will not switch to IDLE but will start receiving the next frame correctly.

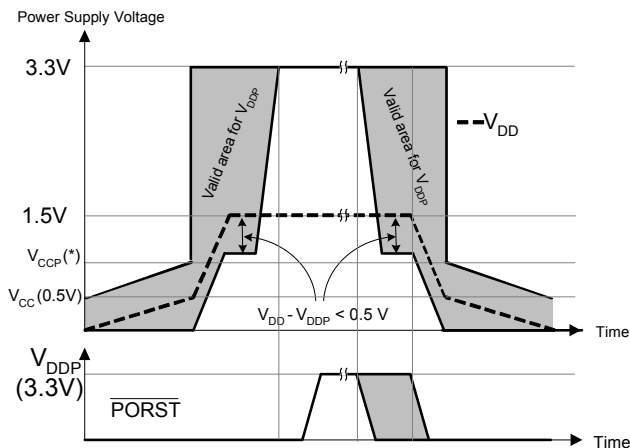
Figure 10 Exemplary power-up/down sequence

- All analog voltages (V_{DDOSC3} , V_{DDM} , V_{DDMF} , V_{DDFL3}) must also follow V_{DDP} power-up/down sequence.
- V_{DDAF} , V_{DDOSC} must follow V_{DD} power-up/down sequence.
- The absolute value of the maximum allowed deviation between any two supplies is 0.5 V while the 1.5V supplies are below their specified operating conditions.

Note: V_{CC} and V_{CCP} in [Figure 10](#) refer to devices with PWR_TC.P009 erratum.
