Device TC1767ED
Marking/Step EES-AD, ES-AD
Package PG-LQFP-176-4

01960AERRA

This Errata Sheet describes the deviations from the current user documentation.

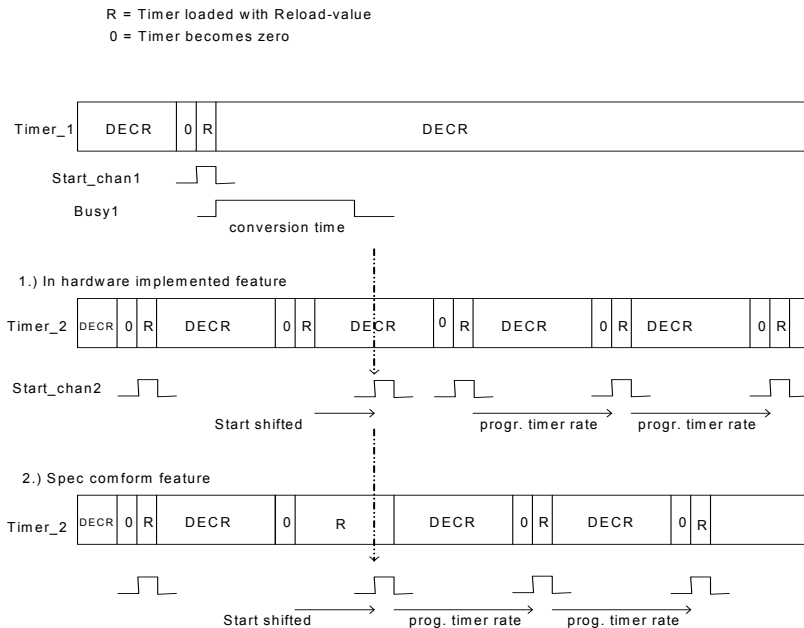
Figure 1 Timing concerning equidistant multiple timers

The correct behavior would be a reload when the requested conversion (of channel_2) is started.

Therefore the start of conversion for channel_2 is delayed by maximum one conversion-time. After this delay it will be continued with equidistant conversion-starts. Please refer to the following figure.

Note: the programmed timer rate is much longer than the conversion time, this means that the fault is much smaller than in the picture

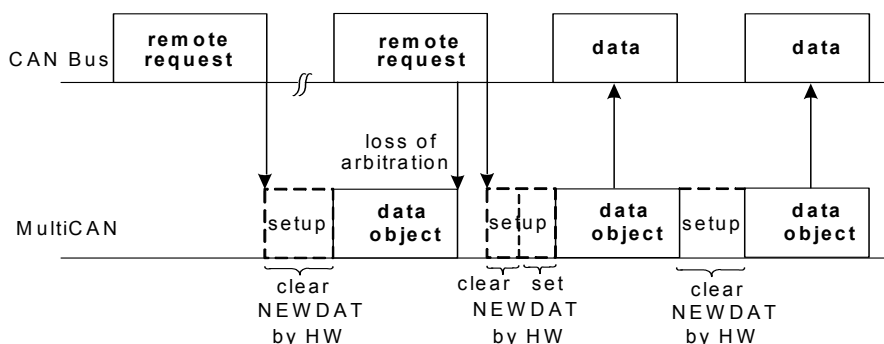
**Figure 2 Loss of Arbitration**

When the appropriate message object (data frame) triggered by the first remote frame wins the arbitration, it will be sent out and `NEWDAT` is not reset. This leads to an additional data frame, that will be sent by this message object (clearing `NEWDAT`).

There will, however, not be more data frames than there are corresponding remote requests.
