Device TC1767
Marking/Step EES-AD, ES-AD, AD
Package PG-LQFP-176-5

01704AERRA

This Errata Sheet describes the deviations from the current user documentation.

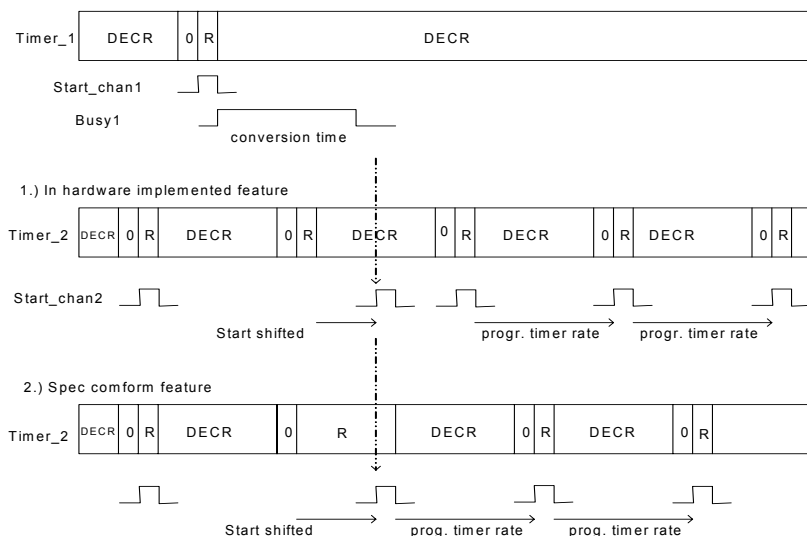
Figure 1 Timing concerning equidistant multiple timers

Therefore the start of conversion for channel_2 is delayed by maximum one conversion-time. After this delay it will be continued with equidistant conversion-starts. Please refer to the following figure.

Note: the programmed timer rate is much longer than the conversion time,
this means that the fault is much smaller than in the picture

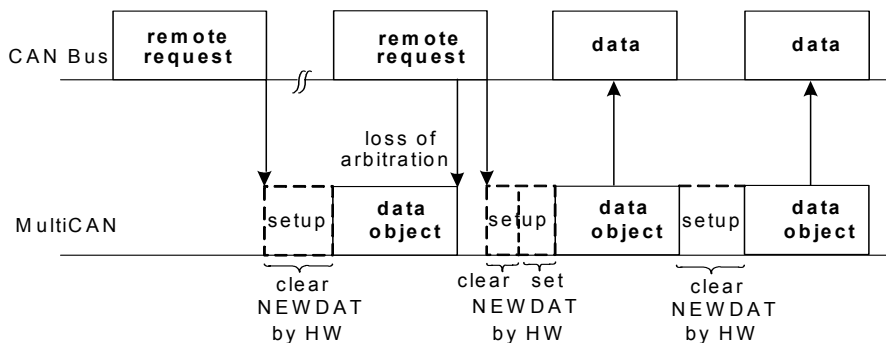
**Figure 2 Loss of Arbitration**

When the appropriate message object (data frame) triggered by the first remote frame wins the arbitration, it will be sent out and NEWDAT is not reset. This leads to an additional data frame, that will be sent by this message object (clearing NEWDAT).

There will, however, not be more data frames than there are corresponding remote requests.
