Device TC1796
Marking/Step EES-BC, ES-BC, BC
Package P-BGA-416, PG-BGA-416

02131AERRA

This Errata Sheet describes the deviations from the current user documentation.

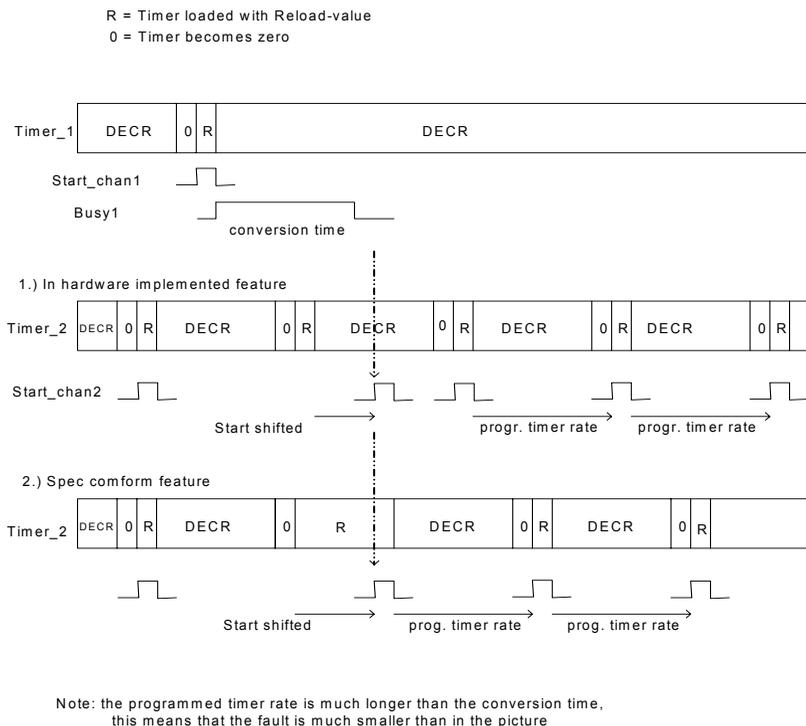
Figure 3 Timing concerning equidistant multiple timers

The correct behavior would be a reload when the requested conversion (of channel_2) is started.

Therefore the start of conversion for channel_2 is delayed by maximum one conversion-time. After this delay it will be continued with equidistant conversion-starts. Please refer to the following figure.

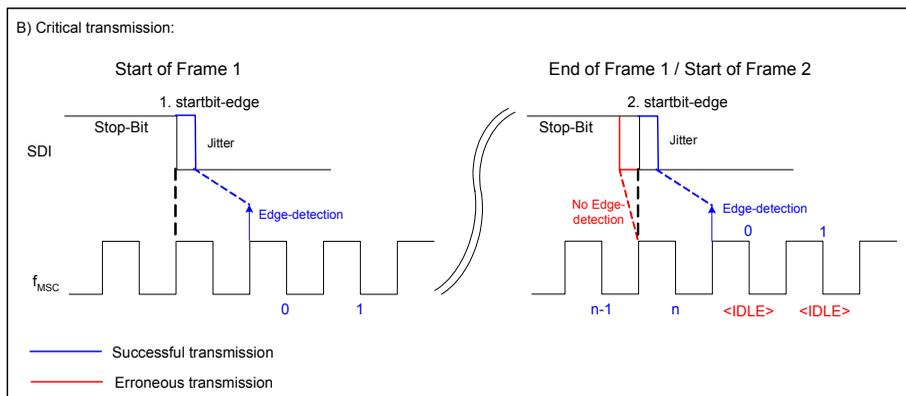
Figure 6 Critical transmission

If the high-low edge of the start-bit in the first frame is just not detected by the near clock-edge (**Figure 6** - left) and the start-bit edge of the second frame is jittering to cycle n-1 (**Figure 6** - right, red coloured), then an erroneous transmission will take place. In this case the state-machine switches to IDLE after the last state n and wakes up on the next falling edge that may be a data-bit recognized as a start-bit. If the start-bit of the second frame is jittering to cycle n (**Figure 6** - right, blue colored), then the state-machine will not switch to IDLE but will start receiving the next frame correctly.

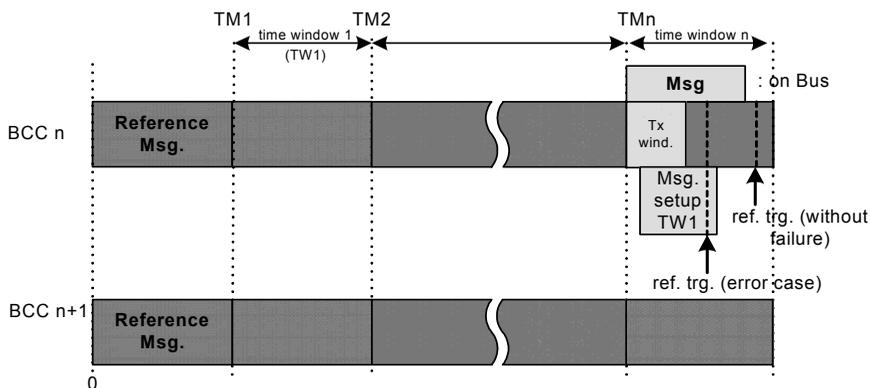
Figure 10
Workaround

The TTCAN controller is configured as timer master, gap mode has been selected and no message is transferred (reception or transmission) after the transmit enable window in the last time window. With the end of the transmit enable window, the TTCAN logic starts waiting for a reference message trigger to send a reference message. At the beginning of each time window, the TTCAN logic evaluates the scheduler entries for the following time window and prepares the setup of the corresponding message for the next transfer window. If the reference trigger becomes active after the end of the transmit enable window, but still during the setup phase, the prepared message will be sent out instead of the reference message. After this erroneously sent message, the reference message will be sent out correctly. The error does not occur if the reference trigger becomes active after the end of the setup time.

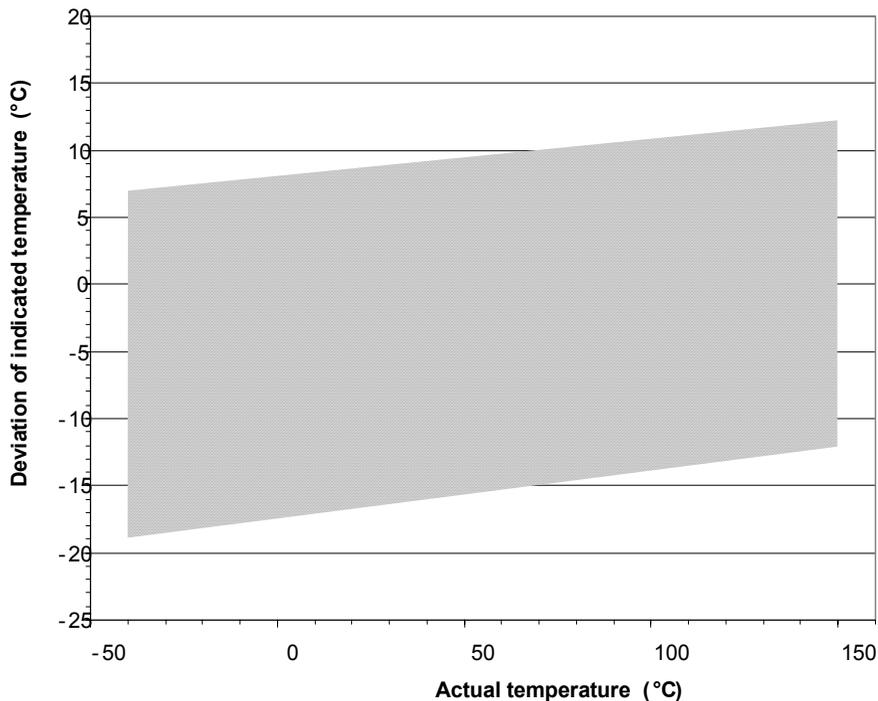
Figure 12 Current accuracy range
Workaround

- +/-12°C at $T_j = 150^{\circ}\text{C}$
- +9/-17°C at $T_j = 25^{\circ}\text{C}$
- +7/-19°C at $T_j = -40^{\circ}\text{C}$

To keep the accuracy within the specified margins of $\pm 10^{\circ}\text{C}$, the following formula to calculate the die temperature is available if MSB of the byte at D000 0003_H is 1_B:

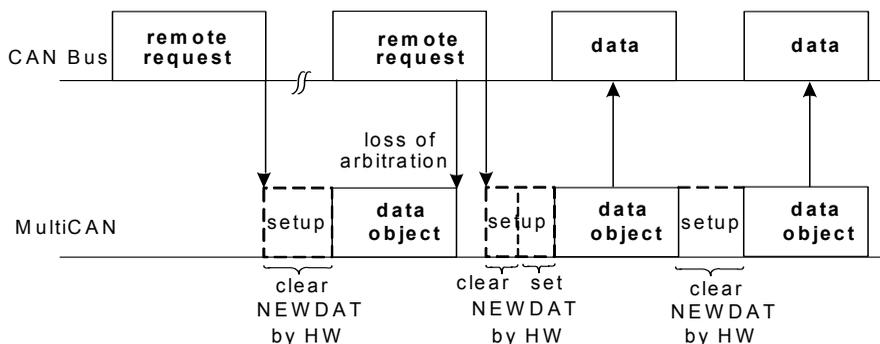
Figure 17 Loss of Arbitration

When the appropriate message object (data frame) triggered by the first remote frame wins the arbitration, it will be sent out and $NEWDAT$ is not reset. This leads to an additional data frame, that will be sent by this message object (clearing $NEWDAT$).

There will, however, not be more data frames than there are corresponding remote requests.

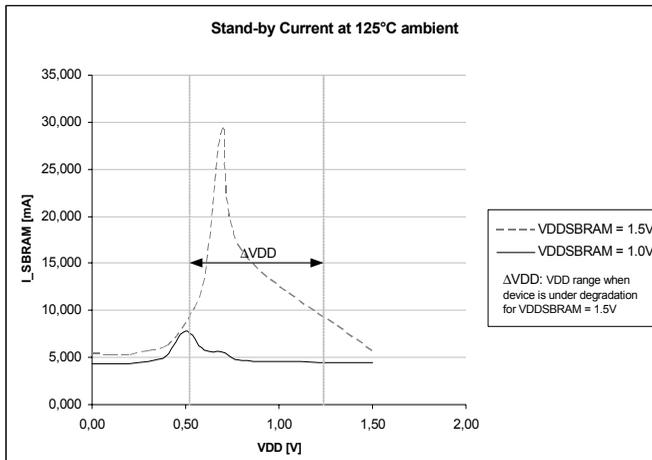
Figure 19 Stand-by current at 125°C ambient

During transition from/to stand-by mode, while increasing or decreasing core power supply (V_{DD}), it may happen, due to cross-current, that I_{SBRAM} reaches high current values.

The worst case takes place when $V_{DD} = V_{DDSB RAM}/2$, specially if $V_{DDSB RAM} = 1.5$ V (SBRAM power supply for normal operation). In this situation, I_{SBRAM} may reach 29.5 mA (hot at 125°C ambient).
