Device TC1798/93/91, TC1748
Marking/Step ES-AB, AB
Package see Data Sheet

02698AERRA

This Errata Sheet describes the deviations from the current user documentation.

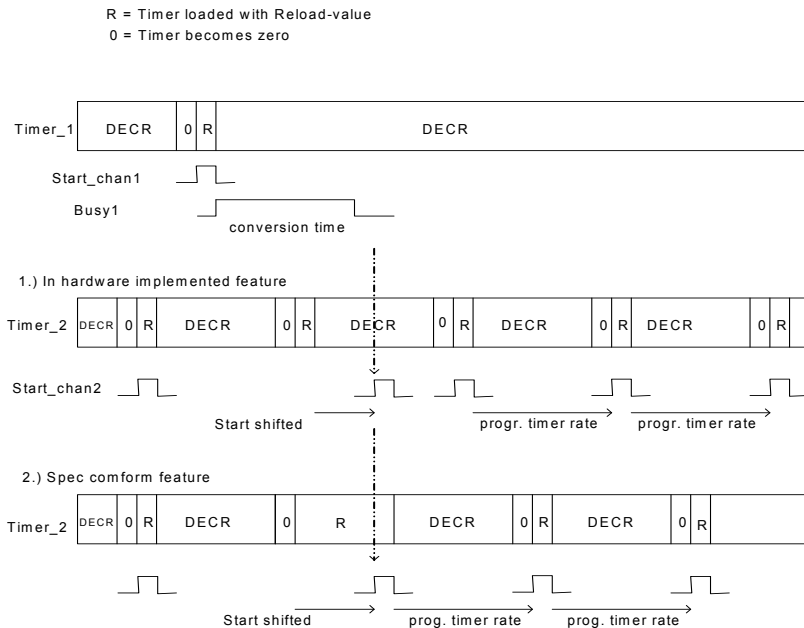
Figure 1 Timing concerning equidistant multiple timers

The correct behavior would be a reload when the requested conversion (of channel_2) is started.

Therefore the start of conversion for channel_2 is delayed by maximum one conversion-time. After this delay it will be continued with equidistant conversion-starts. Please refer to the following figure.

Note: the programmed timer rate is much longer than the conversion time, this means that the fault is much smaller than in the picture
