<b>Device</b>	<b>XC161CJ-16F</b>
<b>Marking/Step</b>	<b>(E)ES-BB, BB</b>
<b>Package</b>	<b>PG-TQFP-144-7, P-TQFP-144-19</b>

This Errata Sheet describes the deviations from the current user documentation.

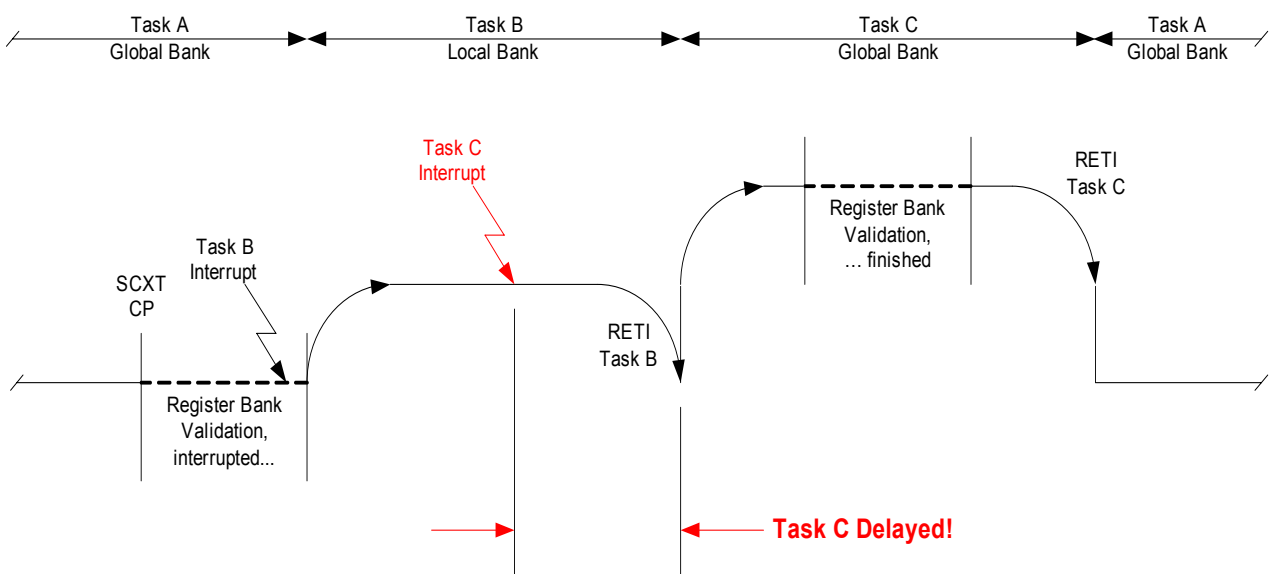
**Figure 1 Example for Case 2: Interrupt Service for Task C delayed**

- The Context Pointer CP is written to (e.g. by POP, MOV, SCXT .. instructions) within a routine (Task A) that uses a **global** register bank (bit field PSW.BANK = 00<sub>B</sub>), i.e. the context for this routine will be modified,
- This context switch procedure (19 cycles) is interrupted by an interrupt request (Task B) which is programmed (with GPRSELx = 1X<sub>B</sub>) to automatically use one of the **local** banks via the bank selection registers BNKSEL0..3 (i.e. the interrupting routine has a priority level ≥12),
- Before the corresponding interrupt service routine is finished, another interrupt request (Task C) occurs which is programmed (with GPRSELx = 00<sub>B</sub>) to automatically use the **global** bank via the bank selection registers BNKSEL0..3 (i.e. the interrupting routine has a priority level ≥13)

In this case service of this interrupt request (for Task C) is delayed until bit field PSW.BANK becomes 00<sub>B</sub> after executing the RETI instruction at the end of the routine (Task B) using the local bank.
