## Errata Sheet

V0.4, 2004-09-27

**Device** XC164CS-8FF, -8F20F, -8F40F  
**Stepping Code/Marking** ES-AC, AC  
**Package** P-TQFP-100-16

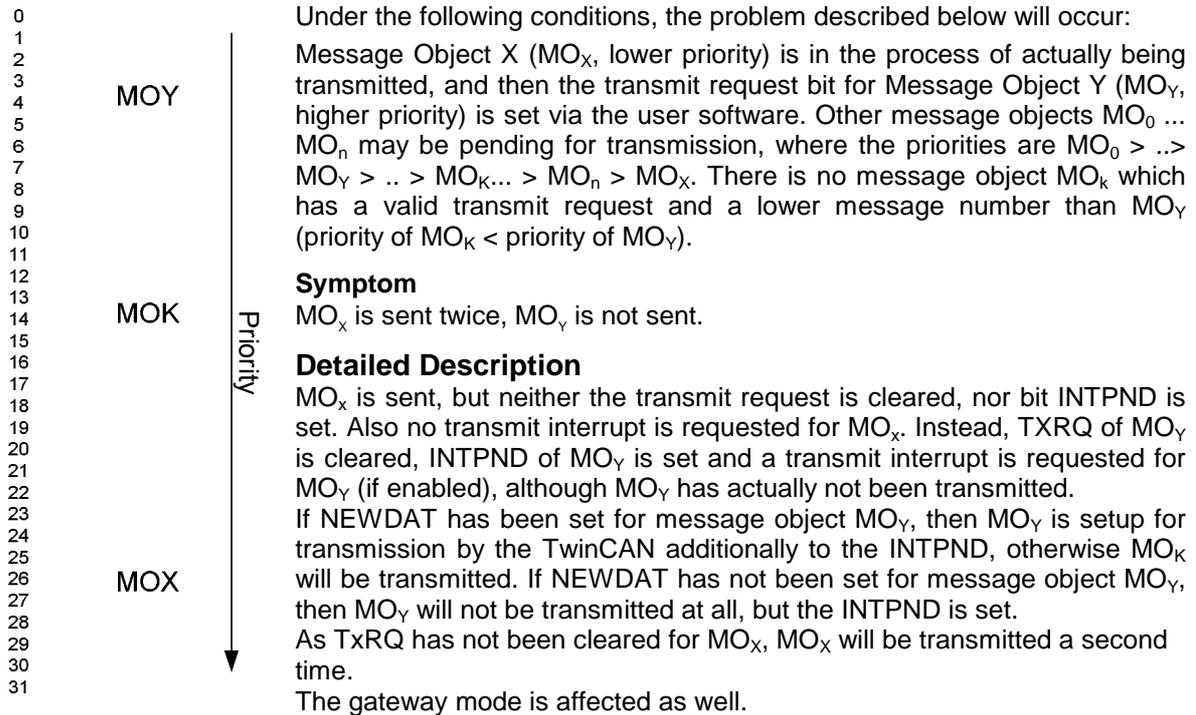
## **TwinCAN2.005: Double Send**

In case the STT bit is used, the error will occur in any case.

- Remote frames have to be forbidden; otherwise an "uncontrolled" TxRQ will be set. Set Message Object Transmit Requests (TxRQs) in order from 0 to 31, rather than at random. This could be done by implementing a software array for transmit requests TxRQs[32]. When a TxRQ bit for a Message Object has to be set, the software should write to the corresponding location within the software array. On a regular basis, all transmit requests then have to be reset and set according to the settings within the software array, to enable all message objects with TxRQs to be updated in the correct order. Between reset and set the application has to wait for the length of two CAN frames.  
In order to use the gateway mode, do not set the GDFS bit in MSGFGCR.

- Under the same software control as in workaround a) TxRQs can be set, as long as CPUUPD is set and only reset in the natural order. In this case Remote Frames are allowed.
