Errata Sheet

V0.3, 2004-09-27

Device	XC164CS-8FF, -8F20F, -8F40F
Stepping Code/Marking	ES-AD, AD
Package	P-TQFP-100-16

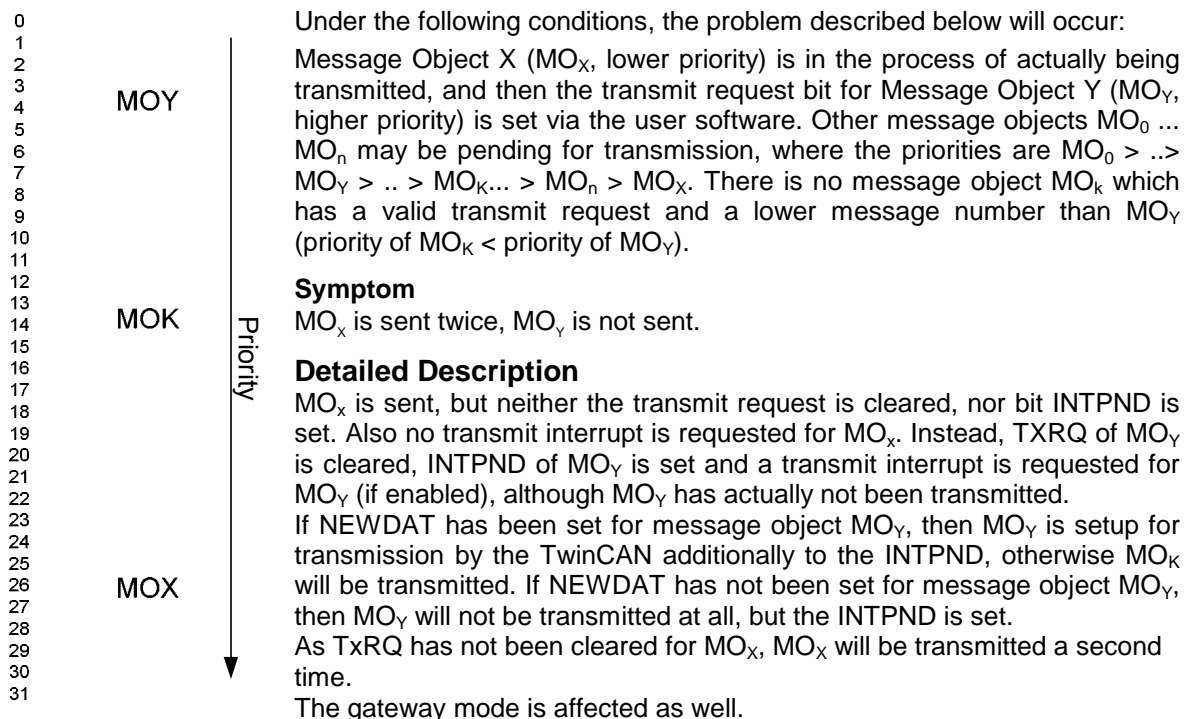
TwinCAN2.005:

Double Send

In case the STT bit is used, the error will occur in any case.

- Remote frames have to be forbidden; otherwise an "uncontrolled" TxRQ will be set. Set Message Object Transmit Requests (TxRQs) in order from 0 to 31, rather than at random. This could be done by implementing a software array for transmit requests TxRQs[32]. When a TxRQ bit for a Message Object has to be set, the software should write to the corresponding location within the software array. On a regular basis, all transmit requests then have to be reset and set according to the settings within the software array, to enable all message objects with TxRQs to be updated in the correct order. Between reset and set the application has to wait for the length of two CAN frames.
In order to use the gateway mode, do not set the GDFS bit in MSGFGCR.

- Under the same software control as in workaround a) TxRQs can be set, as long as CPUUPD is set and only reset in the natural order. In this case Remote Frames are allowed.
