Rel. 1.2, 03.12.2010

Device XC822/824MT Series

Marking/Step AA

Package PG-TSSOP-16/DSO-20

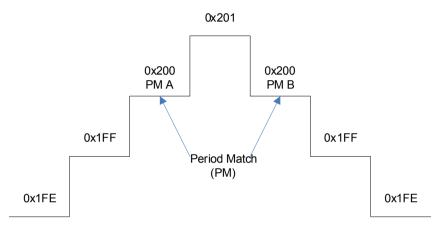
Figure 1 Counting sequence of T12 in center-aligned mode

### CCU6 XC8.H002 CCU6 PM event in center-aligned mode

After detecting a period match (PM A) in centre-aligned mode, T12 counts down from PM + 1 as shown below:

This means a second PM event (PM B) will occur during the counting down. If ADC is triggered externally via REQTRxC (T12PM), it will be triggered twice in succession. Depending on how real-time the application code is running as well as the T12 count rate and ADC conversion rate, the application could observe two ADC interrupts - once at PM A and once at PM B.

To avoid triggering twice the ADC interrupts, it is suggested to use REQTRxF from multi-channel mode instead of REQTRxC as the trigger source for ADC. Additional initialization are as follows:

- Configure MCMCTR.SWSEL = 101<sub>B</sub> (Transfer on T12 period match)
- Configure MCMCTR.SWSYN = 00<sub>B</sub> (Direct transfer)
- Write to MCMOUTSTL = CF<sub>H</sub> (To enable multi-Channel PWM pattern on CC6x and COUT6x)
