Device	XC864L-1FR
Marking/Step	AA
Package	PG-TSSOP-20

This Errata Sheet describes the deviations from the current user documentation. The module oriented classification and numbering system uses an ascending sequence over several derivatives, including already solved deviations. So gaps inside this enumeration can occur.

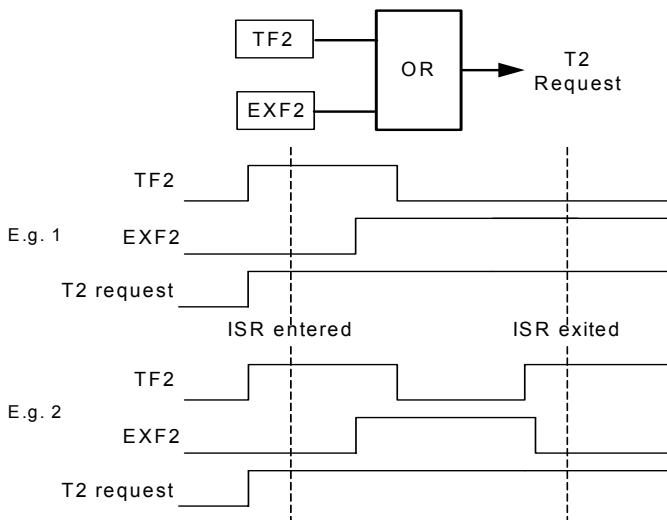
Figure 2

The problem is that it may occur at some point in the application, that any new Timer 2 interrupt request can no longer be detected after a return-from-interrupt (reti) due to service of earlier event(s). This happens when the following conditions are true:

1. Timer 2 events are serviced by interrupt (i.e. flags are checked and cleared only in the interrupt routine ISR),
2. Either TF2 or EXF2 is set at any one time throughout the ISR (even while the other is cleared) such that at least one of the flags is still set after reti, causing the Timer 2 request line, which is an OR-function of the two flags TF2 and EXF2, to remain set throughout the ISR and after reti.

Two example scenarios are illustrated in the following figure:

This means, any future Timer 2 TF2 or EXF2 event is not able to cause a rising edge and therefore not able to trigger an interrupt request to the core – as if the Timer 2 interrupts had been disabled, until both EXF2 and TF2 flags are cleared at some time. The clearing of flags would have to be done by user's code additionally outside of the Timer 2 interrupt routine, which is however normally not feasible with an interrupt service scheme.

1. If other events of Timer 2 interrupt node (ET2) need not be enabled for interrupt, disable this interrupt node and use software polling of the flags instead.
2. Before return from interrupt, check again if TF2 or EXF2 is (still) set (due to new request since the last check). If so, jump and execute the ISR routine from start. Exit only when all flags are checked to be cleared. However, dummy interrupt of the node may occur after return from interrupt, and should be ignored. Another drawback is if Timer 2 events are occurring at high rate, the CPU may be 'stuck' in the service routine of the Timer 2 interrupt for a long time.

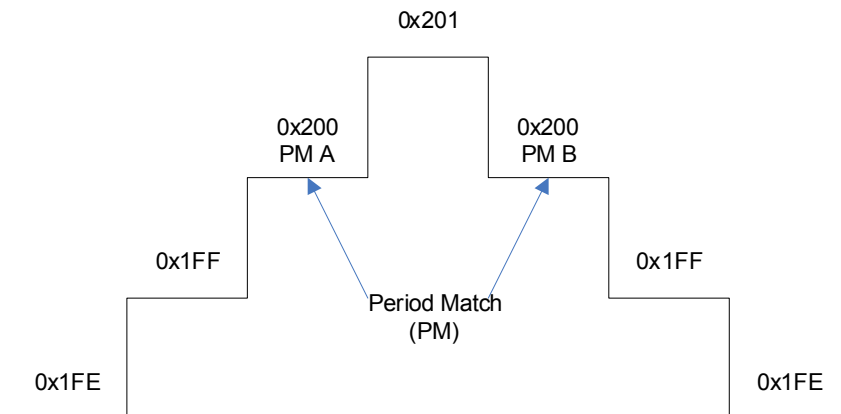
Figure 4 Counting sequence of T12 in center-aligned mode

After detecting a period match (PM A) in centre-aligned mode, T12 counts down from PM + 1 as shown below:

This means a second PM event (PM B) will occur during the counting down. If ADC is triggered externally via ETRx2 (T12PM), it will be triggered twice in succession. Depending on how real-time the application code is running as well as the T12 count rate and ADC conversion rate, the application could observe two ADC interrupts - once at PM A and once at PM B.

To avoid triggering twice the ADC interrupts, it is suggested to use ETRx6 from multi-channel mode instead of ETRx2 as the trigger source for ADC. Additional initialization are as follows:

- Configure MCMCTR.SWSEL = 101_B (Transfer on T12 period match)
- Configure MCMCTR.SWSYN = 00_B (Direct transfer)
- Write to MCMOUTSTL = CF_H (To enable multi-Channel PWM pattern on CC6x and COUT6x)
