Device	XC866-1FR
Marking/Step	EES-AA,ES-AA
Package	PG-TSSOP-38

This Errata Sheet describes the deviations from the current user documentation. The module oriented classification and numbering system uses an ascending sequence over several derivatives, including already solved deviations. So gaps inside this enumeration can occur.

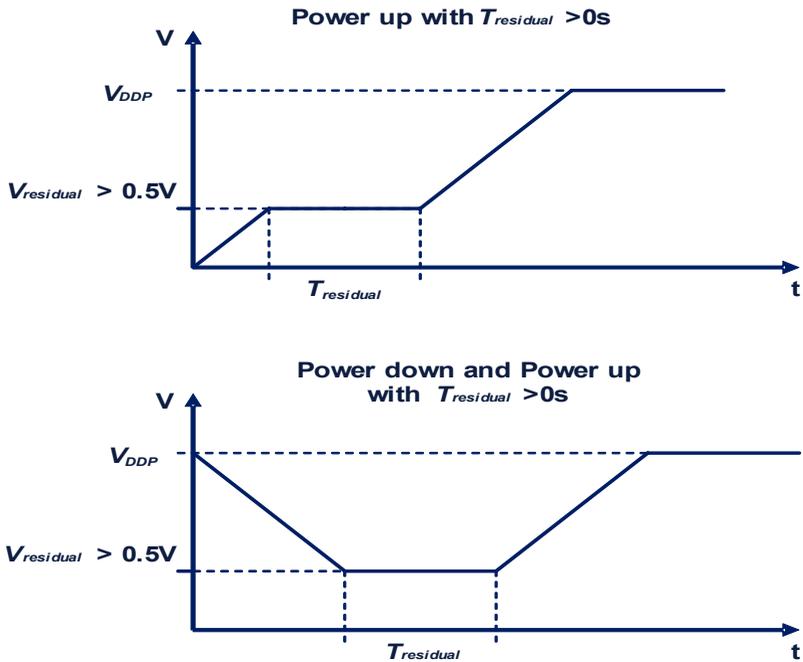
Figure 1 Critical Cases for Power up/ Power down when $V_{residual} > 500mV$

Due to the limitation of the EVR, the reset toggling may occur during the power up. To prevent the reset toggling issue for power up, the following conditions must be met :

1. For power up, the rising time must be less than 2ms/V .
2. The power down time must be more than 0.2ms/V .
3. A permanent V_{DDP} residual voltage is less than 500mV .

In case of V_{DDP} residual voltage is more than 500mV , the holding time of residual voltage affects the reset toggling issue. **Figure 1** shows the critical cases for power up/power down when the residual voltages is held for some time. **Figure 2** shows the uncritical case for power up and power down when the power up is triggered immediately after power down. In case of a residual voltage due to immediate power up after power down, the users have to contact IFX to ensure no power up failure.

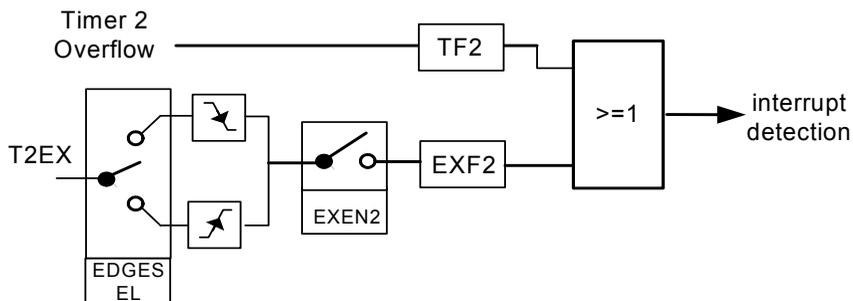
Figure 3

As illustrated in the simplified figure, the Timer 2 interrupt flags TF2 and EXF2 are combined as one interrupt request output. These flags are located within the Timer 2 kernel, with a single interrupt request line as output from the kernel.

Being of interrupt structure 2, the interrupt request of Timer 2 is detected on the rising edge of a positive pulse.

The problem is that it may occur at some point in the application, that any new Timer 2 interrupt request can no longer be detected after a return-from-interrupt (reti) due to service of earlier event(s). This happens when the following conditions are true:

There is no problem if EXF2 is not enabled by setting bit EXEN2 = 0 i.e. external events are disabled, or if bit DCEN = 1 in auto-reload mode.

Otherwise if EXF2 is enabled, while TF2 is always enabled when Timer 2 is running, there are two suggested workaround:

1. If other events of Timer 2 interrupt node (ET2) need not be enabled for interrupt, disable this interrupt node and use software polling of the flags instead.
2. Before return from interrupt, check again if TF2 or EXF2 is (still) set (due to new request since the last check). If so, jump and execute the ISR routine from start. Exit only when all flags are checked to be cleared. However, dummy interrupt of the node may occur after return from interrupt, and should be ignored. Another drawback is if Timer 2 events are occurring at high rate, the CPU may be 'stuck' in the service routine of the Timer 2 interrupt for a long time.

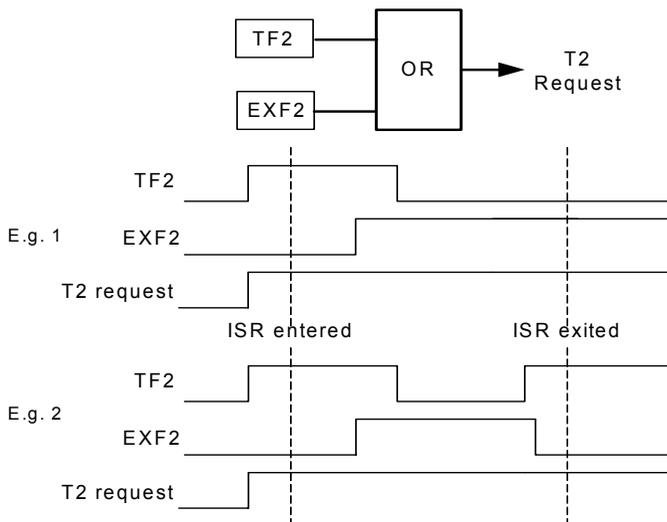
Figure 4

1. Timer 2 events are serviced by interrupt (i.e. flags are checked and cleared only in the interrupt routine ISR),
2. Either TF2 or EXF2 is set at any one time throughout the ISR (even while the other is cleared) such that at least one of the flags is still set after reti, causing the Timer 2 request line, which is an OR-function of the two flags TF2 and EXF2, to remain set throughout the ISR and after reti.

Two example scenarios are illustrated in the following figure:

This means, any future Timer 2 TF2 or EXF2 event is not able to cause a rising edge and therefore not able to trigger an interrupt request to the core – as if the Timer 2 interrupts had been disabled, until both EXF2 and TF2 flags are cleared at some time. The clearing of flags would have to be done by user's code additionally outside of the Timer 2 interrupt routine, which is however normally not feasible with an interrupt service scheme.

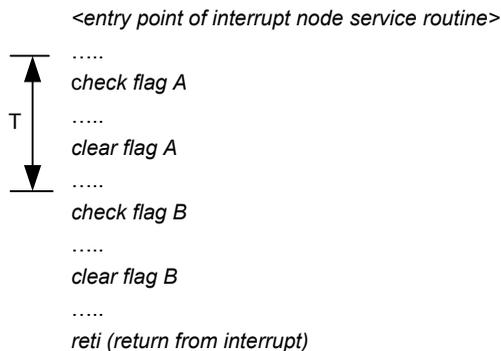
Figure 6

Consider the following interrupt service routine pseudo-code, and scenario where a interrupt source A event leads to interrupt request of the node and CPU vectors to the interrupt routine. Meanwhile, interrupt source B and its flag becomes active any time in the duration indicated by T:

In this case, flag B will be cleared as a standard procedure by the interrupt routine in the current service of the interrupt node. However, the pending interrupt request for the node remains activated after RETI, as it is only cleared by hardware when CPU acknowledge the interrupt and vectors to the interrupt routine.

This leads to following servicing of the interrupt node again, but potentially no active flag is found, i.e. dummy interrupt service. The point to note is that the interrupt source B is not lost, as it was actually serviced in the current service of the interrupt node.

The recommendation is to ignore these dummy interrupt vectoring.

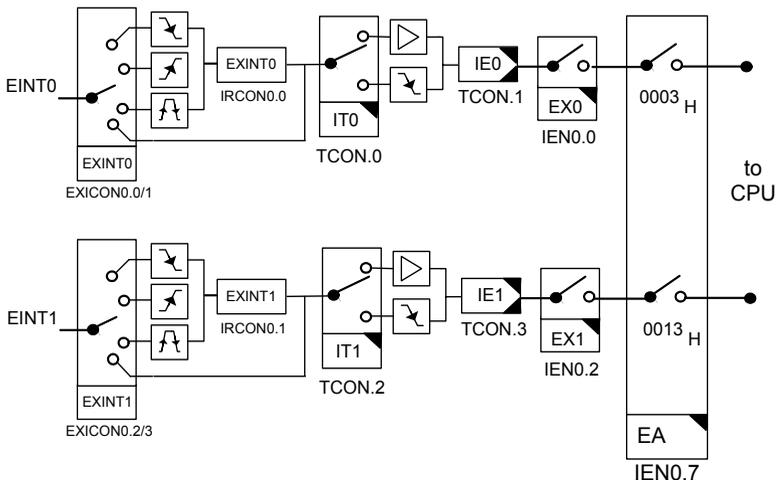
Figure 7

External interrupt 0 and 1 may individually be selected via respective bits ($EXINTx$) in $EXICON0$ register, to request interrupt on falling edge, rising edge, both edges or to bypass the edge detection.

Edge detection is done in the system unit. If enabled, an active event will set the $EXINTx$ flag and correspondingly set the IEx flag in $TCON$. It should be noted that after any external interrupt x event, flag $EXINTx$ must be cleared. In case of falling edge as active event, this allows any future active event to be able to set the flag IEx as interrupt request. In case of low level as active event, this prevents unintended recurring triggering of interrupt request.

In case of bypass edge detection, the input is connected directly to the core (bypass the system unit). The flag IEx in $TCON$ will be set on the selected falling edge or low level (at least 2 clock cycles) event. In case of falling edge selected as active event by $TCON.ITx$, the flag $EXINTx$ is set in addition to the flag IEx . However to use this mode properly, user must not clear the flag $EXINTx$ and if necessary, to only access the flag $TCON.IEx$ (refer to INT_XC8.003).
