Device	XC866-2FR
Marking/Step	BC
Package	PG-TSSOP-38

This Errata Sheet describes the deviations from the current user documentation. The module oriented classification and numbering system uses an ascending sequence over several derivatives, including already solved deviations. So gaps inside this enumeration can occur.

# 1 History List / Change Summary

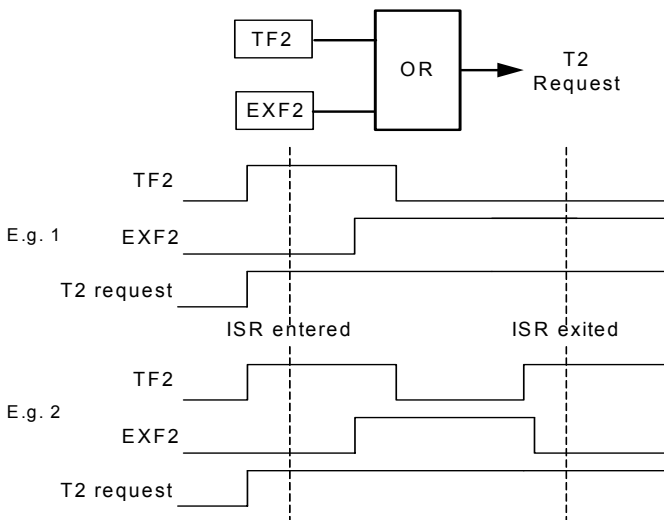
**Figure 4**

1. Timer 2 events are serviced by interrupt (i.e. flags are checked and cleared only in the interrupt routine ISR),
2. Either TF2 or EXF2 is set at any one time throughout the ISR (even while the other is cleared) such that at least one of the flags is still set after reti, causing the Timer 2 request line, which is an OR-function of the two flags TF2 and EXF2, to remain set throughout the ISR and after reti.

Two example scenarios are illustrated in the following figure:

This means, any future Timer 2 TF2 or EXF2 event is not able to cause a rising edge and therefore not able to trigger an interrupt request to the core – as if the Timer 2 interrupts had been disabled, until both EXF2 and TF2 flags are cleared at some time. The clearing of flags would have to be done by user's code additionally outside of the Timer 2 interrupt routine, which is however normally not feasible with an interrupt service scheme.

There is no problem if EXF2 is not enabled by setting bit EXEN2 = 0 i.e. external events are disabled, or if bit DCEN = 1 in auto-reload mode.

Otherwise if EXF2 is enabled, while TF2 is always enabled when Timer 2 is running, there are two suggested workaround:

1. If other events of Timer 2 interrupt node (ET2) need not be enabled for interrupt, disable this interrupt node and use software polling of the flags instead.
2. Before return from interrupt, check again if TF2 or EXF2 is (still) set (due to new request since the last check). If so, jump and execute the ISR routine from start. Exit only when all flags are checked to be cleared. However, dummy interrupt of the node may occur after return from interrupt, and should be ignored. Another drawback is if Timer 2 events are occurring at high rate, the CPU may be 'stuck' in the service routine of the Timer 2 interrupt for a long time.

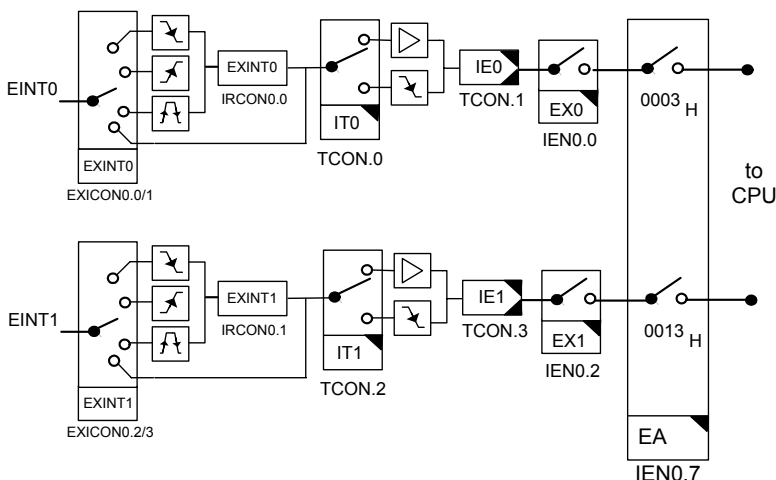
**Figure 7**

External interrupt 0 and 1 may individually be selected via respective bits ( $EXINTx$ ) in  $EXICON0$  register, to request interrupt on falling edge, rising edge, both edges or to bypass the edge detection.

Edge detection is done in the system unit. If enabled, an active event will set the  $EXINTx$  flag and correspondingly set the  $IEx$  flag in  $TCON$ . It should be noted that after any external interrupt  $x$  event, flag  $EXINTx$  must be cleared. In case of falling edge as active event, this allows any future active event to be able to set the flag  $IEx$  as interrupt request. In case of low level as active event, this prevents unintended recurring triggering of interrupt request.

In case of bypass edge detection, the input is connected directly to the core (bypass the system unit). The flag  $IEx$  in  $TCON$  will be set on the selected falling edge or low level (at least 2 clock cycles) event. In case of falling edge selected as active event by  $TCON.ITx$ , the flag  $EXINTx$  is set in addition to the flag  $IEx$ . However to use this mode properly, user must not clear the flag  $EXINTx$  and if necessary, to only access the flag  $TCON.IEx$  (refer to INT\_XC8.003).
