Device XC866L-2FR
Marking/Step BC
Package PG-TSSOP-38

This Errata Sheet describes the deviations from the current user documentation. The module oriented classification and numbering system uses an ascending sequence over several derivatives, including already solved deviations. So gaps inside this enumeration can occur.

1 History List / Change Summary

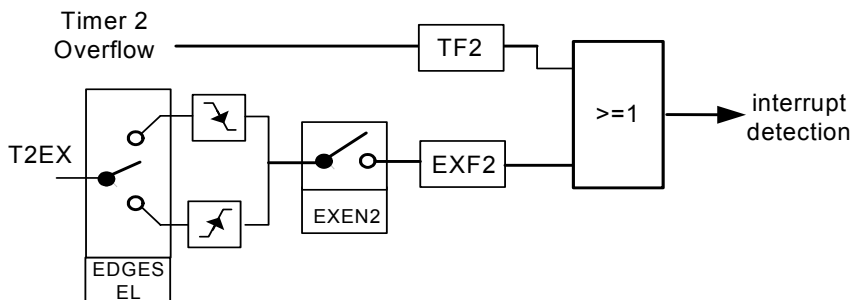
Figure 3

As illustrated in the simplified figure, the Timer 2 interrupt flags TF2 and EXF2 are combined as one interrupt request output. These flags are located within the Timer 2 kernel, with a single interrupt request line as output from the kernel.

Being of interrupt structure 2, the interrupt request of Timer 2 is detected on the rising edge of a positive pulse.

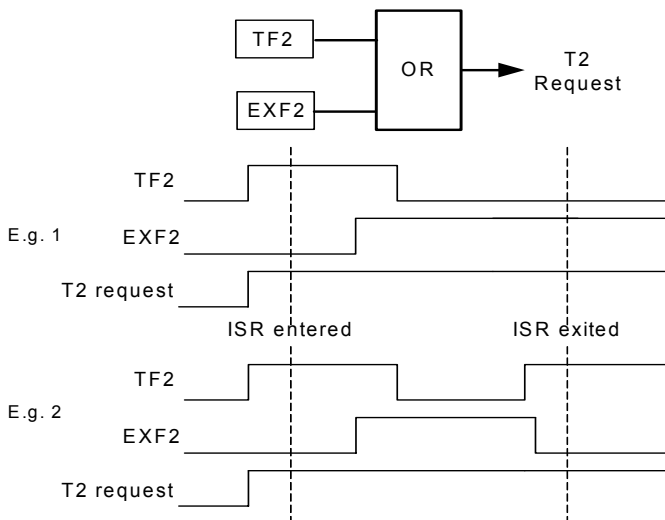
Figure 4

The problem is that it may occur at some point in the application, that any new Timer 2 interrupt request can no longer be detected after a return-from-interrupt (reti) due to service of earlier event(s). This happens when the following conditions are true:

1. Timer 2 events are serviced by interrupt (i.e. flags are checked and cleared only in the interrupt routine ISR),
2. Either TF2 or EXF2 is set at any one time throughout the ISR (even while the other is cleared) such that at least one of the flags is still set after reti, causing the Timer 2 request line, which is an OR-function of the two flags TF2 and EXF2, to remain set throughout the ISR and after reti.

This means, any future Timer 2 TF2 or EXF2 event is not able to cause a rising edge and therefore not able to trigger an interrupt request to the core – as if the Timer 2 interrupts had been disabled, until both EXF2 and TF2 flags are cleared at some time. The clearing of flags would have to be done by user's code additionally outside of the Timer 2 interrupt routine, which is however normally not feasible with an interrupt service scheme.

There is no problem if EXF2 is not enabled by setting bit EXEN2 = 0 i.e. external events are disabled, or if bit DCEN = 1 in auto-reload mode.

Otherwise if EXF2 is enabled, while TF2 is always enabled when Timer 2 is running, there are two suggested workaround:

1. If other events of Timer 2 interrupt node (ET2) need not be enabled for interrupt, disable this interrupt node and use software polling of the flags instead.
2. Before return from interrupt, check again if TF2 or EXF2 is (still) set (due to new request since the last check). If so, jump and execute the ISR routine from start. Exit only when all flags are checked to be cleared. However, dummy interrupt of the node may occur after return from interrupt, and should be ignored. Another drawback is if Timer 2 events are occurring at high rate, the CPU may be 'stuck' in the service routine of the Timer 2 interrupt for a long time.

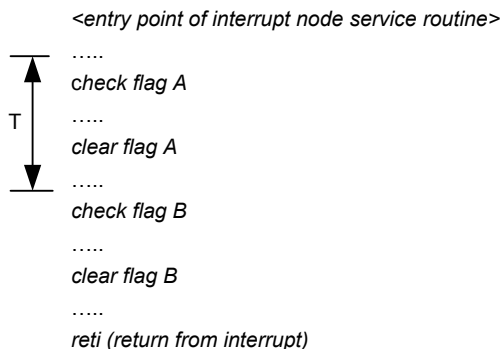
Figure 6

Consider the following interrupt service routine pseudo-code, and scenario where a interrupt source A event leads to interrupt request of the node and CPU vectors to the interrupt routine. Meanwhile, interrupt source B and its flag becomes active any time in the duration indicated by T:

In this case, flag B will be cleared as a standard procedure by the interrupt routine in the current service of the interrupt node. However, the pending

interrupt request for the node remains activated after RETI, as it is only cleared by hardware when CPU acknowledge the interrupt and vectors to the interrupt routine.

This leads to following servicing of the interrupt node again, but potentially no active flag is found, i.e. dummy interrupt service. The point to note is that the interrupt source B is not lost, as it was actually serviced in the current service of the interrupt node.

The recommendation is to ignore these dummy interrupt vectoring.

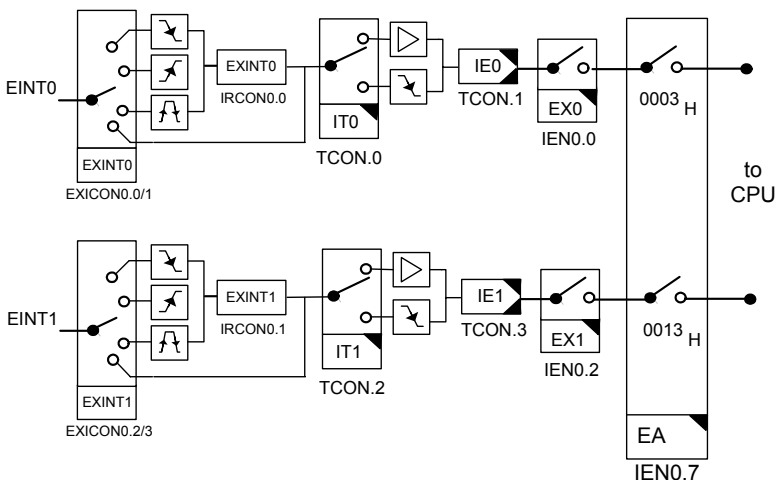
Figure 7

External interrupt 0 and 1 may individually be selected via respective bits (**EXINTx**) in **EXICON0** register, to request interrupt on falling edge, rising edge, both edges or to bypass the edge detection.

Edge detection is done in the system unit. If enabled, an active event will set the **EXINTx** flag and correspondingly set the **IEx** flag in **TCON**. It should be noted that after any external interrupt x event, flag **EXINTx** must be cleared. In case of falling edge as active event, this allows any future active event to be able to set the flag **IEx** as interrupt request. In case of low level as active event, this prevents unintended recurring triggering of interrupt request.
