Device **XC886CM-8FF**
Marking/Step **EES AA**
Package **PG-TQFP-48**

This Errata Sheet describes the deviations from the current user documentation.

Current Documentation

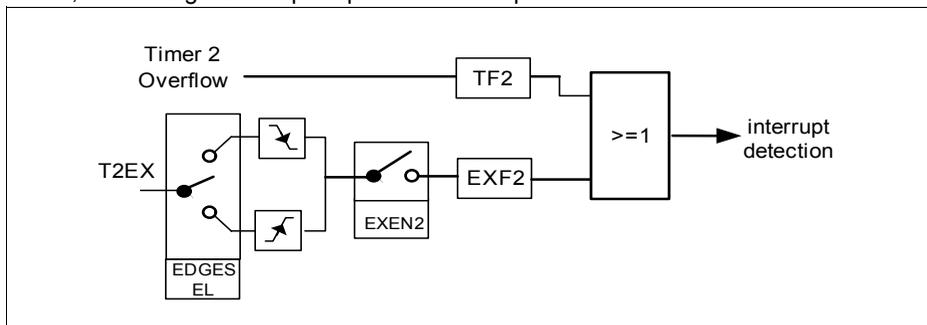
INT_XC8.004 Unable to Detect New Interrupt Request if Any One of Timer 2/Timer 21/UART1 Interrupt Flags Is Not Cleared (Unexpectedly)

As illustrated in the simplified figure, the Timer 2 interrupt flags TF2 and EXF2 are combined as one interrupt request output. These flags are located within the Timer 2 kernel, with a single interrupt request line as output from the kernel.

Being of interrupt structure 2, the interrupt request of Timer 2 is detected on the rising edge of a positive pulse.

There is no problem if EXF2 is not enabled by setting bit EXEN2 = 0 i.e. external events are disabled, or if bit DCEN = 1 in auto-reload mode.

Otherwise if EXF2 is enabled, while TF2 is always enabled when Timer 2 is running, there are two suggested workaround:

1. If other events of Timer 2 interrupt node (ET2) need not be enabled for interrupt, disable this interrupt node and use software polling of the flags instead.
2. Before return from interrupt, check again if TF2 or EXF2 is (still) set (due to new request since the last check). If so, jump and execute the ISR routine from start. Exit only when all flags are checked to be cleared. However, dummy interrupt of the node may occur after return from interrupt, and should be ignored. Another drawback is if Timer 2 events are occurring at high rate, the CPU may be 'stuck' in the service routine of the Timer 2 interrupt for a long time.
