Device **XC886LM-6FF**
Marking/Step **ES AB**
Package **PG-TQFP-48**

This Errata Sheet describes the deviations from the current user documentation. The module oriented classification and numbering system uses an ascending sequence over several derivatives, including already solved deviations. So gaps inside this enumeration can occur.

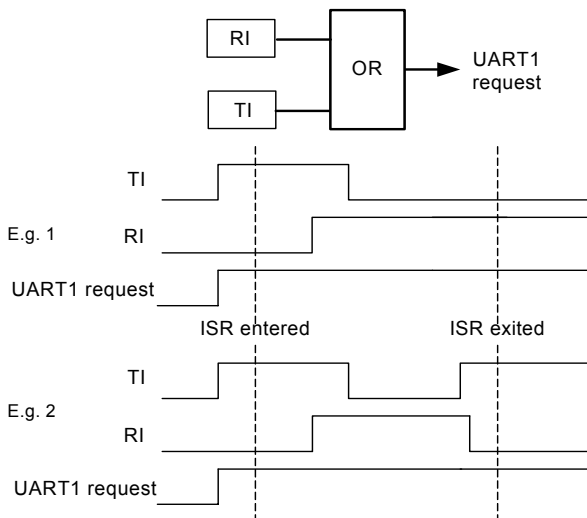
Figure 4

Two example scenerios are illustrated in the following figure:

This means, any future UART1 RI or TI event is not able to cause a rising edge and therefore not able to trigger an interrupt request to the core – as if the UART1 interrupts had been disabled, until both RI and TI flags are cleared at some time. The clearing of flags would have to be done by user's code additionally outside of the UART1 interrupt routine, which is however normally not feasible with an interrupt service scheme.

1. If other events of interrupt node XINTR8 (EX2) need not be enabled for interrupt, disable this interrupt node and use software polling of the flags instead.
2. Before return from interrupt, check again if RI or TI is (still) set (due to new request since the last check). If so, jump and execute the ISR routine from start. Exit only when all flags are checked to be cleared. However, dummy

interrupt of the node may occur after return from interrupt, and should be ignored. Another drawback is if UART1 events are occurring at high rate, the CPU may be 'stuck' in the service routine of the UART1 interrupt for a long time.

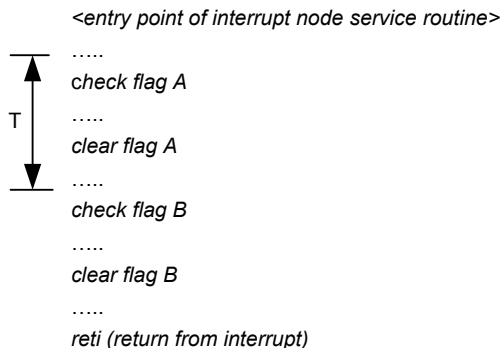
Figure 7

Consider the following NMI interrupt service routine pseudo-code, and scenario where a NMI interrupt source A event leads to interrupt request of the NMI node and CPU vectors to the NMI interrupt routine. Meanwhile, NMI interrupt source B and its flag becomes active any time in the duration indicated by T:

In this case, NMI flag B will be cleared as a standard procedure by the NMI interrupt routine in the current service. However, the pending interrupt request for the NMI node remains activated after RETI, as it is only cleared by hardware when CPU acknowledge the NMI interrupt and vectors to the NMI service routine.

This leads to following servicing of the NMI interrupt node again, but potentially no active NMI flag is found, i.e. dummy NMI interrupt service. The point to note is that the NMI interrupt source B is not lost, as it was actually serviced in the current service of the NMI interrupt node.

The recommendation is to ignore these dummy NMI interrupt vectoring.
