Device	XC886/888LM Series
Marking/Step	AC
Package	PG-TQFP-48/64

This Errata Sheet describes the deviations from the current user documentation. The module oriented classification and numbering system uses an ascending sequence over several derivatives, including already solved deviations. So gaps inside this enumeration can occur.

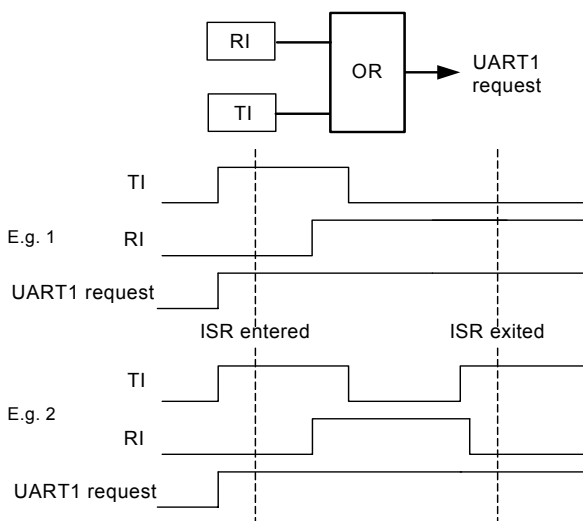
Figure 2

The problem is that it may occur at some point in the application, that any new UART1 interrupt request can no longer be detected after a return-from-interrupt (reti) due to service of earlier event(s). This happens when the following conditions are true:

Two example scenerios are illustrated in the following figure:

This means, any future UART1 RI or TI event is not able to cause a rising edge and therefore not able to trigger an interrupt request to the core – as if the UART1 interrupts had been disabled, until both RI and TI flags are cleared at some time. The clearing of flags would have to be done by user's code

1. If other events of interrupt node XINTR8 (EX2) need not be enabled for interrupt, disable this interrupt node and use software polling of the flags instead.
2. Before return from interrupt, check again if RI or TI is (still) set (due to new request since the last check). If so, jump and execute the ISR routine from start. Exit only when all flags are checked to be cleared. However, dummy interrupt of the node may occur after return from interrupt, and should be ignored. Another drawback is if UART1 events are occurring at high rate, the CPU may be 'stuck' in the service routine of the UART1 interrupt for a long time.
