Device	XMC4400
Marking/Step	EES-AA, ES-AA
Package	PG-LQFP-64/100

Document ID is **02512AERRA**.

This “Errata Sheet” describes product deviations with respect to the user documentation listed below.

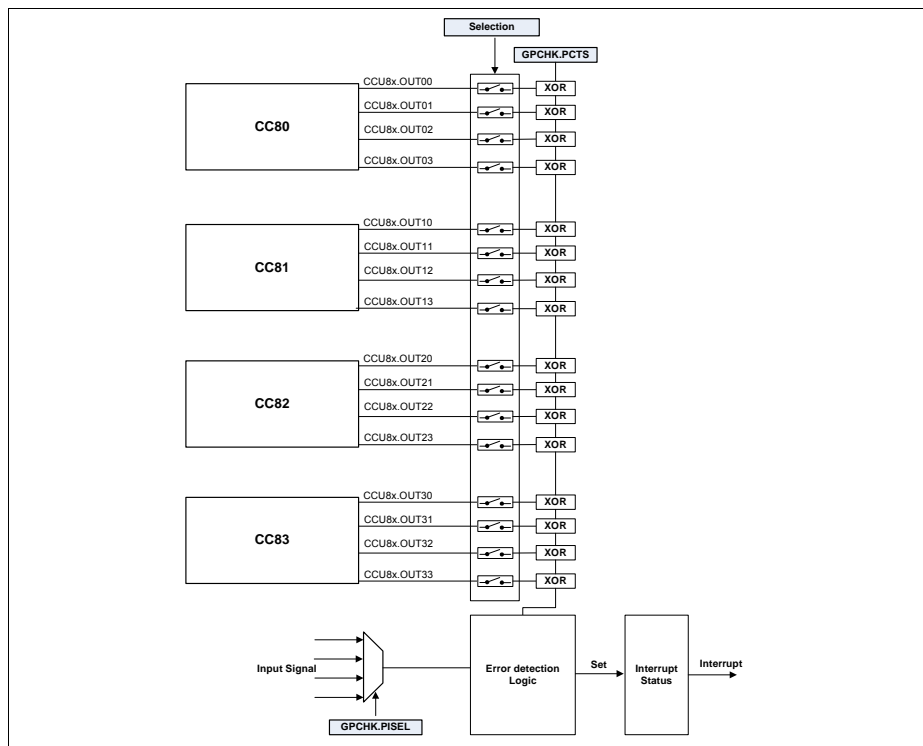
Figure 3 Parity Checker diagram

When using the parity checker function, the associated status bitfield, is cleared automatically by hardware in the next PWM cycle whenever an error is not present.

This means that if in the previous PWM cycle an error was detected and one interrupt was triggered, the software needs to read back the status register before the end of the immediately next PWM cycle.

Not ORing the Parity Checker error interrupt with any other interrupt source. With this approach, the software does not need to read back the status information to understand what was the origin of the interrupt - because there is only one source.

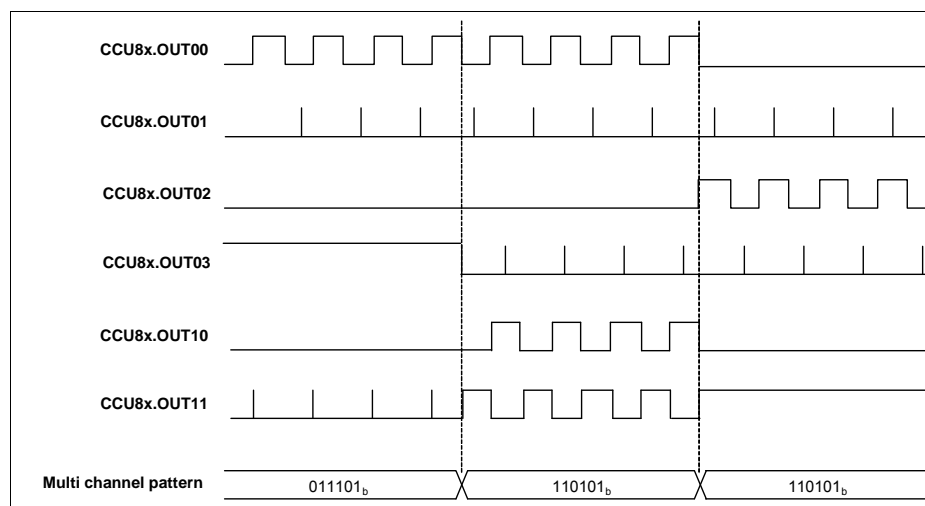
Figure 6 PWM output glitch

A glitch is present at the PWM outputs whenever the dead time of the specific compare channel is enabled - CC8yDTC.DTE1 and/or CC8yDTC.DTE2 set to 1_B (each compare channel has a separate dead time function) - and the specific multi channel pattern for the channel is 01_B or 10_B.

This glitch only affects the PWM output that is linked to the inverting ST path of each compare channel (non inverting outputs are not affected).

The effect of this glitch can be seen in Figure 3. The duration of the PWM glitch has the same length has the dead time value programmed into the CC8yDC1R.DT1F field (for compare channel 1) or into the CC8yDC1R.DT2F.

To avoid the glitch on the inverting path of the PWM output, one can disable the dead time function before the Multi Channel Pattern is set to 01_B or 10_B. Disabling the dead time of the inverting PWM output can be done by setting:

CC8yDTC.DCEN2 = 0 //if compare channel 1 is being used

```
CC8yDTC.DCEN4 = 0 //if compare channel 2 is being used
```

The dead time needs to be re enabled, before the complementary outputs become modulated at the same time:

```
CC8yDTC.DCEN2 = 1 //if compare channel 1 is being used
```

```
CC8yDTC.DCEN4 = 1 //if compare channel 2 is being used
```

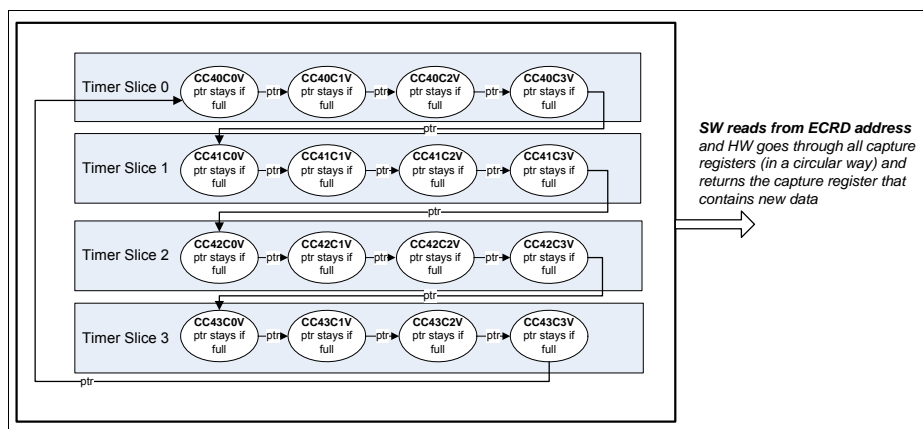
Figure 7 Extended Read Back access - example for CCU4 (CCU8 structure is the same)

ECRD address, we have already capture two values. The ECRD read back will output CC4xC2V -> CC4xC2V (CC4xC3V value is lost)

- Timer X and Timer Y have 4 capture registers each and they are both configured with ECM = 1_B. At the moment that the software starts reading the capture registers via the ECRD address, we have already capture two values on Timer X and 4 on Timer Y. The ECRD read back will output CC4xC0V -> CC4xC1V -> CC4xC2V -> CC4xC3V -> CC4yC2V -> CC4yC2V (CC4yC3V value is lost)

None.

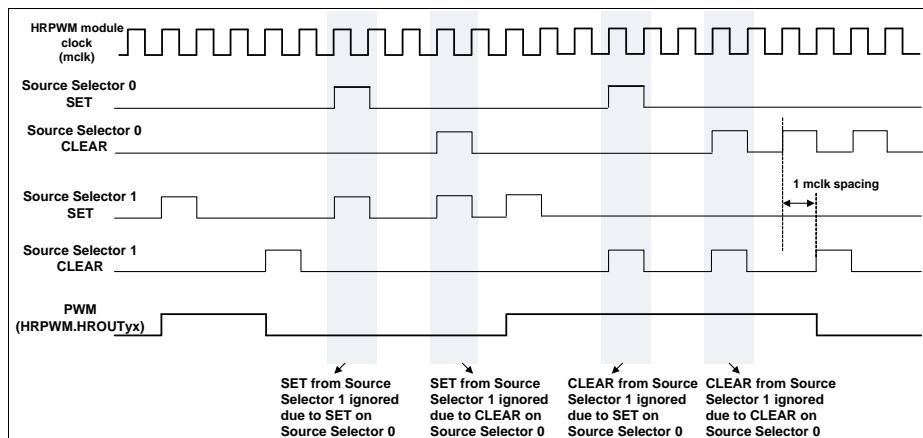
Figure 11 Collision between signals of the two Source Selectors - valid only when HRCyST.ST = 1_B

- at the same module clock time frame Source Selector 0 and Source Selector 1 both decode a signal (a PWM set or PWM clear).

If the described condition occurs, then the signal generated by Source Selector 1 is lost and the PWM signal is not handled properly - **Figure 11**.

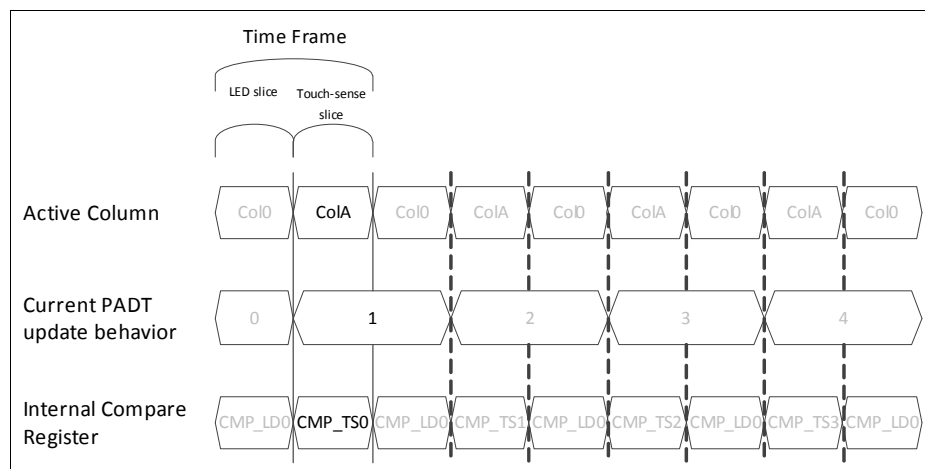
Figure 14 Effect of delay on the update of Internal Compare Register with 1 LED column enabled

If the number of LED columns enabled is smaller than 2, the delay will affect the activation period of the current active pad. At the beginning of every new Col A, the value of the current PADT's compare register is updated to the internal compare register. However, the delay causes the value of the previous PADT's compare register is updated to the internal compare register instead. This means that the current active pad would be activated with the duration of the previous pad's oscillation window ([Figure 14](#)). In addition to this, when no LEDs

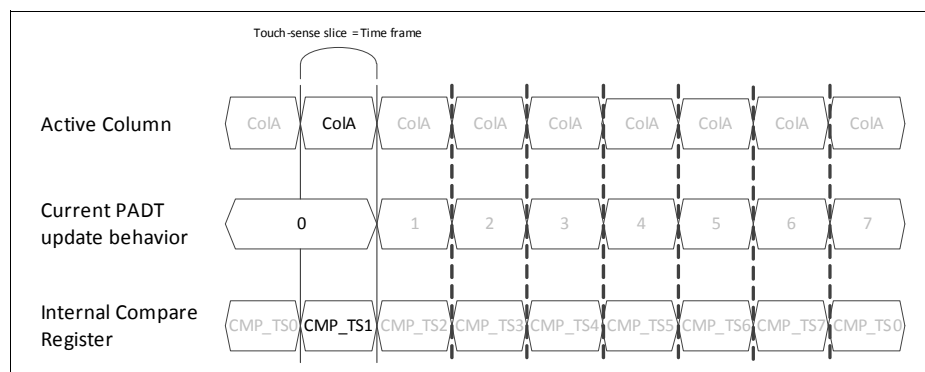
Figure 15 Pad turn 0 prevails for one time slice longer when no LEDs are enabled

are enabled, pad turn 0 will prevail for one time slice longer before it gets updated ([Figure 15](#)).

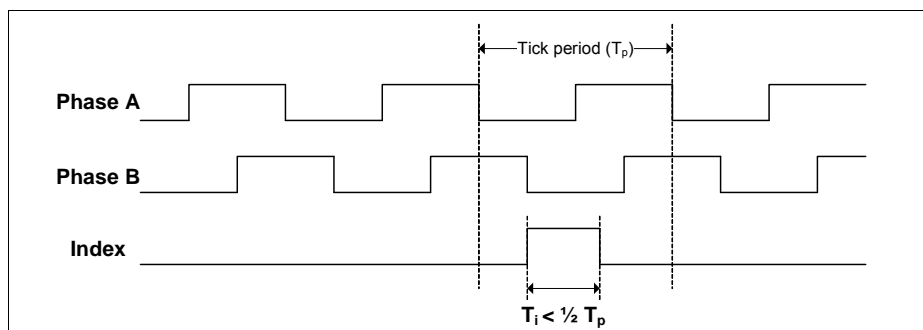
Figure 19 Different index signal types

When the index signal is smaller than 1/2 of the tick period, the POSIF module is not able to decode this signal properly, Figure 2 - notice that the reference edge of the index generation in this figure is the falling of Phase B, nevertheless this is an example and depending on the encoder type, this edge may be one of the other three.

Due to this fact it is not possible to use the POSIF to decode these type of signals (index with duration below 1/2 of the tick period).
