| Device | XMC4500 |
| Marking/Step | EES-AA, ES-AA |

Overview

Document ID is **02462AERRA**.

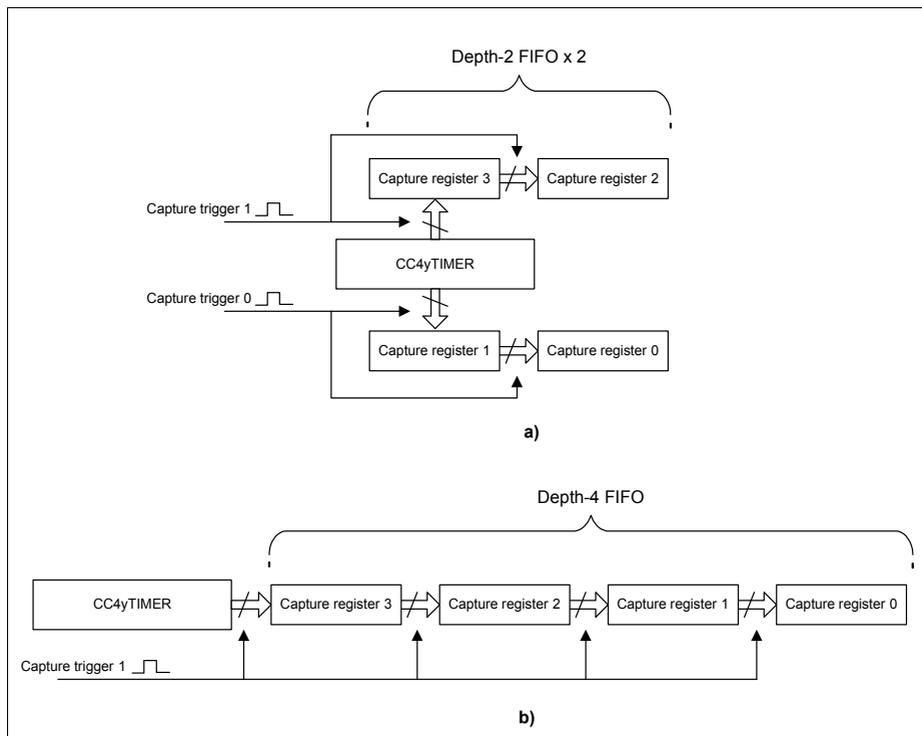
Figure 1 CCU4 capture modes - a) Depth-2 x2 Capture; b) Depth-4 Capture

CCU4_AI.001 CCU4 period interrupt is not generated in capture mode

The period interrupt is not generated when the timer slice is programmed in the depth-4 capture mode or when is programmed in depth-2 capture mode and the capture trigger 1 is used.

These situations occur whenever capture trigger 1 is being used (when the $CC4yCMC.CAP1S$ field is programmed with a value different from 00_B).

A straightforward workaround is to use only 2 capture registers (instead of a maximum of 4). This is done by setting the CC4yCMC.CAP1S to 00_B and program the CC4yCMC.CAP0S with a value different from 00_B.

By using the floating prescaler function present in each timer slice, the capture routine can ignore the missing period interrupt, for a capture trigger frequency as low as 0.25 Hz (for f_{CCU} equal to 120 MHz).

The floating prescaler function can be enabled by setting the CC4yTC.FPE = 1_B.

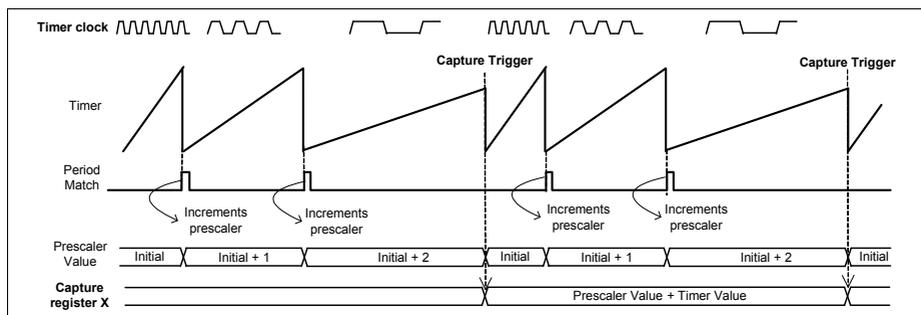
Figure 2 Floating Prescaler for Capturing

CCU8_AI.001 CCU8 Floating Prescaler function does not work with Capture Trigger 1

The usage of Capture Register 2 and Capture Register 3 is not possible when the Floating Prescaler function is enabled, $CC8yTC.FPE = 1_B$. This only happens when the Capture Trigger 1 is being used, $CC8yCMD.CAP1S \neq 00_B$. Therefore is not possible to use the Floating Prescaler feature with the capture trigger 1. The usage of the capture trigger 0 is not affected, which means that capture register 0 and capture register 1 can be used with the floating prescaler feature.

None.

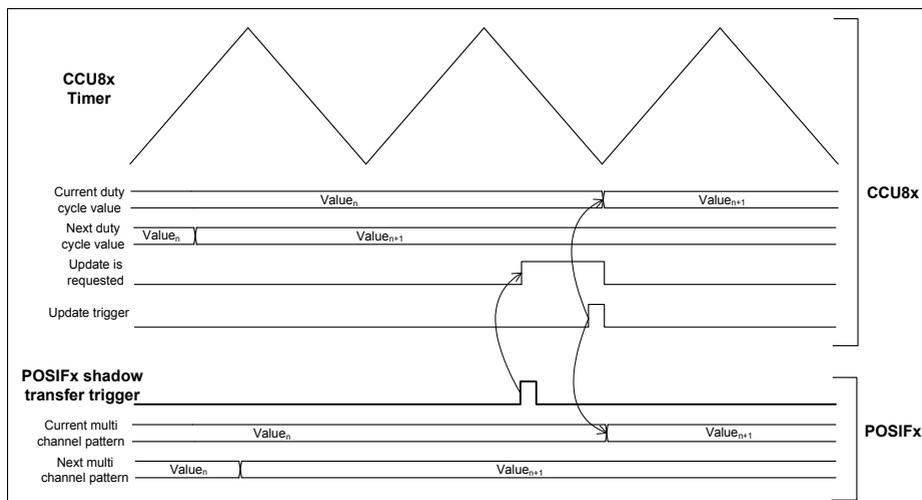
Figure 4 Value update handshake between CCU8x and POSIFx

CCU8_AI.002 CC82 Timer of the CCU8x module cannot use the external shadow transfer trigger connected to the POSIFx module

This feature cannot be used with the Timer2 (defined as CC82 in the documentation) of the CCU8x module(s) (more than one CCU8 module can be contained on a specific device).

All the other 3 Timers (defined as CC80, CC81, CC83) inside the CCU8x modul are not affected by this issue.

None

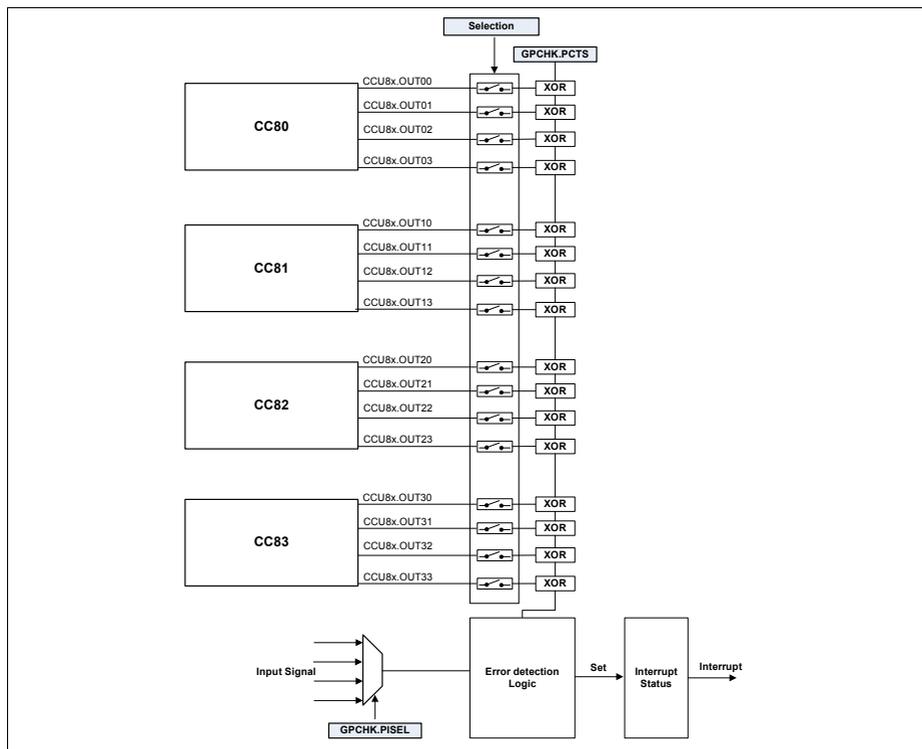
Figure 5 Parity Checker diagram

CCU8 AI.003 CCU8 Parity Checker Interrupt Status is cleared automatically by hardware

This means that if in the previous PWM cycle an error was detected and one interrupt was triggered, the software needs to read back the status register before the end of the immediately next PWM cycle.

This is indeed only necessary if multiple interrupt sources are ORed together in the same interrupt line. If this is not the case and the parity checker error source is the only one associated with an interrupt line, then there is no need to read back the status information. This is due to the fact, that only one action can be triggered in the software routine, the one linked with the parity checker error.

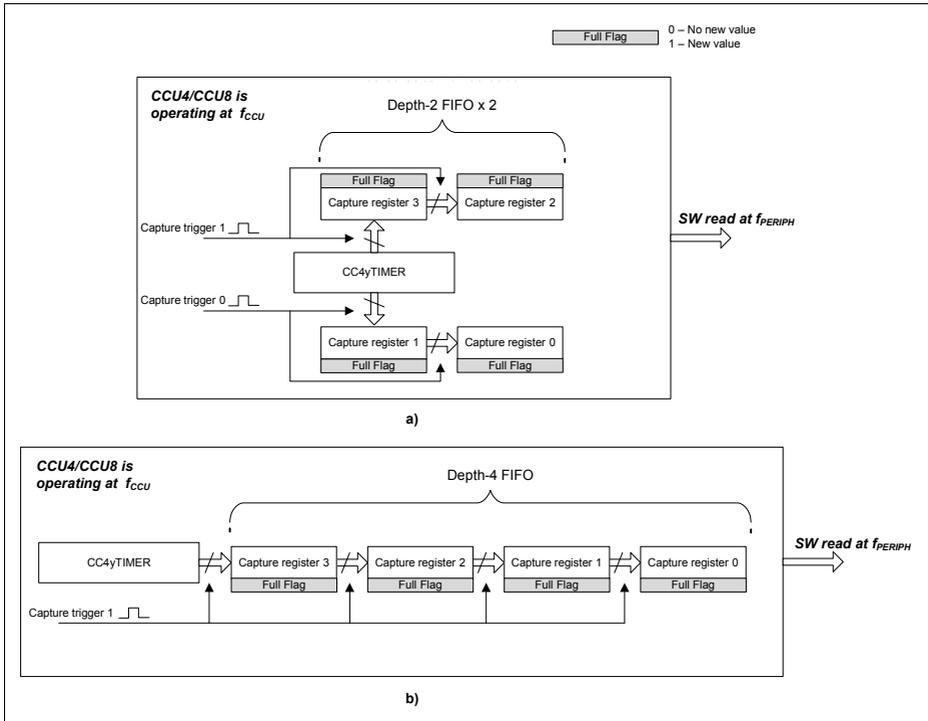
Figure 6 Capture Modes Structure - a) Depth-2 x2 Capture; b) Depth-4 Capture

When the peripheral bus clock frequency is smaller than the CCU4/CCU8 module clock frequency, $f_{\text{periph}} < f_{\text{CCU}}$, the read back of the full flag is inconsistent. Sometimes it returns the information that a new value has been captured and sometimes it does not.

Note: The capture interrupt is generated correctly.

To do this, the following SCU (System Control Unit) registers should be set with values that force this condition: CCUCLKCR.CCUDIV, CPUCLKCR.CPUDIV and PBCLKCR.PBDIV.

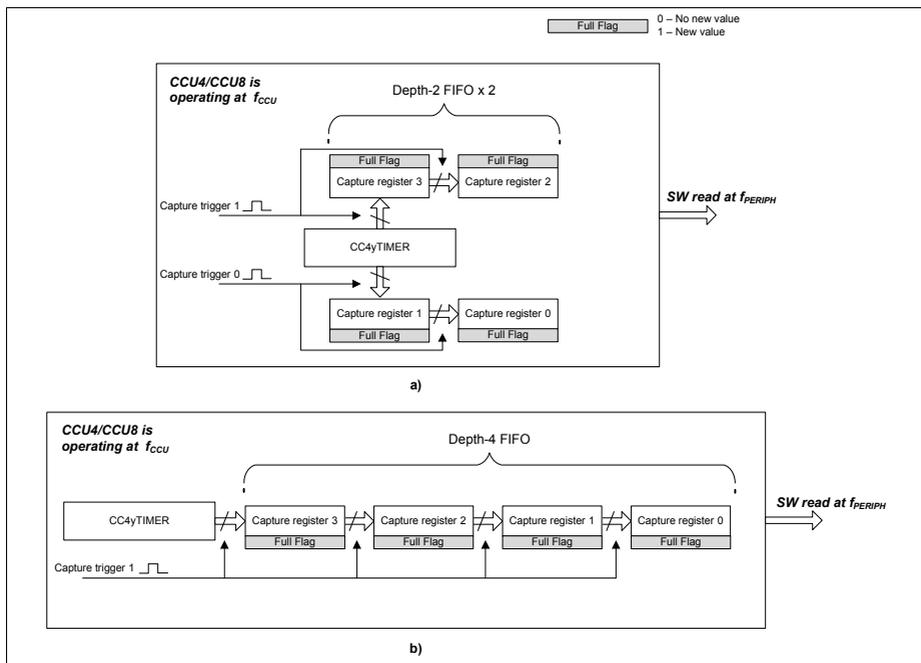
Figure 7 Capture Modes Structure - a) Depth-2 x2 Capture; b) Depth-4 Capture

Referring to [Figure 8](#), it can be understood that the proper data is sent to the software when it reads back the capture register 1, nevertheless this same data is shifted to the next capture register (capture register 0) and the full flag of this register is set.

After this if the software reads back capture register 0, a value is going to be returned with a full flag set (indicating that this is a new value - that has not yet been read, which is not true).

In every read back where the software finds a value equal to the previous one, it should then poll the interrupt status to understand if the timer has rollover or not. If the timer has not rollover, then this is the same value that was previously read.

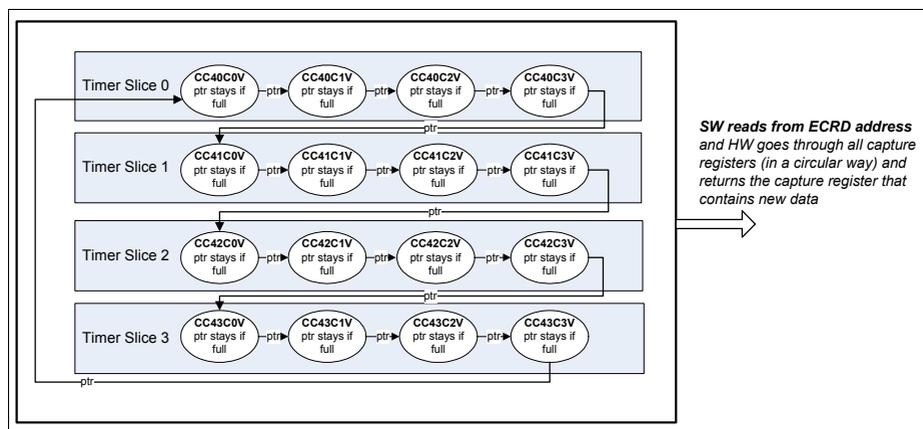
Figure 9 Extended Read Back access - example for CCU4 (CCU8 structure is the same)

- Timer X has 4 capture registers and is the only Timer set with $ECM = 1_B$. At the moment that the software starts reading the capture registers via the ECRD address, we have already capture two values. The ECRD read back will output CC4xC2V -> CC4xC2V (CC4xC3V value is lost)

- Timer X and Timer Y have 4 capture registers each and they are both configured with $ECM = 1_B$. At the moment that the software starts reading the capture registers via the ECRD address, we have already capture two values on Timer X and 4 on Timer Y. The ECRD read back will output CC4xC0V -> CC4xC1V -> CC4xC2V -> CC4xC3V -> CC4yC2V -> CC4yC2V (CC4yC3V value is lost)

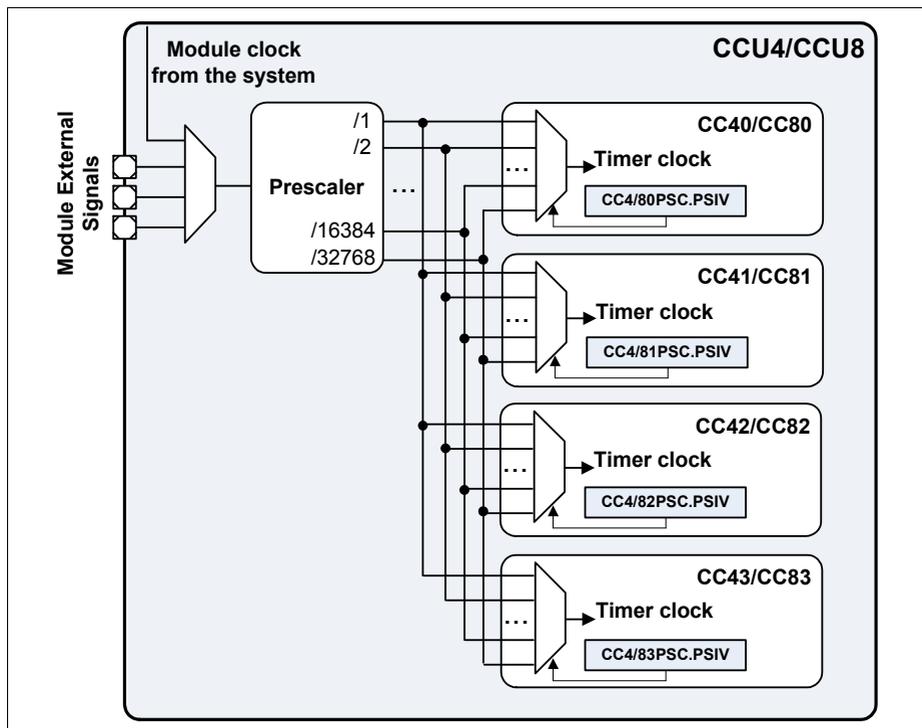
Figure 10 Clock Selection Diagram for CCU4/CCU8

This is only applicable if the Module Clock provided by the system (the normal default configuration and use case scenario) is not being used. In the case that the normal clock configured and programmed at system level is being used, there is not any type of constraints.

One should not also confuse the usage of an external signal as clock for the module with the usage of an external signal for counting. These two features are completely unrelated and there are not any dependencies between both.

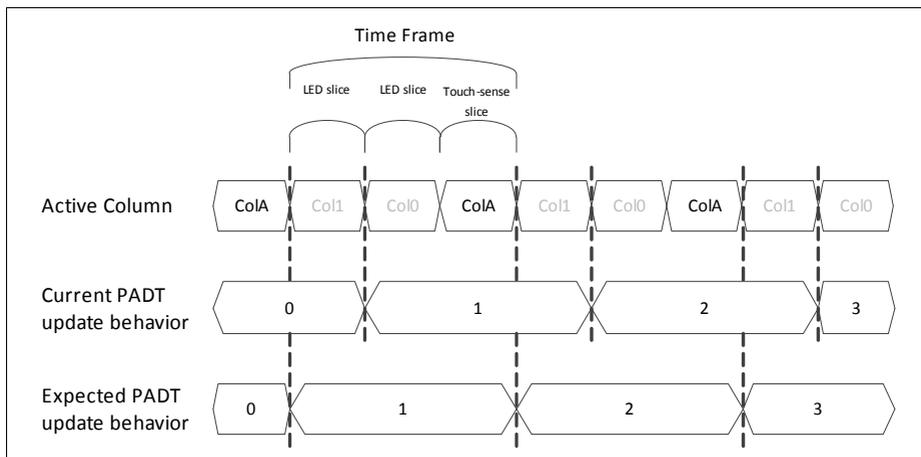
Figure 11 PADT update behavior

LEDTS_AI.001 Delay in the update of FNCTL.PADT bit field

The touch-sense pad turn (PADT) value is updated, not at the end of the touch-sense time slice (CoIA), but one time slice later ([Figure 11](#)).

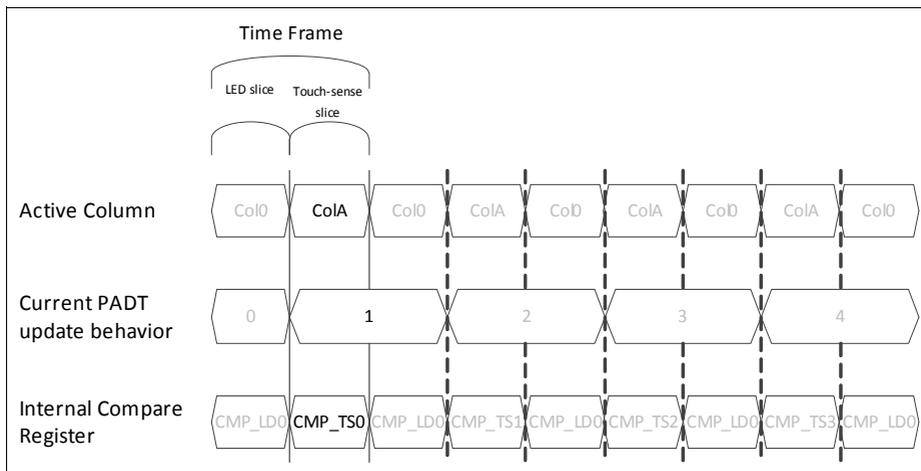
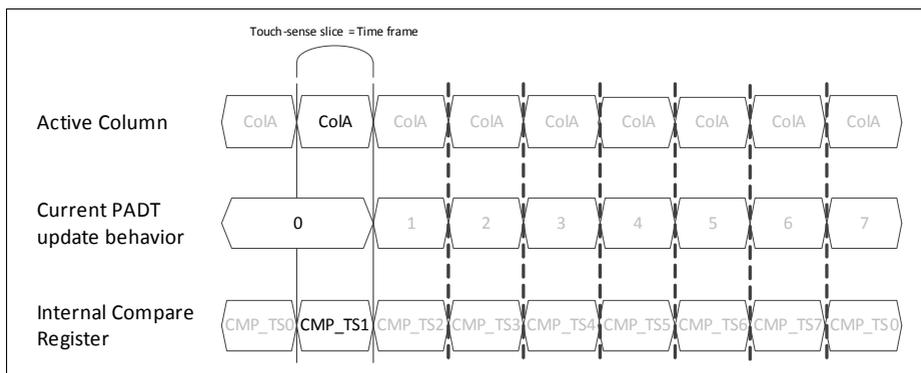
If the number of LED columns enabled is smaller than 2, the delay will affect the activation period of the current active pad. At the beginning of every new Col A, the value of the current PADT's compare register is updated to the internal compare register. However, the delay causes the value of the previous PADT's compare register is updated to the internal compare register instead. This means that the current active pad would be activated with the duration of the previous pad's oscillation window ([Figure 12](#)). In addition to this, when no LEDs are enabled, pad turn 0 will prevail for one time slice longer before it gets updated ([Figure 13](#)).

Figure 12 Effect of delay on the update of Internal Compare Register with 1 LED column enabled

Figure 13 Pad turn 0 prevails for one time slice longer when no LEDs are enabled

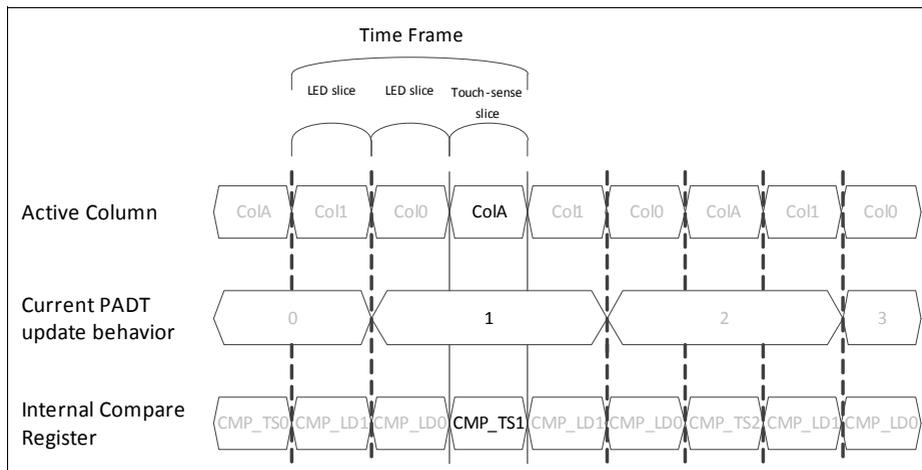
Figure 14 Internal Compare Register updated with correct compare register value with 2 LED columns enabled

If the number of LED columns enabled is 2 or more, the additional LED columns would provide some buffer time for the delay. So, at the start of a new touch-sense time slice, the update of PADT value would have taken place. Hence, the current active PADT compare register value is updated to the internal compare register (Figure 14).

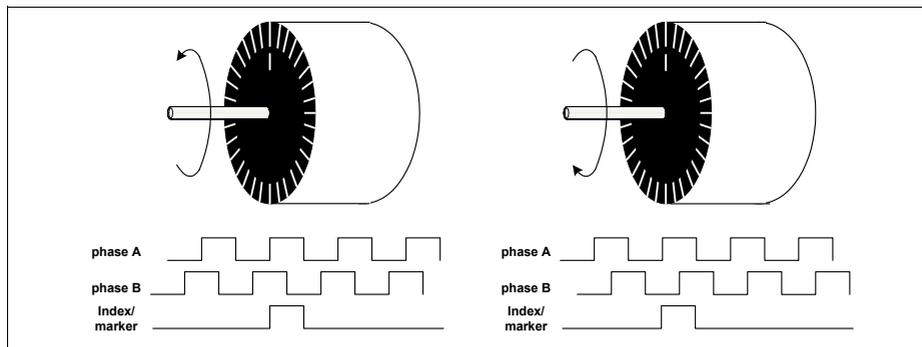
Figure 16 Rotary Encoder outputs - Phase A, Phase B and Index

POSIF_AI.001 Input Index signal from Rotary Encoder is not decoded when the length is 1/4 of the tick period

Each POSIF module can be used as an input interface for a Rotary Encoder. It is possible to configure the POSIF module to decode 3 different signals: Phase A, Phase B (these two signals are 90° out of phase) and Index. The index signal is normally understood as the marker for the zero position of the motor Figure 1.

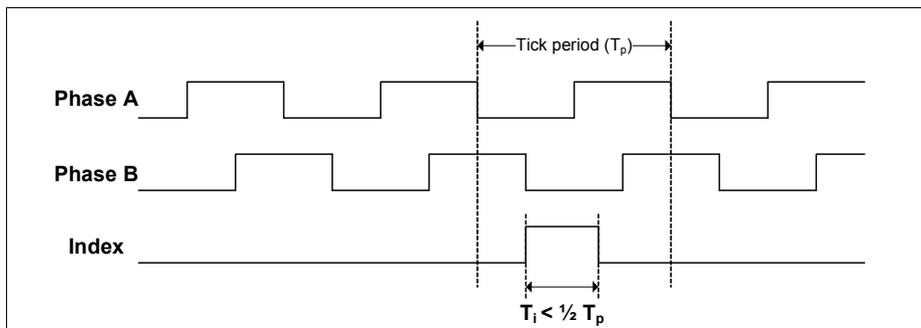
Figure 17 Different index signal types

When the index signal is smaller than 1/2 of the tick period, the POSIF module is not able to decode this signal properly, Figure 2 - notice that the reference edge of the index generation in this figure is the falling of Phase B, nevertheless this is an example and depending on the encoder type, this edge may be one of the other three.

Due to this fact it is not possible to use the POSIF to decode these type of signals (index with duration below 1/2 of the tick period).

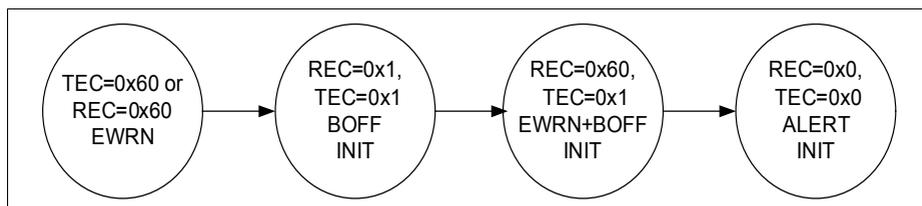
Figure 19 Alert Interrupt Behavior in case of Bus-Off

MultiCAN_AI.H007 Alert Interrupt Behavior in case of Bus-Off

The MultiCAN module shows the following behavior in case of a bus-off status:

When the threshold for error warning (EWRN) is reached (default value of Error Warning Level EWRN = 0x60), then the EWRN interrupt is issued. The bus-off (BOFF) status is reached if TEC > 255 according to CAN specification, changing the MultiCAN module with REC and TEC to the same value 0x1, setting the INIT bit to 1_B, and issuing the BOFF interrupt. The bus-off recovery phase starts automatically. Every time an idle time is seen, REC is incremented. If REC = 0x60, a combined status EWRN+BOFF is reached. The corresponding interrupt can also be seen as a pre-warning interrupt, that the bus-off recovery phase will be finished soon. When the bus-off recovery phase has finished (128 times idle time have been seen on the bus), EWRN and BOFF are cleared, the ALERT interrupt bit is set and the INIT bit is still set.

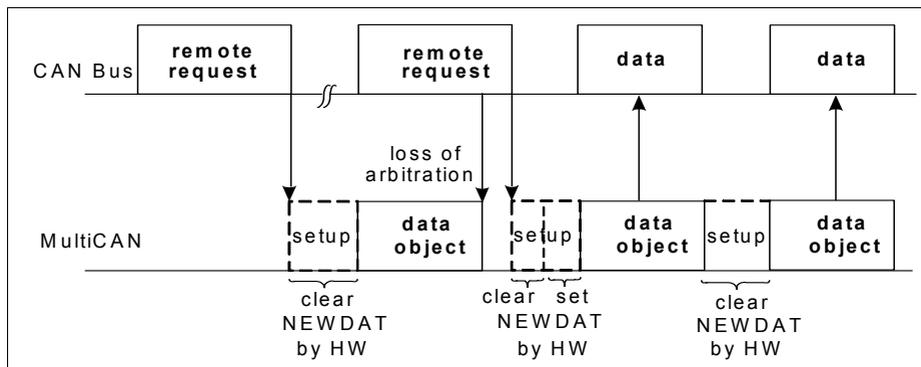
Figure 20 Loss of Arbitration

When the appropriate message object (data frame) triggered by the first remote frame wins the arbitration, it will be sent out and `NEWDAT` is not reset. This leads to an additional data frame, that will be sent by this message object (clearing `NEWDAT`).

There will, however, not be more data frames than there are corresponding remote requests.
