Device	XMC4500
Marking/Step	ES-AB, AB
Package	PG-LQFP-100/144, PG-LFBGA-144

Document ID is **082/18**.

This “Errata Sheet” describes product deviations with respect to the user documentation listed below.

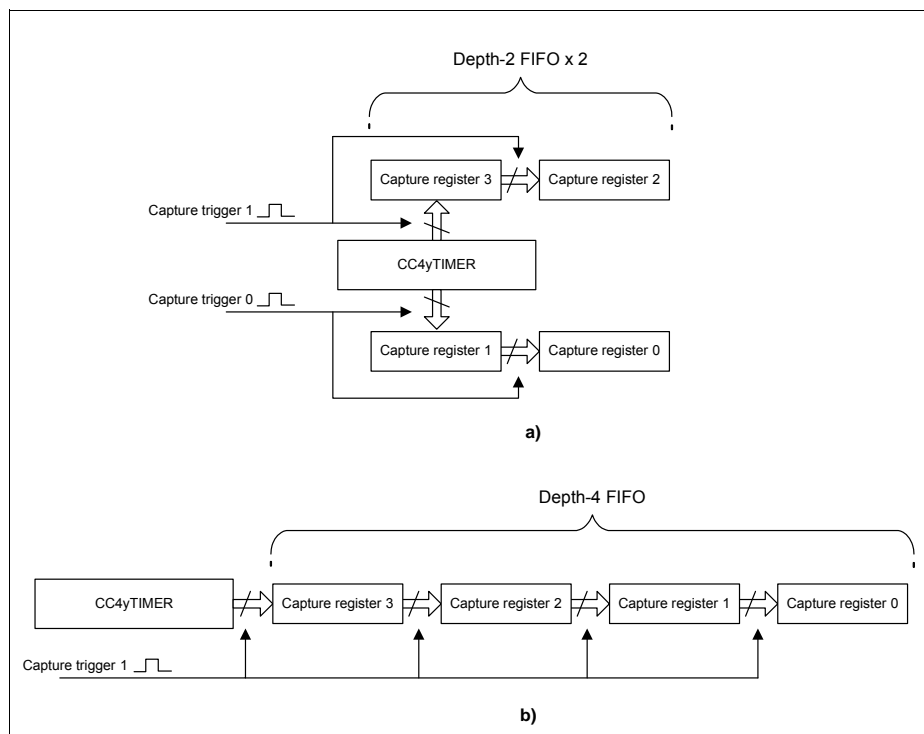
**Figure 1 CCU4 capture modes - a) Depth-2 x2 Capture; b) Depth-4 Capture**

These situations occur whenever capture trigger 1 is being used (when the CC4yCMC.CAP1S field is programmed with a value different from 00<sub>B</sub>).

Note that the period interrupt is only necessary if the capture trigger periodicity is bigger than the timer period itself.

By using the floating prescaler function present in each timer slice, the capture routine can ignore the missing period interrupt, for a capture trigger frequency as low as 0.25 Hz (for  $f_{CCU}$  equal to 120 MHz).

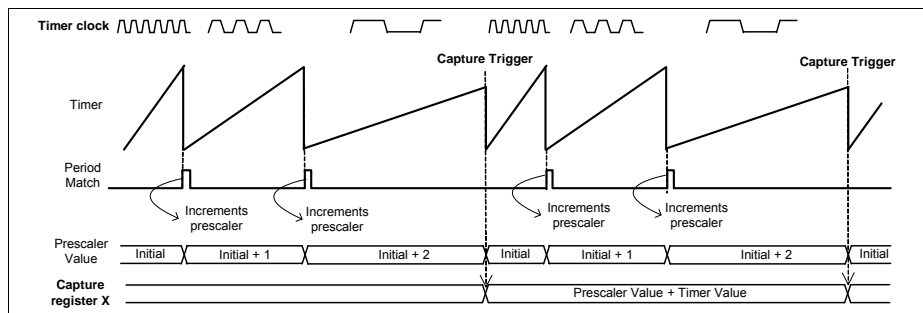
**Figure 2 Floating Prescaler for Capturing**

Each CCU8 Timer also has four capture registers: Capture Register 0, Capture Register 1, Capture Register 2 and Capture Register 3. All these registers can be used to capture the Timer Value and the Current Prescaler Value.

The usage of Capture Register 2 and Capture Register 3 is not possible when the Floating Prescaler function is enabled, CC8yTC.FPE = 1<sub>B</sub>. This only happens when the Capture Trigger 1 is being used, CC8yCMD.CAP1S != 00<sub>B</sub>. Therefore is not possible to use the Floating Prescaler feature with the capture trigger 1. The usage of the capture trigger 0 is not affected, which means that capture register 0 and capture register 1 can be used with the floating prescaler feature.

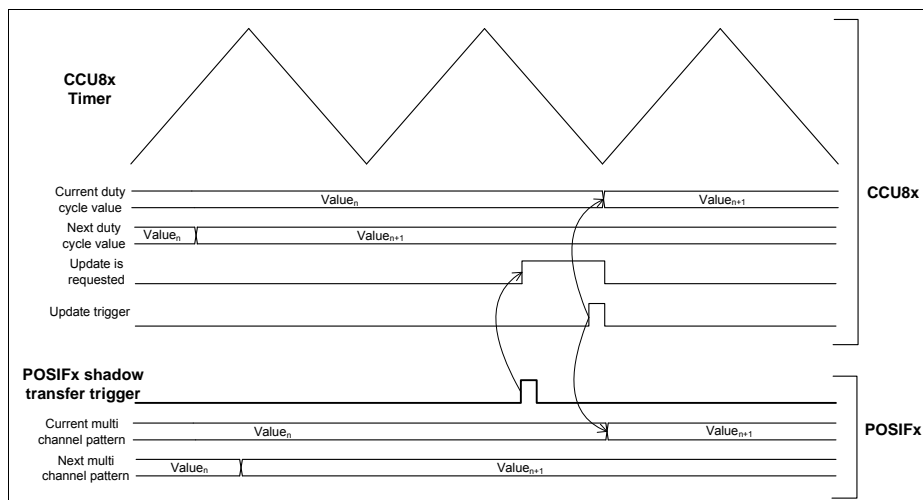
**Figure 4 Value update handshake between CCU8x and POSIFx**

This feature cannot be used with the Timer2 (defined as CC82 in the documentation) of the CCU8x module(s) (more than one CCU8 module can be contained on a specific device).

All the other 3 Timers (defined as CC80, CC81, CC83) inside the CCU8x modul are not affected by this issue.

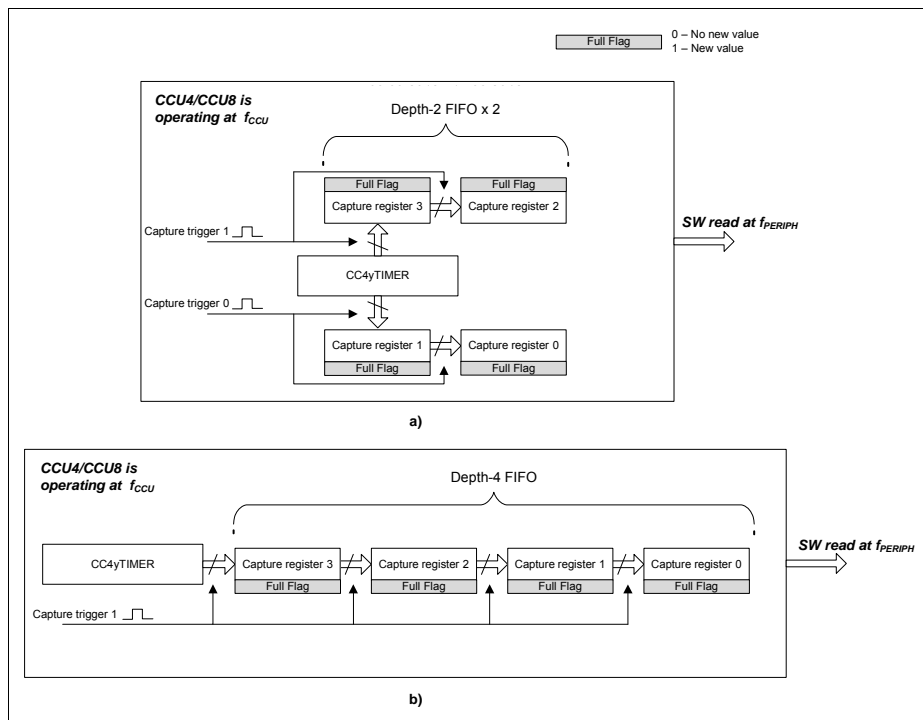
**Figure 10 Capture Modes Structure - a) Depth-2 x2 Capture; b) Depth-4 Capture**

When the peripheral bus clock frequency is smaller than the CCU4/CCU8 module clock frequency,  $f_{\text{periph}} < f_{\text{CCU}}$ , the read back of the full flag is inconsistent. Sometimes it returns the information that a new value has been captured and sometimes it does not.

*Note: The capture interrupt is generated correctly.*

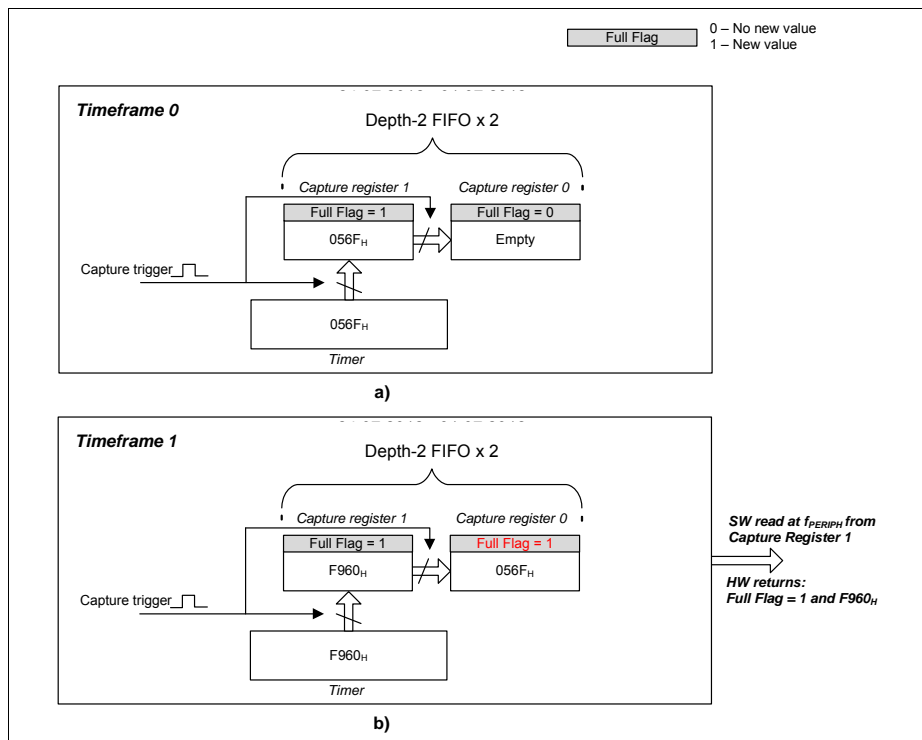
**Figure 12 Capture shift during read back phase - a) Capture trigger without collision with read back; b) Capture trigger collision with read back**

Referring to [Figure 12](#), it can be understood that the proper data is sent to the software when it reads back the capture register 1, nevertheless this same data is shifted to the next capture register (capture register 0) and the full flag of this register is set.

After this if the software reads back capture register 0, a value is going to be returned with a full flag set (indicating that this is a new value - that has not yet been read, which is not true).

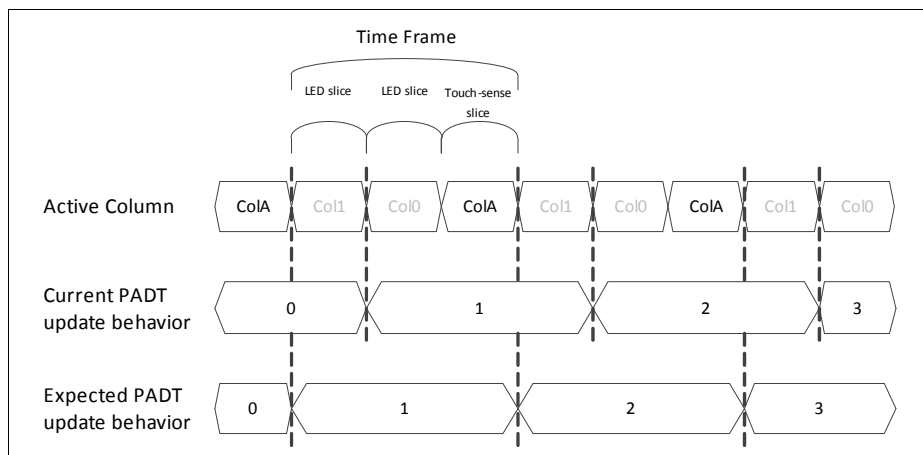
**Figure 15 PADT update behavior**

The touch-sense pad turn (PADT) value is updated, not at the end of the touch-sense time slice (CoIA), but one time slice later ([Figure 15](#)).

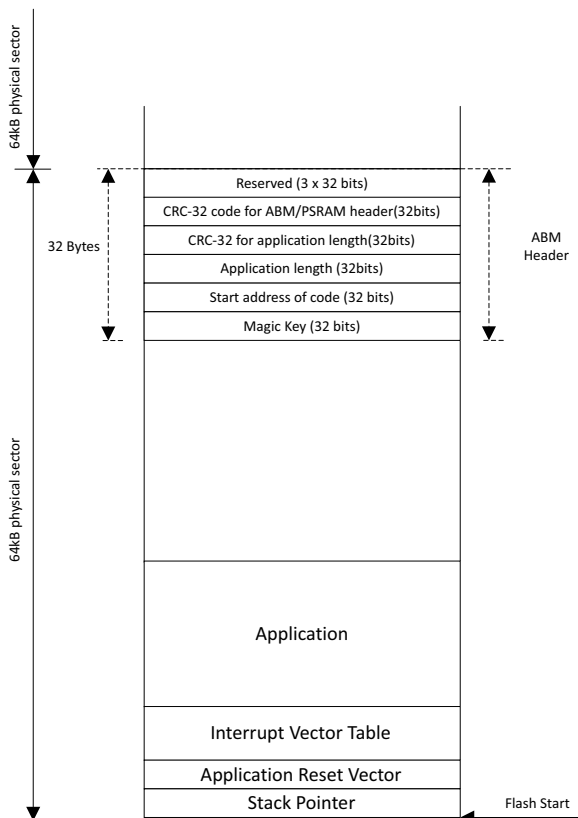
**Figure 25 ABM/PSRAM Header - Location of reserved bytes**

The reference manual is specifying PSRAM/ABM Header of 32 byte size. Only for 20byte of these 32 bytes the functionality is defined. The remaining 12bytes are reserved. Inside the chapter for Startup modes of the reference manual only the functional bytes are specified but not the location of the reserved bytes.
