| <b>Device</b> | <b>C505A-4RM,<br/>C505CA-2RM/4RM/LM,<br/>C505CA-4RC</b> |
| <b>Marking/Step</b> | <b>Step ES-CA, CA</b> |
| <b>Package</b> | <b>P-MQFP-44, Bare Die</b> |

This Errata Sheet describes the deviations from the current user documentation.

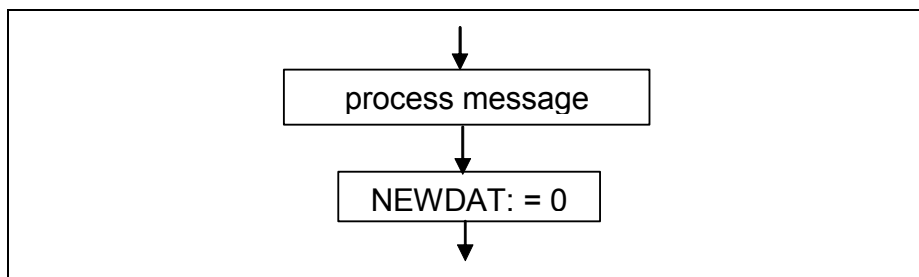
### **CAN.4: Flowchart sequence in figure in User's Manual regarding Micro-controller handling of the Last Message Object is partly incorrect**

For the software flowchart figure 6-48 in User's Manual 11.97, the correct would be to first 'process message contents' and then to 'clear bit NEWDAT'.

This correction will be updated to the future versions of the User's Manuals.
