Errata Sheet

9 July 2001 / Release 1.4

Device: C515C-8E
Stepping Code / Marking: BB
Package: P-MQFP-80

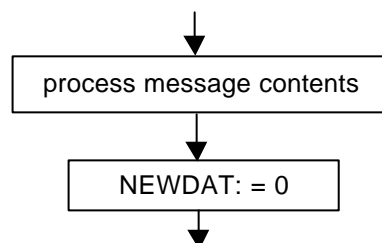
CAN.4: Flowchart sequence in figure in User's Manual regarding Micro-controller handling of the Last Message Object is partly incorrect

For the software flowchart figure 6-48 in User's Manual 11.97, the correct would be to first 'process message contents' and then to 'clear bit NEWDAT'.

This correction will be updated to the future versions of the User's Manuals.
