Device	C515C-8R, C515C-L
Marking/Step	Step AA
Package	P-MQFP-80

This Errata Sheet describes the deviations from the current user documentation.

# 1 History List/Change Summary

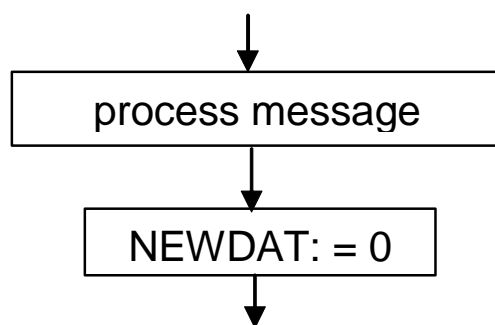
### **CAN.4: Flowchart sequence in figure in User's Manual regarding Micro-controller handling of the Last Message Object is partly incorrect**

For the software flowchart figure 6-48 in User's Manual 11.97, the correct would be to first 'process message contents' and then to 'clear bit NEWDAT'.

This correction will be updated to the future versions of the User's Manuals.
