Errata Sheet

December 23, 1998 / Release 1.2

Device:	SAB 83C166W-5M SAB 83C166W-5M-T3 SAB 83C166W-5M-T4 SAB 80C166W-M SAB 80C166W-M-T3 SAB 80C166W-M-T4
Stepping Code / Marking:	ES-DC, DC
Package:	MQFP-100

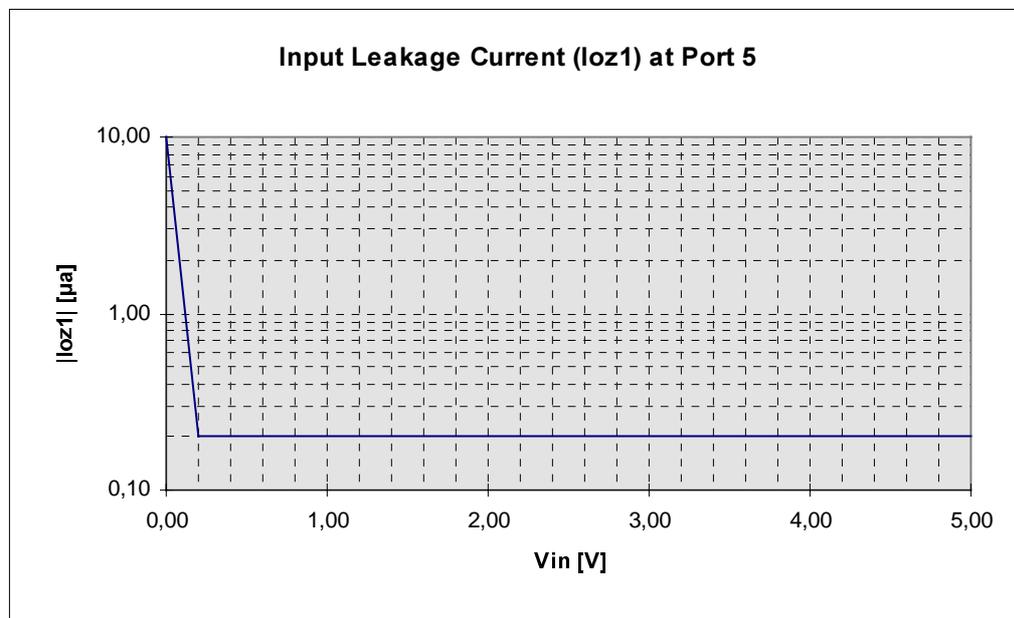
Problem 11: Input Leakage Current (I_{oz1}) at Port 5

The input leakage current (I_{oz1}) of some devices can deviate from the actual specified limit value of ±200 nA at input voltages (V_{in}) close to 0 V. High ambient temperature and maximum supply voltage lead to a maximum increase of the leakage current.

The following equation describes the behavior of the leakage current for input voltages between 0 V and 200 mV and covers all specified operating conditions. This equation stands for an exponential decrease from ±10 µA leakage current at V_{in} = 0 V to ±200 nA at V_{in} = 200 mV.

Input Voltage (V _{in})	0 ≤ V _{in} ≤ 200 mV	200 mV ≤ V _{in} ≤ V _{cc} ¹⁾
Input Leakage Current (I _{oz1})	$I_{oz1} = \pm a \cdot e^{(b \cdot V_{in})}$ a = 10 µA; b = -0,0196 mV ⁻¹	I _{oz1} = ±200 nA

The figure below shows the input leakage current as function of the input voltage.
