## XC2300C Derivatives

16/32-Bit Single-Chip Microcontroller  
with 32-Bit Performance

Errata Sheet

V1.6 2013-03

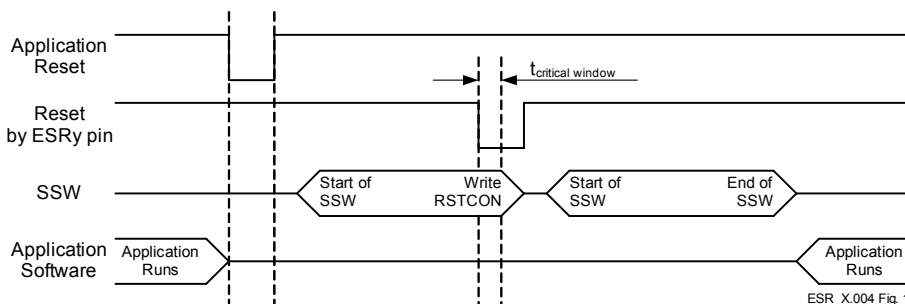
**Figure 1 Critical application reset sequence**

SCU\_RSTCONx registers are reset only by Power-On, but they may be wrongly affected after a second application reset requested by an ESRy pin. This may lead to the SCU\_RSTCONx register values being set to zero, which could unexpectedly disable reset sources within the user application. The conditions which lead to this behavior are:

at the same time, the ESRy reset request is processed by the reset circuitry. The width of this critical window  $t_{\text{critical window}}$  is less than 13 cycles.
