XC2700 Derivatives

16/32-Bit Single-Chip Microcontroller with
32-Bit Performance

Edition 22.08.2008

This Errata Sheet describes the deviations of the XC2700 Derivatives from the current user documentation.

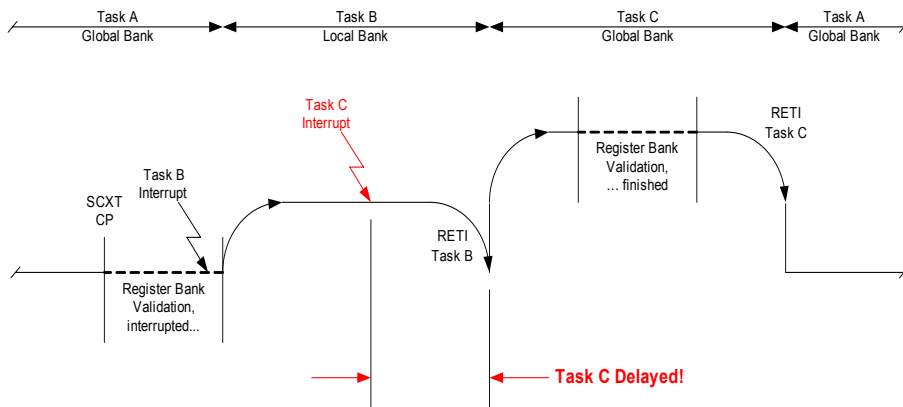
Figure 1 Example for Case 2: Interrupt Service for Task C delayed

00_B) to automatically use the **global** bank via the bank selection registers BNKSEL0...3 (i.e. the interrupting routine has a priority level ≥ 13)

In this case service of this interrupt request (for Task C) is delayed until bit field PSW.BANK becomes 00_B after executing the RETI instruction at the end of the routine (Task B) using the local bank.

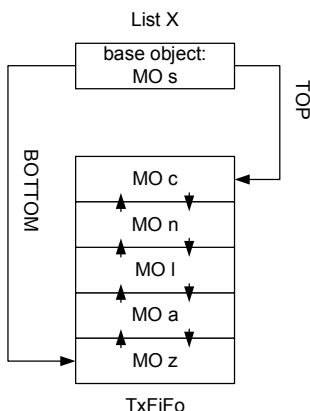
Figure 2 FIFO structure

After the successful transmission of a Tx FIFO element, a Tx overflow interrupt is generated if the FIFO base object fulfils these conditions:

If Tx FIFO overflow interrupt needed, take the FIFO base object out of the circular list of the Tx message objects. That is to say, just use the FIFO base object for FIFO control, but not to store a Tx message.

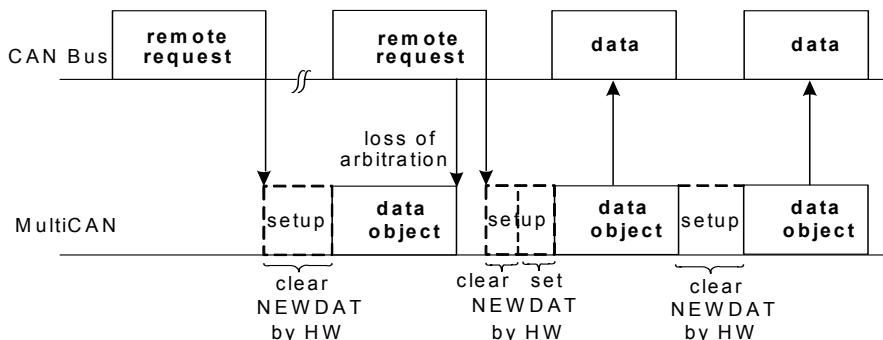
Figure 4 Loss of Arbitration

When the appropriate message object (data frame) triggered by the first remote frame wins the arbitration, it will be sent out and `NEWDAT` is not reset. This leads to an additional data frame, that will be sent by this message object (clearing `NEWDAT`).

There will, however, not be more data frames than there are corresponding remote requests.
