XC27x7X Derivatives

16/32-Bit Single-Chip Microcontroller
with 32-Bit Performance
XC2000 Family / High Line

Errata Sheet

V1.6 2013-03

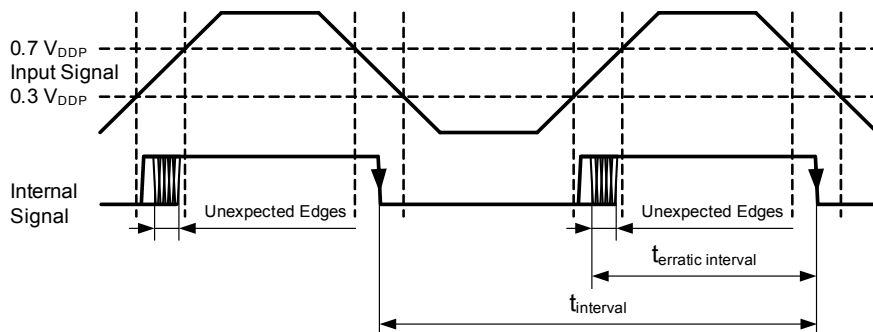
Figure 3 Falling Edge Detection Approach

- Measure the time interval since the last interrupt (shown as in t_{interval} in [Figure 3](#) below) and check that it is in the expected time range.
 In the example, an erratic edge would cause the measured time interval/erratic interval to be approximately 50% of the expected value.
- The state of the input pin that caused the interrupt could be read several times in the interrupt service routine and a majority decision made to check if the input pin really is at a low level to determine whether this is a genuine falling edge interrupt or whether the interrupt was triggered by a spike generated by a slow rising edge.
