## XC27x8X Derivatives

16/32-Bit Single-Chip Microcontroller  
with 32-Bit Performance

Errata Sheet

V1.2 2013-07

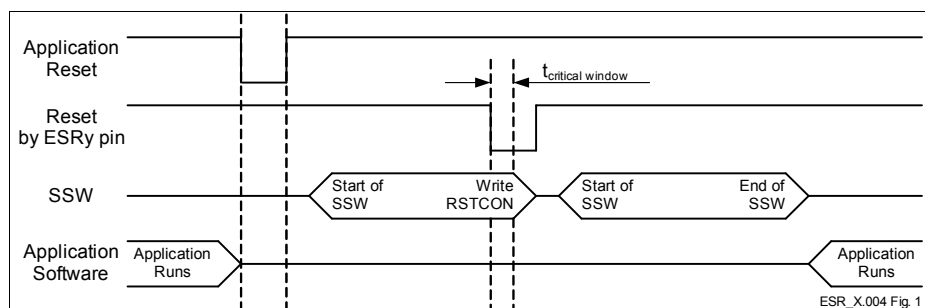
**Figure 1    Critical application reset sequence**

SCU\_RSTCONx registers are reset only by Power-On, but they may be wrongly affected after a second application reset requested by an ESRy pin. This may lead to the SCU\_RSTCONx register values being set to zero, which could unexpectedly disable reset sources within the user application. The conditions which lead to this behavior are:

1. First, an application reset by SW (software), CPU (Central Processing Unit), MP (Memory), WDT (Watchdog Timer) or ESRy (External Service Request y) occurs.
2. Following this, an application reset on an ESRy pin occurs.
3. If the above mentioned ESRy reset occurs during a critical time window of the SSW (startup software), then it's possible that the application will operate with the wrong SCU\_RSTCONx register value. The critical time window occurs when the SSW is writing the SCU\_RSTCONx registers, and at the same time, the ESRy reset request is processed by the reset circuitry. The width of this critical window  $t_{critical\ window}$  is less than 13 cycles.

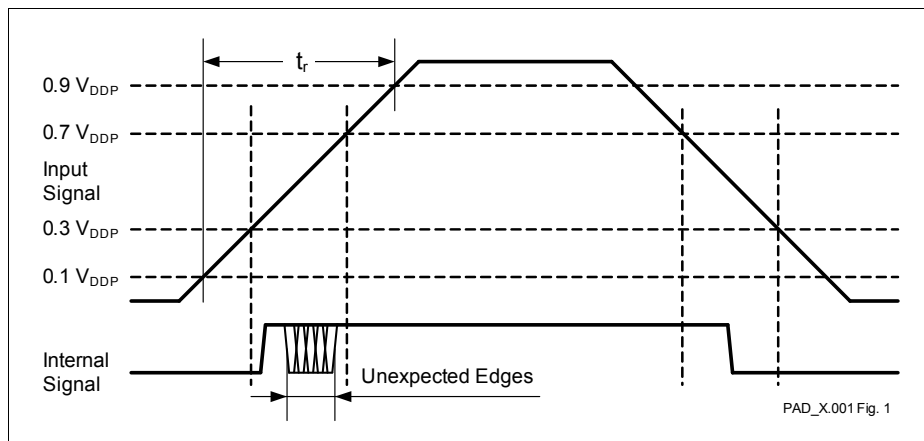
**Figure 2 Example for a Slow Input Signal**

The digital input- and I/O-pins are designed using Schmitt trigger input structures with hysteresis. Even with this structure, it is possible that very slow rising edges may generate spikes, resulting in unexpected additional edges at the input signal.

The first rising edge in [Figure 2](#) of the internal signal is always valid. The edges which are marked with “Unexpected Edges” must be ignored.

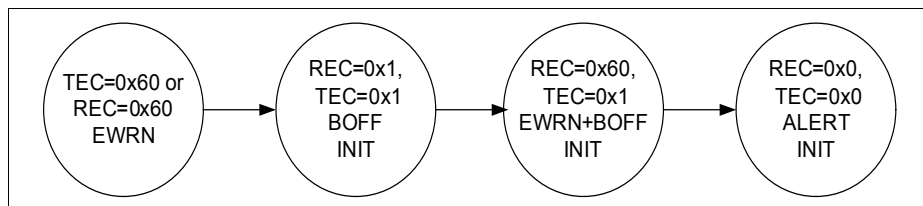
**Figure 6 Alert Interrupt Behavior in case of Bus-Off**

The MultiCAN module shows the following behavior in case of a bus-off status:

When the threshold for error warning (EWRN) is reached (default value of Error Warning Level EWRN = 0x60), then the EWRN interrupt is issued. The bus-off (BOFF) status is reached if  $TEC > 255$  according to CAN specification, changing the MultiCAN module with REC and TEC to the same value 0x1, setting the INIT bit to 1<sub>B</sub>, and issuing the BOFF interrupt. The bus-off recovery phase starts automatically. Every time an idle time is seen, REC is incremented. If REC = 0x60, a combined status EWRN+BOFF is reached. The corresponding interrupt can also be seen as a pre-warning interrupt, that the bus-off recovery phase will be finished soon. When the bus-off recovery phase has finished (128 times idle time have been seen on the bus), EWRN and BOFF are cleared, the ALERT interrupt bit is set and the INIT bit is still set.
