XE166L Derivatives

Real Time Signal Controller

Errata Sheet

V1.3 2013-09

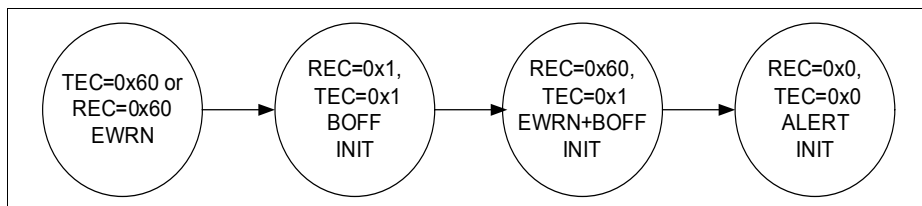
Figure 2 Alert Interrupt Behavior in case of Bus-Off

MultiCAN_AI.H007 Alert Interrupt Behavior in case of Bus-Off

The MultiCAN module shows the following behavior in case of a bus-off status:

When the threshold for error warning (EWRN) is reached (default value of Error Warning Level EWRN = 0x60), then the EWRN interrupt is issued. The bus-off (BOFF) status is reached if TEC > 255 according to CAN specification, changing the MultiCAN module with REC and TEC to the same value 0x1, setting the INIT bit to 1_B, and issuing the BOFF interrupt. The bus-off recovery phase starts automatically. Every time an idle time is seen, REC is incremented. If REC = 0x60, a combined status EWRN+BOFF is reached. The corresponding interrupt can also be seen as a pre-warning interrupt, that the bus-off recovery phase will be finished soon. When the bus-off recovery phase has finished (128 times idle time have been seen on the bus), EWRN and BOFF are cleared, the ALERT interrupt bit is set and the INIT bit is still set.
