# AURIX™ TC37x errata sheet

**Marking/Step: (E)ES-AA, AA**

## About this document

This document describes the deviations of the device from the current user documentation, to support the assessment of the effects of these deviations on your custom hardware and software implementations.

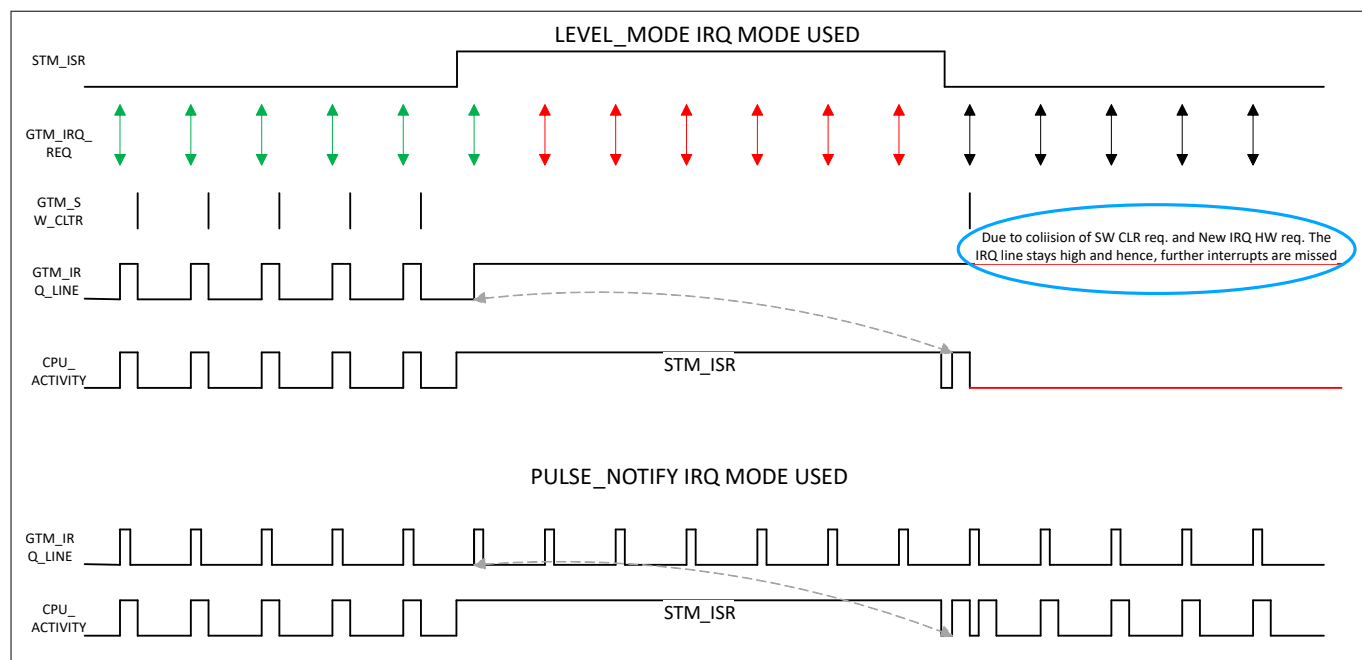
**Figure 11** Interrupt Level vs. Pulse-Notify mode - Corner Case Example

Hence, in Level Mode, in some scenarios where another interrupt request is generated by GTM while the ISR handle also requests a SW clear, then, as the interrupt event is dominant over the clear event (for simultaneous interrupt and clear events), GTM\_IRQ\_XXX is not cleared and remains high. As a consequence, the IR observes no transition on GTM\_IRQ\_XX. Thus, any forthcoming interrupt events in this scenario are lost as there is no chance to release the CPU IRQ when a collision happens as shown in Figure below.

If Pulse-Notify mode is selected, every internal trigger will be forwarded to the IR, irrespective of the time of occurrence and the clear event, as the pulse-notify leads to set and reset of GTM\_IRQ\_XXX as compared to only setting of the GTM\_IRQ\_XXX line in Level mode.
