AURIX™ TC37xEXT errata sheet

Marking/Step: (E)ES-AB, AB

About this document

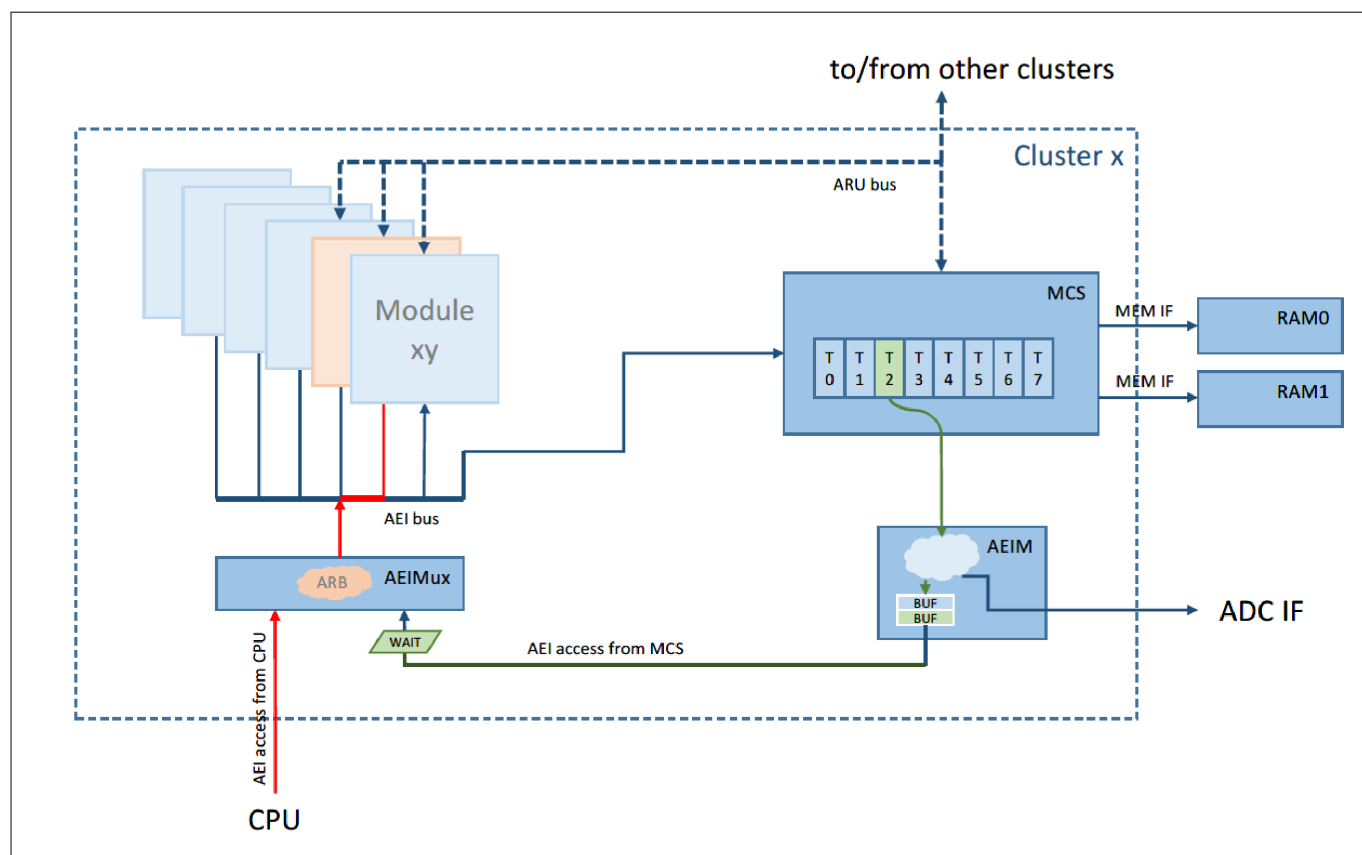
Figure 5 MCS AEI master access path

Figure 5 shows an uncritical traffic situation. Here an access of a MCS thread to the AEI bus (green access path) is temporary delayed due to an ongoing AEI bus access from the CPU (red access path). The MCS access to the AEI bus will be safely buffered at the AEIM (green buffer). As soon as the CPU access to the AEI bus completes, the buffered AEI bus access from MCS will be executed.
