AURIX™ TC4Dx errata sheet

Marking/Step: (E)ES-AB

32-bit single-chip microcontroller
10581AERRA

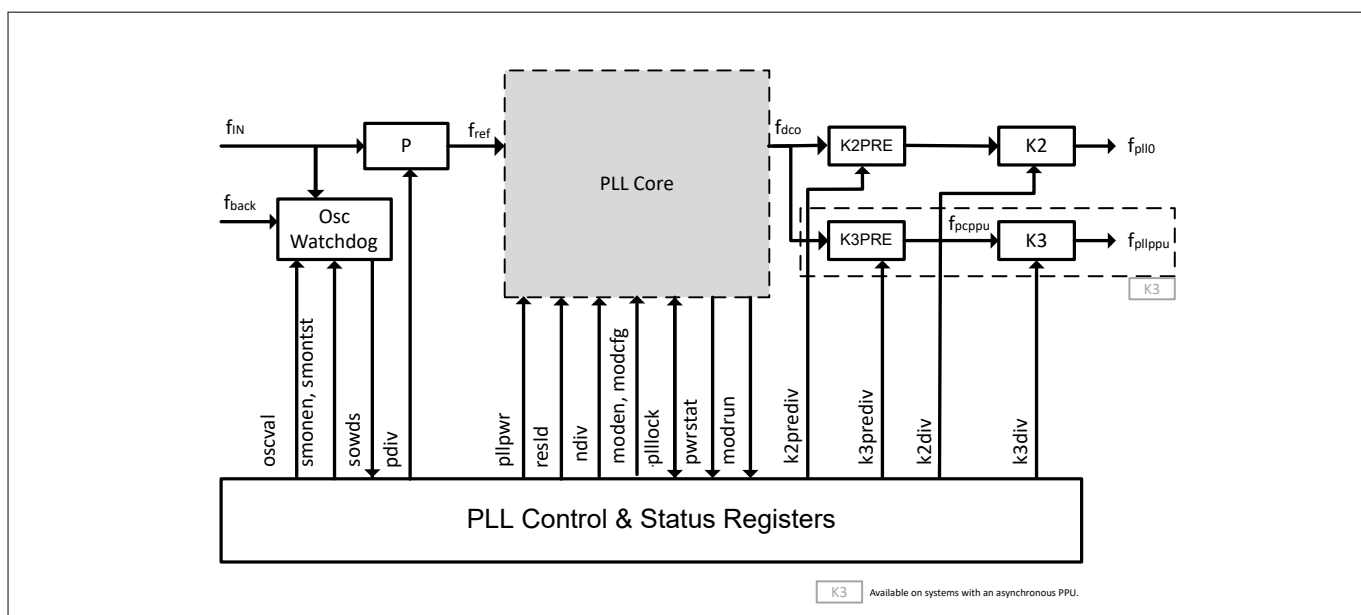
Figure 1 **System PLL block diagram**

There is an inconsistency between CLOCK_SYSPLLCON1 register description and the Functional description chapter of the SYSPLL. K2PRE is added to the figure with the recommendation to only use the K2PRE = 1.0 pre-divider value. The description is corrected as follows:

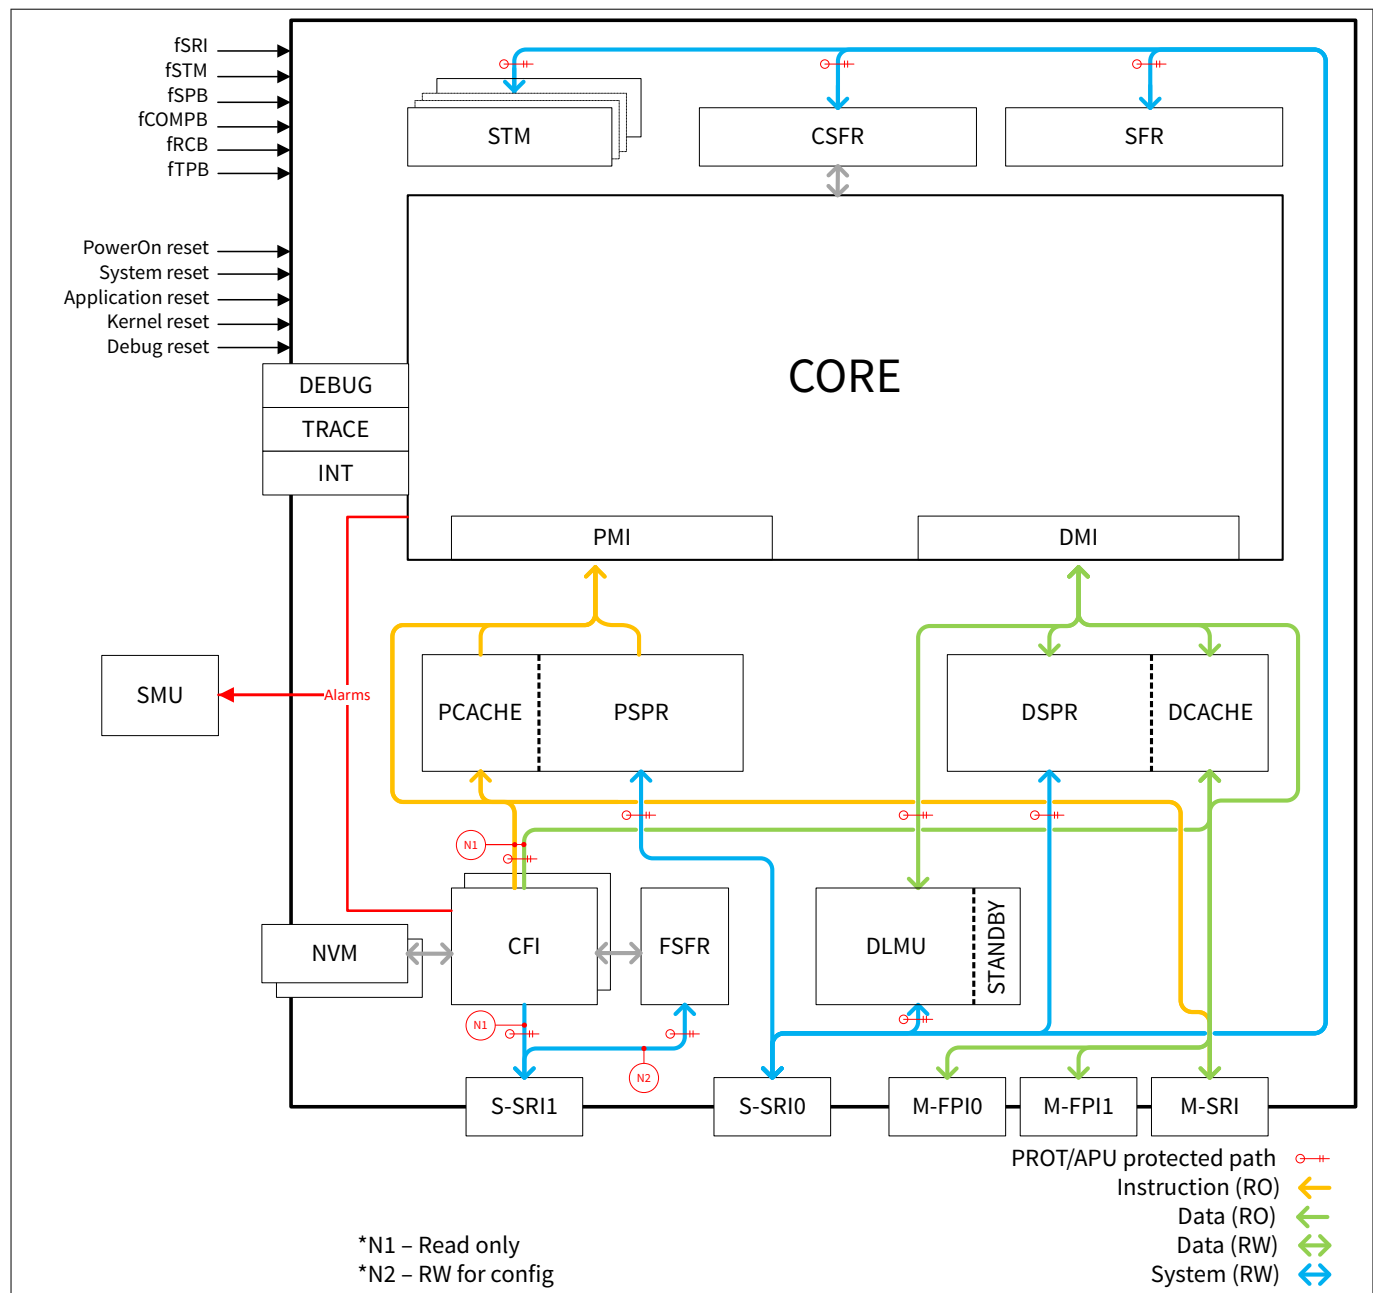
Figure 2 CPU block diagram

The following figure must be used instead:

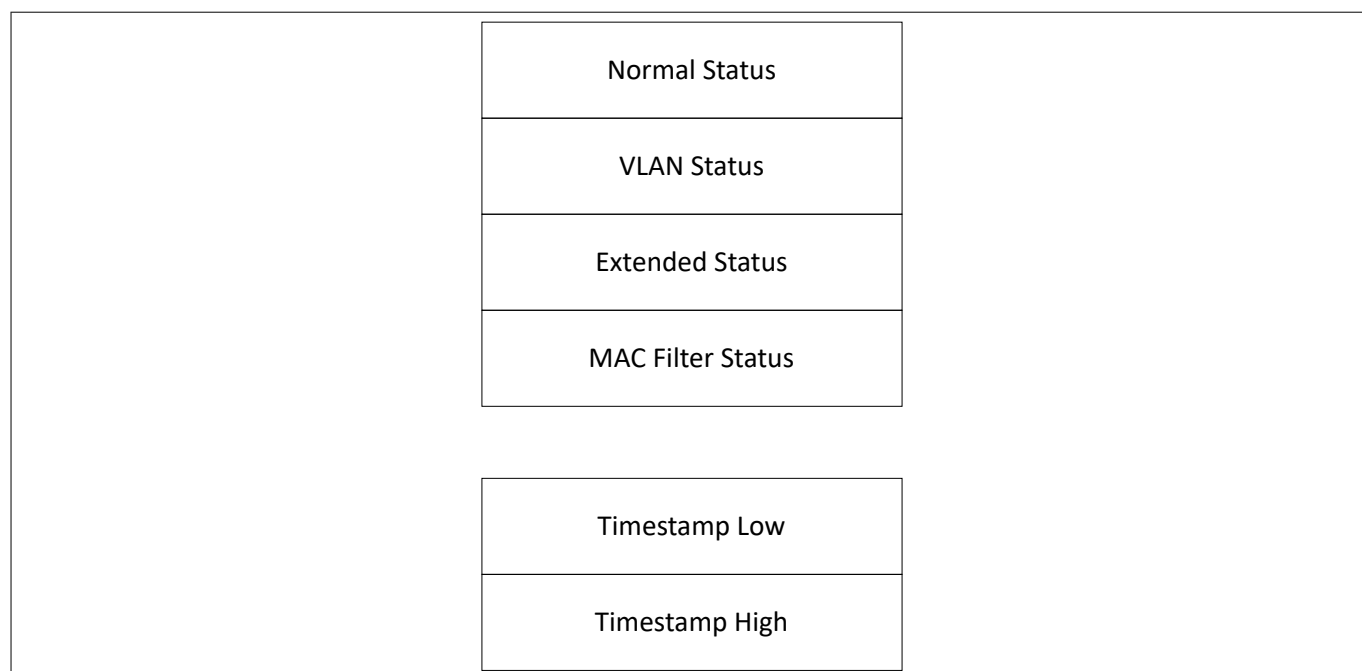
Figure 3 **Format of the receive status word order**

The Bridge calculates the number of status words from the ingress port after receiving the first status word (Normal Status) of ARI Rx Status (after EOP is accepted). The Bridge identifies the end of a packet from an ingress port to a DMA channel when the DMA accepts the final status word (Rx status or Rx Timestamp status) for that channel (indicated by the ARI channel number signal).

The defect scenario occurs when the Rx packet has only Normal status (untagged packet with timestamp capturing disabled), and the Normal status is accepted by Bridge in the same clock cycle. The ARI channel number provided by the ingress port can change in the next cycle once the Normal status is accepted.

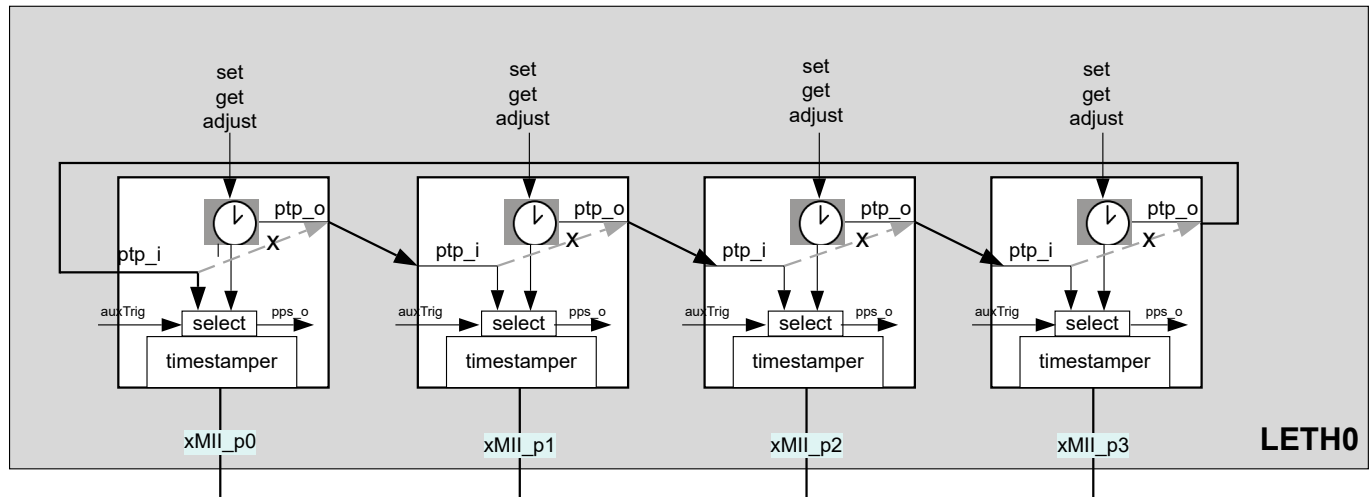
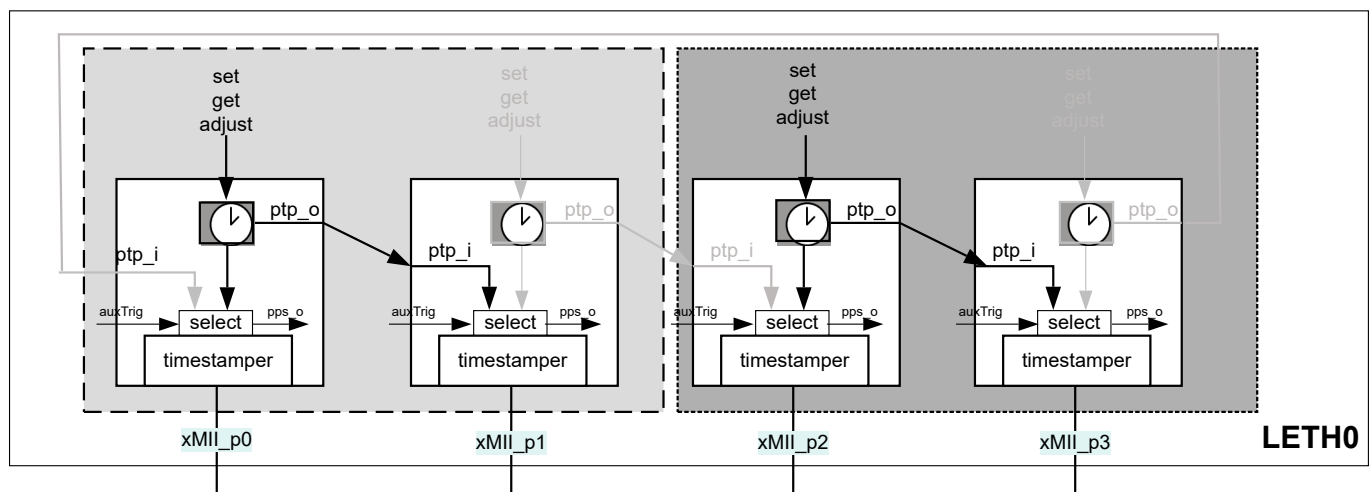
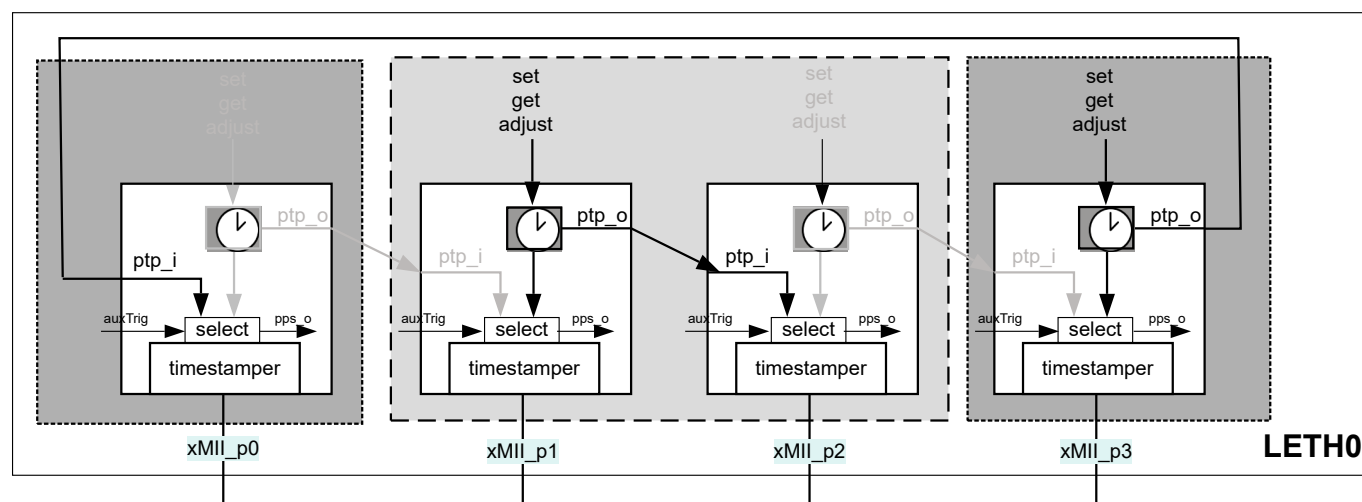
A daisy-chaining of internal local time base output of LETH0 MAC port (j) and external time base input to LETH0 MAC port (j+1) provides a mechanism for time base distribution between LETH0 MAC ports.

However, due to limitation in LETH0 MAC ports if timebase for timestamping is selected via external time base input by setting Portj_MAC_Timestamp_Control.ESTI register bit, LETH0 MAC port cannot output the 64-bit PTP time.

LETH0 MAC port 0 internal time base output can be forwarded to external time base input of LETH0 MAC port 1

LETH0 MAC port 2 internal time base output can be forwarded to external time base input of LETH0 MAC port 3

LETH0 MAC port 3 internal time base output can be forwarded to external time base input of LETH0 MAC port 0

LETH0 MAC port 1 internal time base output can be forwarded to external time base input of LETH0 MAC port 2

No workaround possible.

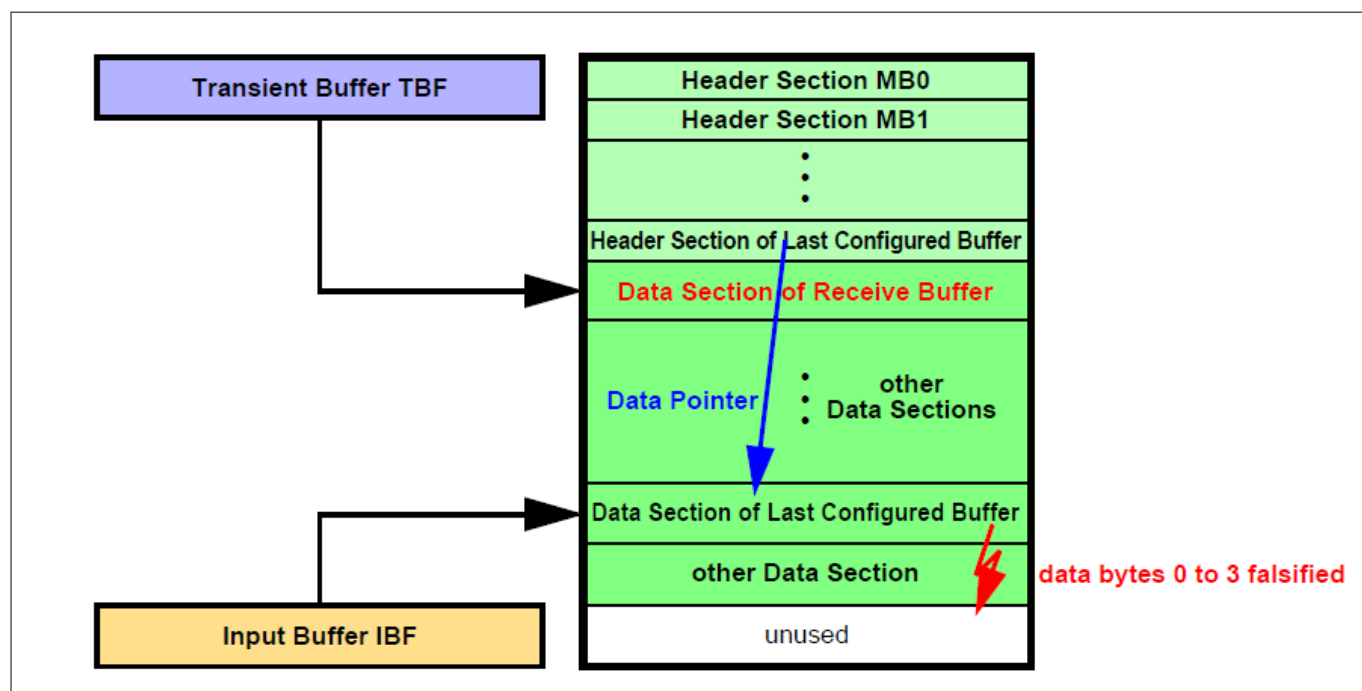
Figure 5 Message buffer transfer from IBF to Message RAM

After the Data Section of the selected message buffer in the Message RAM has been written, one additional write access overwrites the following word in the Message RAM which might be the first word of the next Data Section.

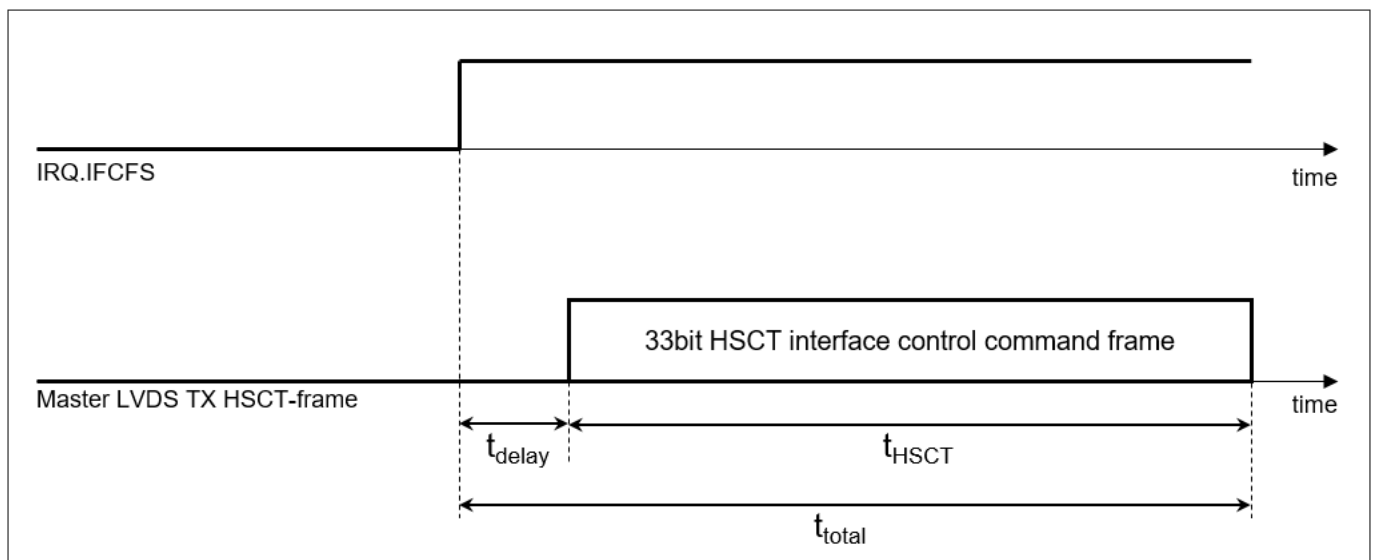
Figure 7 Timing of LVDS TX interface command sending in relation to IRQ.IFCFS

the user might falsely assume that also the actual sending on the LVDS TX port has already occurred once the IRQ.IFCFS flag is set, which is not true.

Instead the timing shown in the following figure applies.

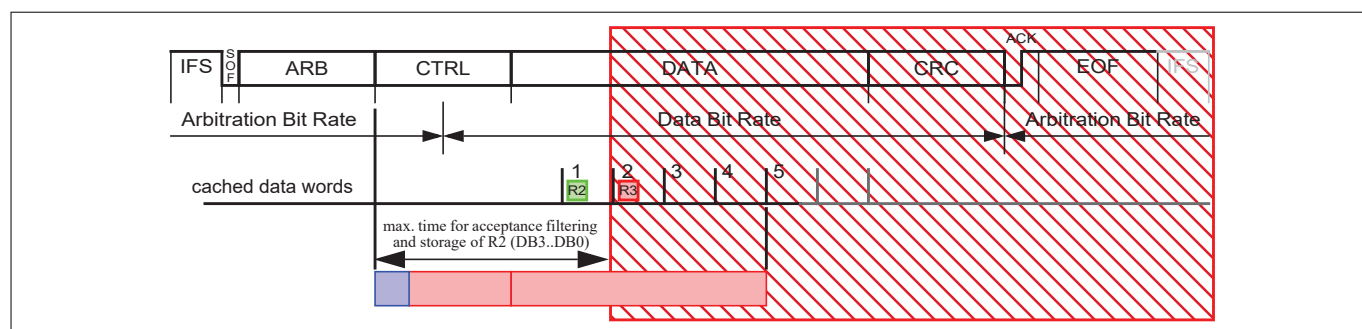
Figure 9 CAN Frame with DLC > 4

The figure that follows shows how the available time for acceptance filtering and storage is reduced.
