# TRAVEO™ T2G CYT2B6 errata sheet

## Marking/Step: Rev. D

32-bit single-chip microcontroller

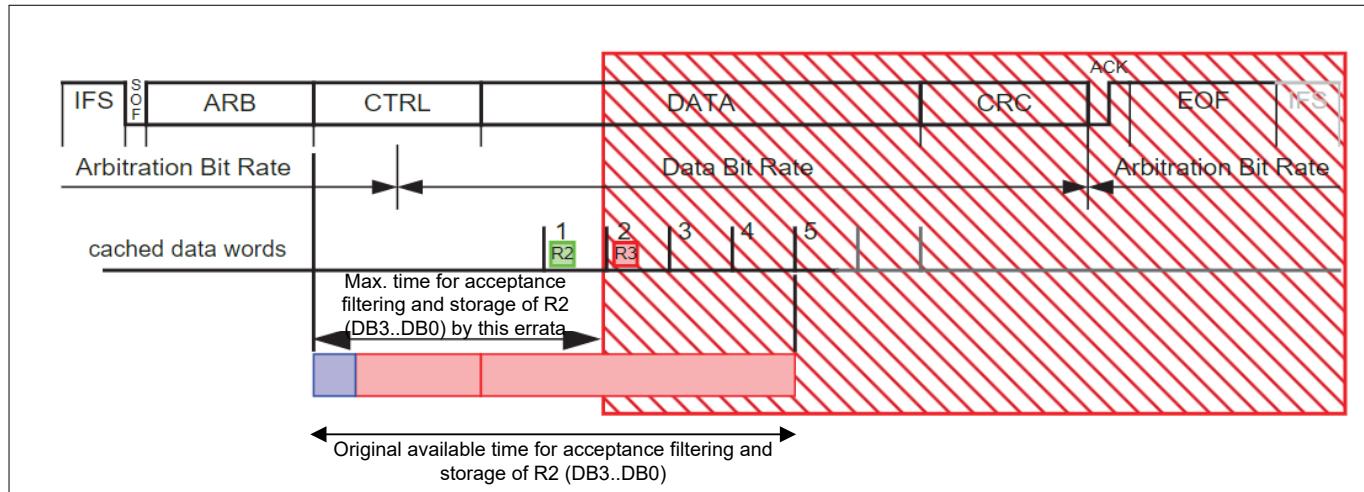
Figure 2 CAN frame with  $DLC > 4$

Under the following conditions a received message will have corrupted data while the received message is signaled as valid to the host.

1. The data length code (DLC) of the received Message is greater than 4 (DLC > 4)
2. The storage of Ri of a received message into the Message RAM (after acceptance filtering is done) has not completed before R(i+1) is transferred from the CAN Core into the cache of the Rx Handler (where  $2 \leq i \leq 5$ )
3. While condition 1 and 2 apply, a concurrent read of data word Ri from the cache and write of data word R(i+1) into the cache of the Rx handler happens

The issue may occur in FD Frame Format as well as in Classic Frame Format.

Figure 2 shows how the available time for acceptance filtering and storage is reduced.

Due to condition 3 the issue occurs only sporadically. Use an end-to-end (E2E) protection (for example, checksum or CRC covering the data field) and add it to all messages in the CAN system, to detect data corruption in received frames.
