TRAVEO™ T2G CYT4BF errata sheet

Marking/Step: Rev. D

32-bit single-chip microcontroller

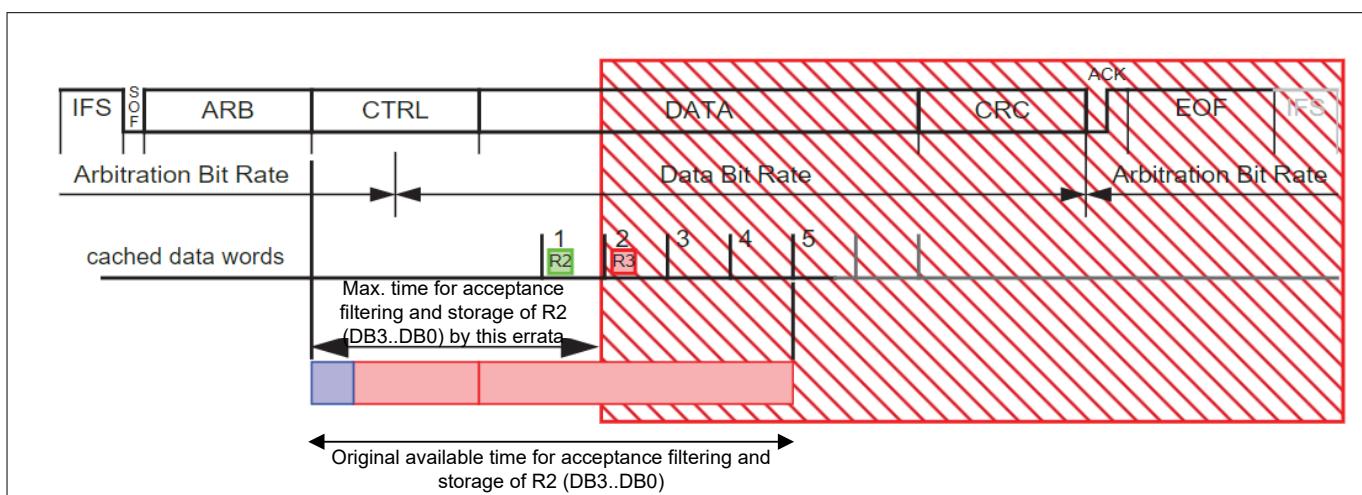
Figure 2 CAN frame with DLC > 4

Under the following conditions a received message will have corrupted data while the received message is signaled as valid to the host.

1. The data length code (DLC) of the received Message is greater than 4 (DLC > 4)
2. The storage of Ri of a received message into the Message RAM (after acceptance filtering is done) has not completed before R(i+1) is transferred from the CAN Core into the cache of the Rx Handler (where $2 \leq i \leq 5$)
3. While condition 1 and 2 apply, a concurrent read of data word Ri from the cache and write of data word R(i+1) into the cache of the Rx handler happens

[Figure 2](#) shows how the available time for acceptance filtering and storage is reduced.

Due to condition 3 the issue occurs only sporadically. Use an end-to-end (E2E) protection (for example, checksum or CRC covering the data field) and add it to all messages in the CAN system, to detect data corruption in received frames.

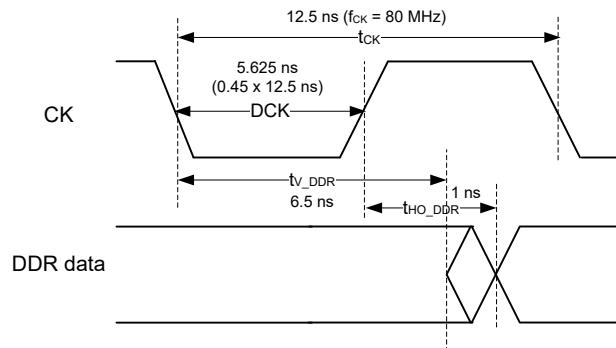
Existing read timing specification (data input) of SMIF HSSPI (SDR/DDR) has self-contradiction and required setup time for MCU is unclear. The example case (DDR for HSIO_STD) of this problem is shown below.

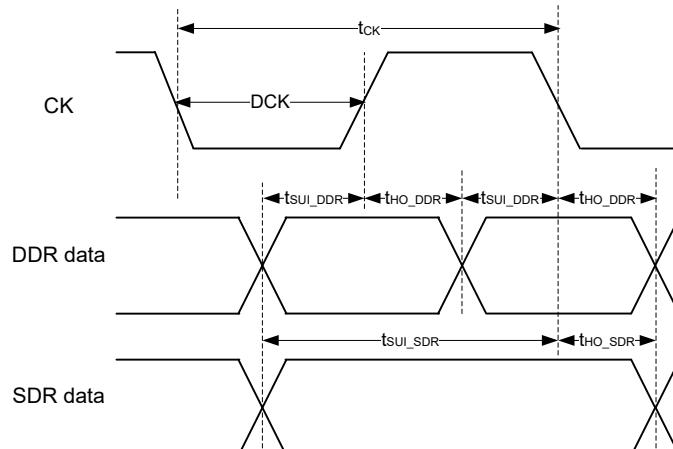
Therefore, we remove t_V spec (SID781/A/B/C) and add the setup time spec as below to avoid this problem.

Spec ID	Parameter	Description	Min	Typ	Max	Units	Details/Conditions
SID789	$t_{SUI_SDR_HSIO}$	Input setup time	2	-	-	ns	SMIF_CTL.C LOCK_IF_RX _SEL=3, SMIF_CTL.D ELAY_TAP_E NABLED=0
SID789A	$t_{SUI_SDR_GPIO}$	Input setup time	10	-	-	ns	SMIF_CTL.C LOCK_IF_RX _SEL=3, SMIF_CTL.D ELAY_TAP_E NABLED=0
SID789B	$t_{SUI_DDR_HSIO}$	Input setup time	1.25	-	-	ns	SMIF_CTL.C LOCK_IF_RX _SEL=3, SMIF_CTL.D ELAY_TAP_E NABLED=0
SID789C	$t_{SUI_DDR_GPIO}$	Input setup time	6	-	-	ns	SMIF_CTL.C LOCK_IF_RX _SEL=3, SMIF_CTL.D ELAY_TAP_E NABLED=0
