AURIX™ TC33x/TC32x errata sheet

Marking/Step: (E)ES-AA, AA

10594AERRA

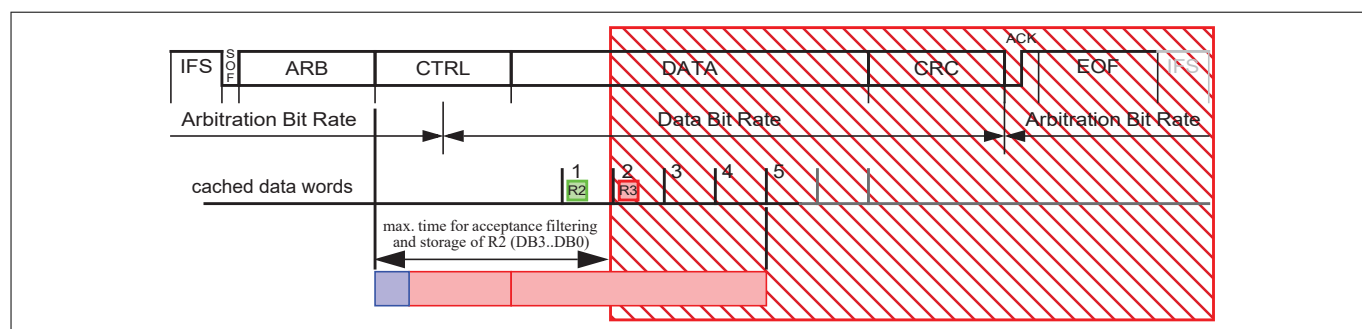
Figure 5 CAN Frame with DLC > 4

Under the following conditions a received message will have corrupted data while the received message is signaled as valid to the host.

The figure that follows shows how the available time for acceptance filtering and storage is reduced.

Due to condition 3) the issue only occurs sporadically. Use an end-to-end (E2E) protection (for example, checksum or CRC covering the data field) and add it to all messages in the CAN system, to detect data corruption in received frames.

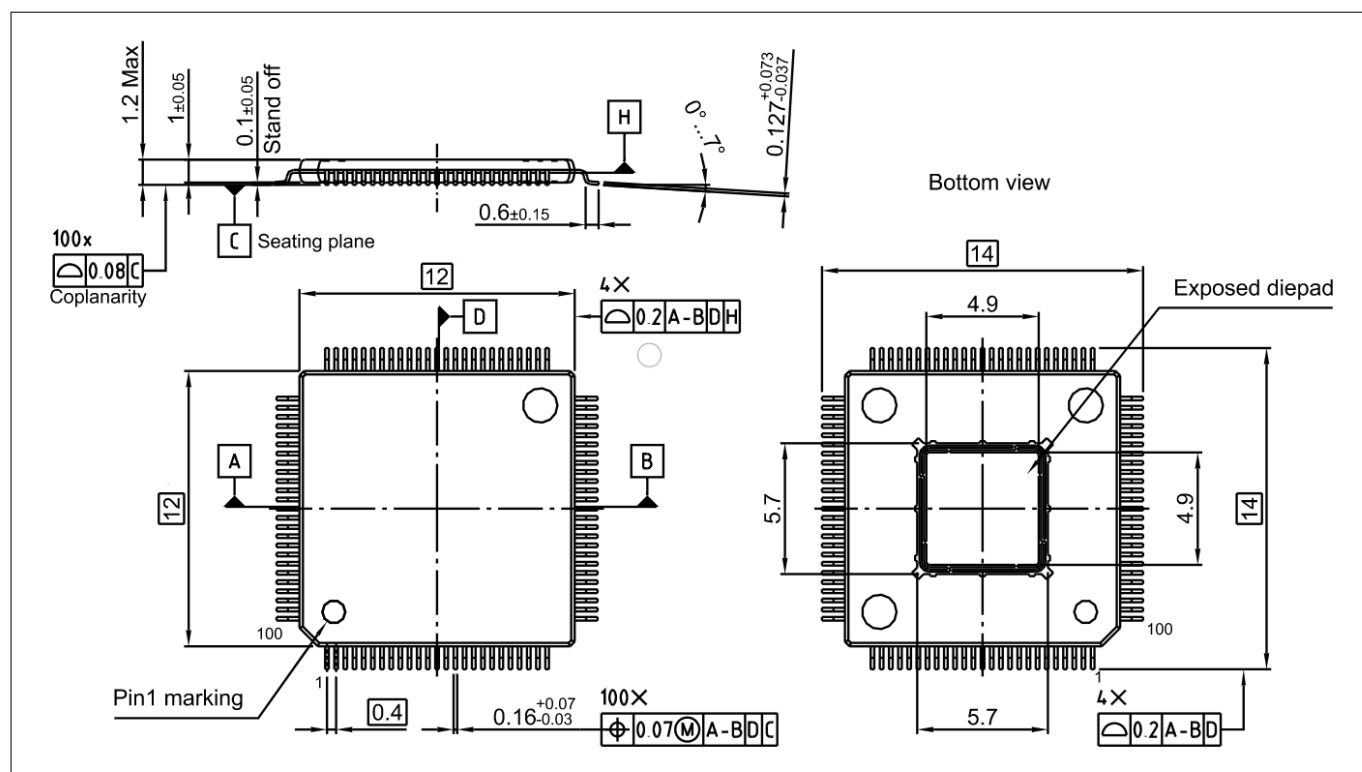
Figure 8 Package Outlines TQFP-100 for TC33x/TC32x

Note: For the exposed diepad of the TQFP-100 package of the TC33x/TC32x, structural corner protrusions have to be considered for purposes of system design and integration with a maximum boundary of 6.3 mm.
