AURIX™ TC33xEXT errata sheet

Marking/Step: (E)ES-AA, AA

10595AERRA

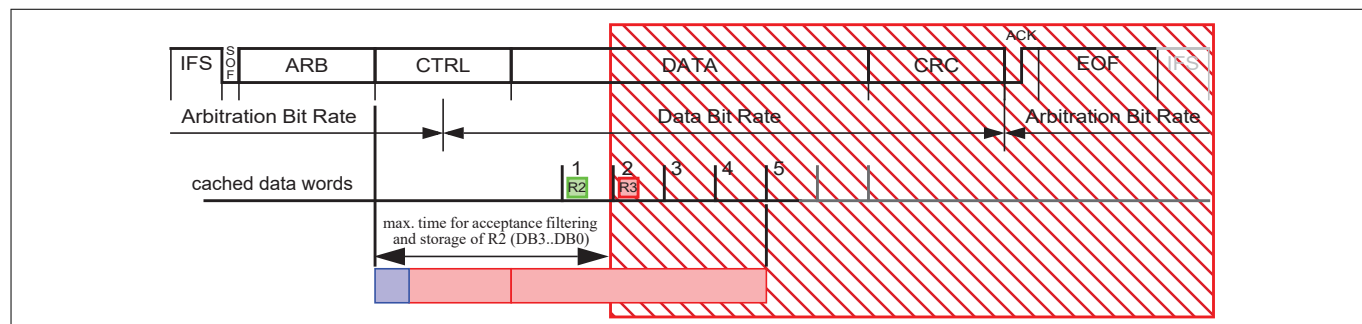
Figure 2 CAN Frame with DLC > 4

Under the following conditions a received message will have corrupted data while the received message is signaled as valid to the host.

1. The data length code (DLC) of the received message is greater than 4 ($DLC > 4$)
2. The storage of R_i of a received message into the Message RAM (after acceptance filtering is done) has not completed before R_(i+1) is transferred from the CAN Core into the cache of the Rx Handler (where $2 \leq i \leq 5$)
3. While condition 1) and 2) apply, a concurrent read of data word R_i from the cache and write of data word R_(i+1) into the cache of the Rx handler happens

The issue may occur in FD Frame Format as well as in Classic Frame Format.

The figure that follows shows how the available time for acceptance filtering and storage is reduced.

Due to condition 3) the issue only occurs sporadically. Use an end-to-end (E2E) protection (for example, checksum or CRC covering the data field) and add it to all messages in the CAN system, to detect data corruption in received frames.
