# AURIX™ TC35x errata sheet

**Marking/Step: (E)ES-AB, AB**

10593AERRA

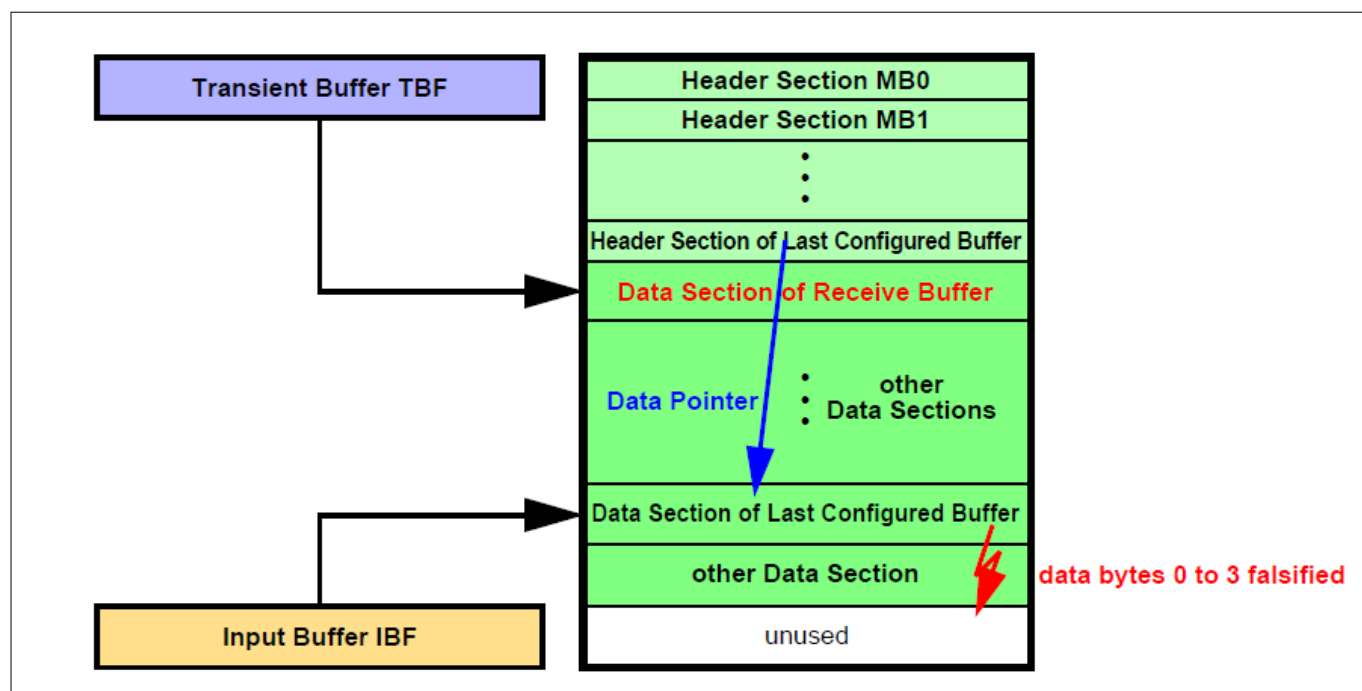
**Figure 2** Message buffer transfer from IBF to Message RAM

After the Data Section of the selected message buffer in the Message RAM has been written, one additional write access overwrites the following word in the Message RAM which might be the first word of the next Data Section.
