# AURIX™ TC26x errata sheet

**Marking/Step: ES-BC, BC**

10504AERRA

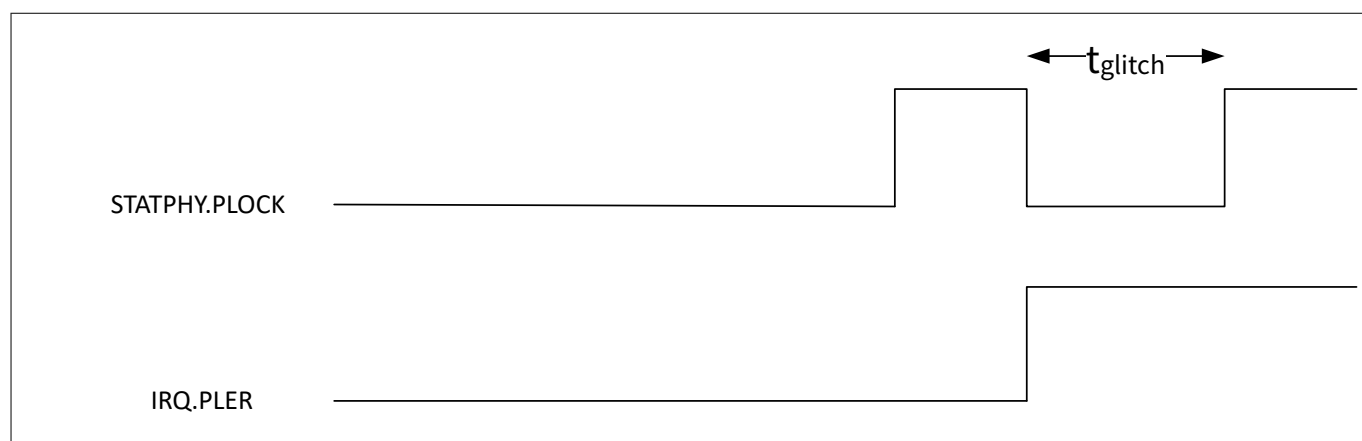
**Figure 4 PLL Unlock Event Glitch**

After STATPHY.PLOCK shows lock status, there is a possibility that the PLL is unlocked once for a short time ( $t_{\text{glitch}}$ ) again at start-up phase, as shown in the figure below. This single unlock event as indicated by STATPHY.PLOCK recovers back to lock status without any software intervention.

The minimum time duration of  $t_{\text{glitch}}$  is 224 cycles of the PLL reference clock (RefClk). An example of minimum  $t_{\text{glitch}}$  duration for RefClk with 20 MHz and 10 MHz is shown in the table below.

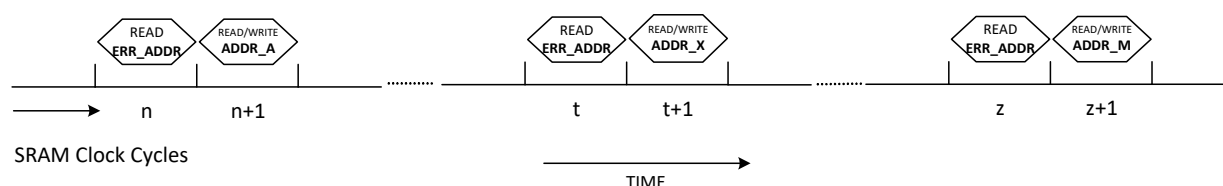
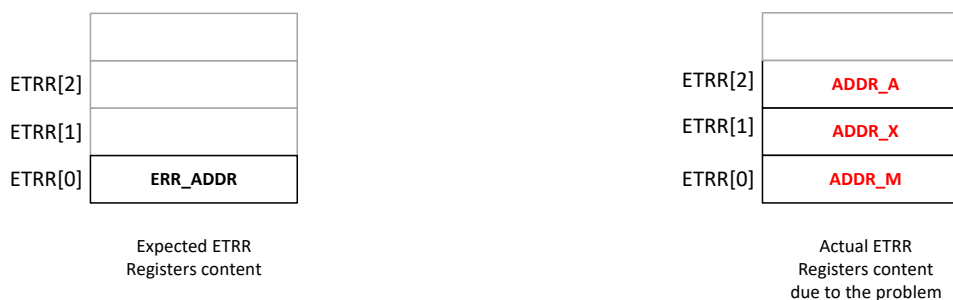
**Figure 5** Example sequence showing how registers ETRRx may be filled with “Error Free” addresses

- The expected behaviour is that **only** ERR\_ADDR is stored in the ETRR.
- Due to the problem, ERR\_ADDR is not stored in the ETRR, and addresses **ADDR\_A, ADDR\_X and ADDR\_M** are stored instead.

The consequence of the scenario explained in [Figure 5](#) is that a single error in the SRAM – example just one correctable error at a location ERR\_ADDR – can result in registers ETRRx getting filled with fault-free address, and thus potentially even triggering an ETRR overflow.

If there is at least one valid ETRR entry (i.e. MCx.ECCD.VAL  $\neq$  0) then the software shall run a Non-Destructive-Inversion (NDI) Test on the affected SRAM. Please refer to application note AP32197 (AURIX™ Memory tests using the MTU) for an example regarding running this test.

At the end of this test, if an ETRR overflow is detected (MCx.ECCD.EOV = 1<sub>B</sub>) then the MCU shall be considered non-operational. Refer to section on Correctable SRAM Error handling in the Safety Manual.

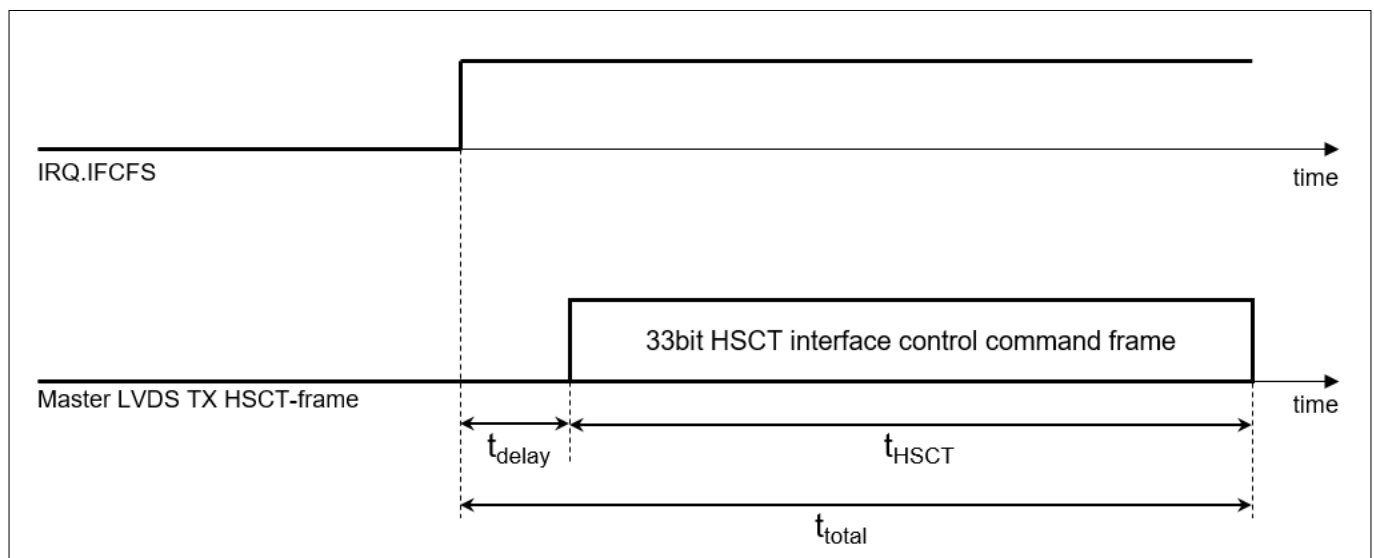
**Figure 10**      **Timing of LVDS TX interface command sending in relation to IRQ.IFCFS**

the user might falsely assume that also the actual sending on the LVDS TX port has already occurred once the IRQ.IFCFS flag is set, which is not true.

Instead the timing shown in the following figure applies.

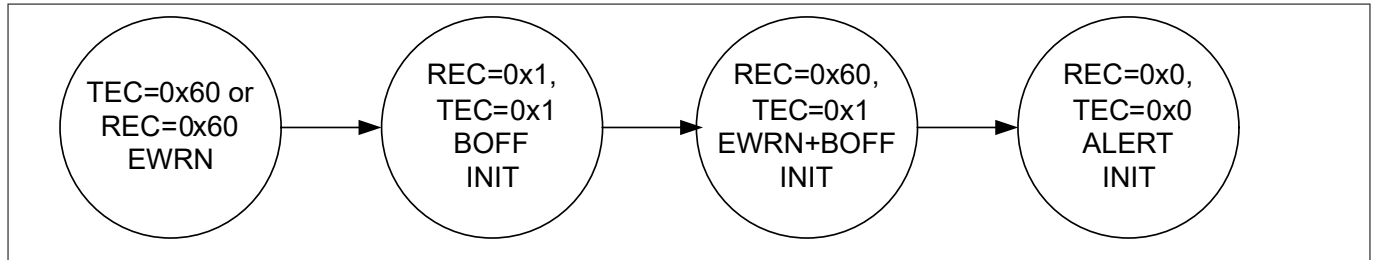
**Figure 12 Alert Interrupt Behavior in case of Bus-Off**

When the threshold for error warning (EWRN) is reached (default value of Error Warning Level EWRN = 0x60), then the EWRN interrupt is issued. The bus-off (BOFF) status is reached if TEC > 255 according to CAN specification, changing the MultiCAN module with REC and TEC to the same value 0x1, setting the INIT bit to 1<sub>B</sub>, and issuing the BOFF interrupt. The bus-off recovery phase starts automatically. Every time an idle time is seen, REC is incremented. If REC = 0x60, a combined status EWRN+BOFF is reached. The corresponding interrupt can also be seen as a pre-warning interrupt, that the bus-off recovery phase will be finished soon. When the bus-off recovery phase has finished (128 times idle time have been seen on the bus), EWRN and BOFF are cleared, the ALERT interrupt bit is set and the INIT bit is still set.

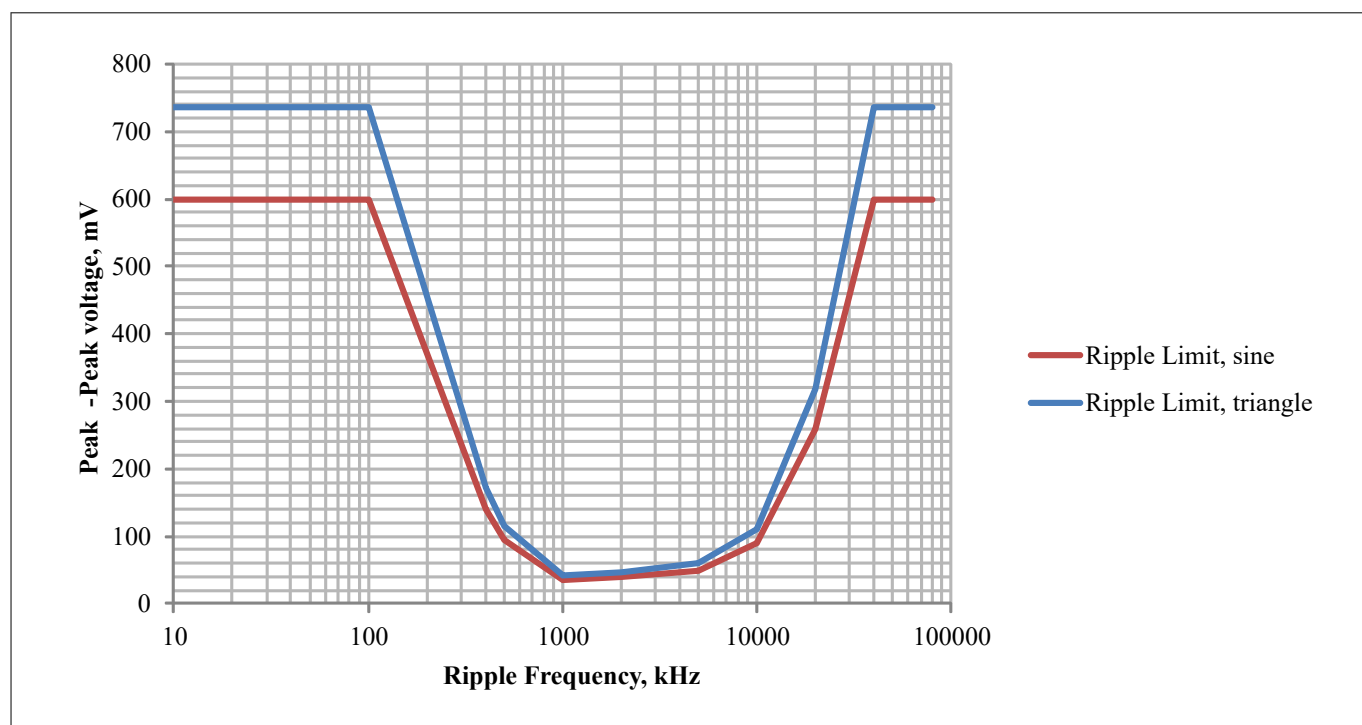
**Figure 18** Ripple Voltage vs. Frequency Characteristic

The internal back-up clock is sensitive to specific power supply voltage disturbance/ripple caused by a voltage ripple intrinsic to DC-DC converters. Specific conditions such as insufficient filtering of the ripple may lead to improper behavior of the start-up scheme of the back-up clock, and thus stuck-at state during the start-up of the microcontroller until this condition is removed.

The diagram reflects acceptable ripple level during the cold start of the microcontroller at the respective VDDP3/VEXT/VEVRSB supply of the PMS subsystem, depending on the device and package type, as shown in the following table.

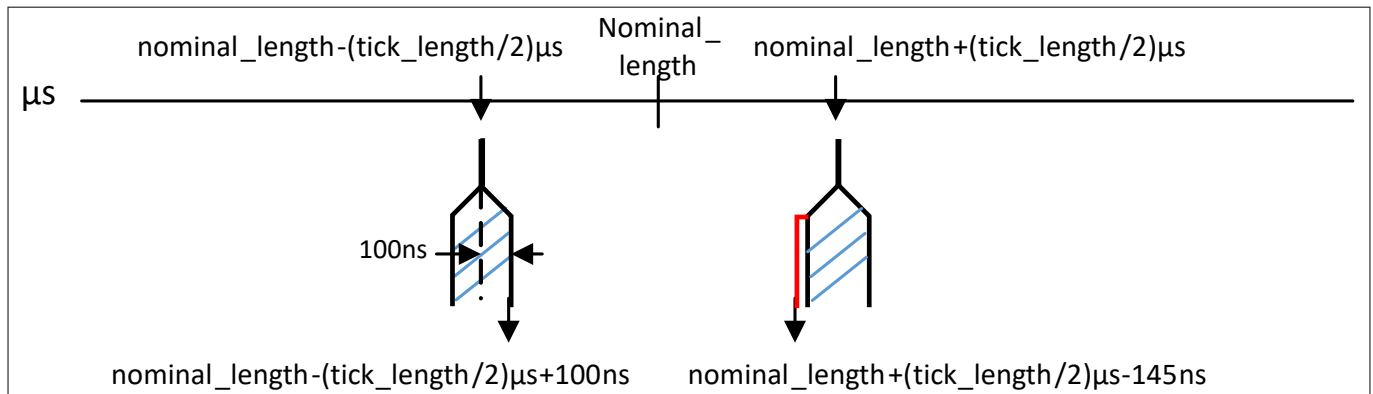
**Figure 20** SENT Tolerance of this Design Step

- The lower border is  $\text{nominal\_value} - (\text{tick\_length}/2) \mu\text{s} + 100 \text{ ns}$
- The upper border is  $\text{nominal\_value} + (\text{tick\_length}/2) \mu\text{s} - 145 \text{ ns}$

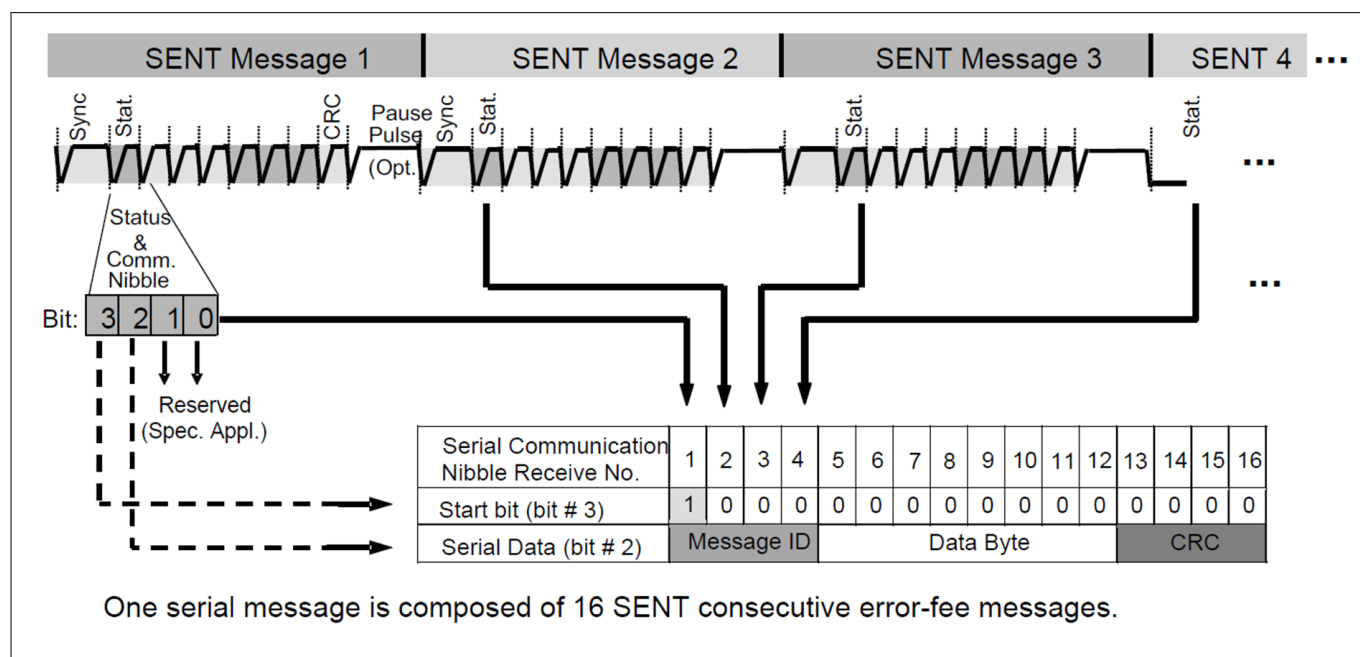
**Figure 21** Short Serial Message, Serial Data Encoding over 16 messages

Figure 21 shows a corrected version of this figure.
