Device	XMC4500
Marking/Step	ES-AC, AC
Package	PG-LQFP-100/144, PG-LFBGA-144

Document ID is **116/17**.

This “Errata Sheet” describes product deviations with respect to the user documentation listed below.

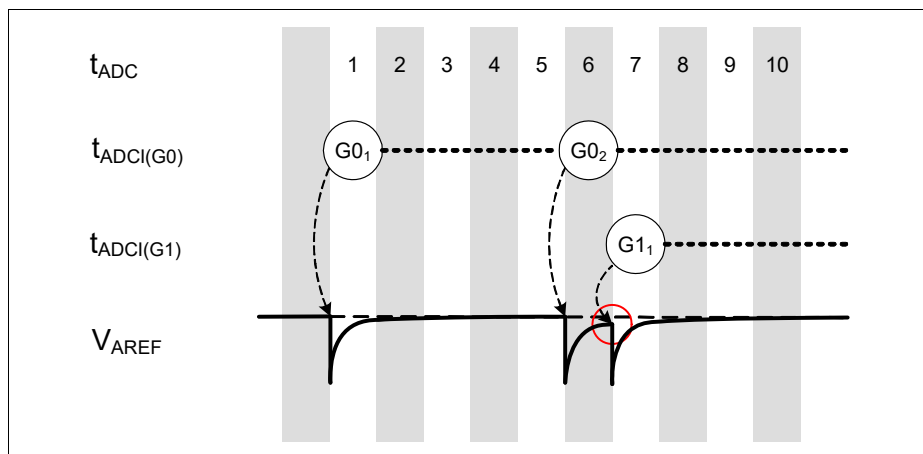
Due to this architecture, the individual prescalers may be displaced by one module clock as shown in the figure below for G0₂ and G1₁. In this example the division factor is 5 (DIVA=4).

Figure 1 Influence of concurrent conversions on reference voltage

In cycle 1 only the G0 conversion step is started. At start time the reference voltage is strobed and a certain amount of electric charge (see data sheet parameter Q_{CONV}) is consumed. This causes a drop of the reference voltage level V_{AREF} . Quantity of voltage drop depends on analog voltage level to convert.

In repeated measurements using the example setup errors up to 25 LSB have been observed in 10-16 of 4096 conversions. Magnitude of the error however depends on the system configuration and load. The workaround therefore should be applied for all applications.

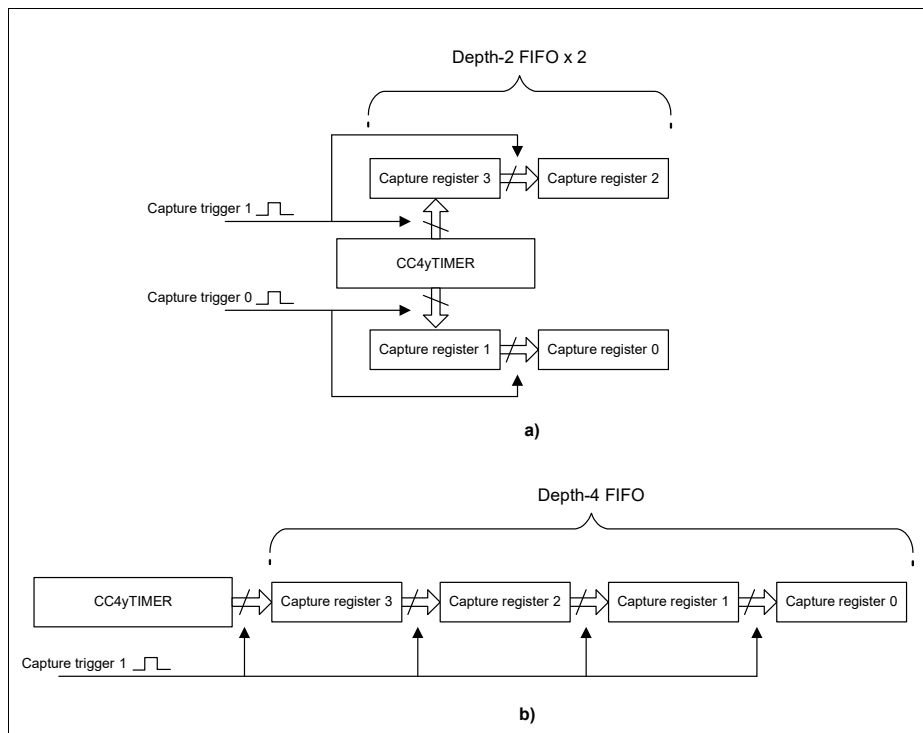
These situations occur whenever capture trigger 1 is being used (when the CC4yCMC.CAP1S field is programmed with a value different from 00_B).

Figure 2 CCU4 capture modes - a) Depth-2 x2 Capture; b) Depth-4 Capture

By using the floating prescaler function present in each timer slice, the capture routine can ignore the missing period interrupt, for a capture trigger frequency as low as 0.25 Hz (for f_{CCU} equal to 120 MHz).

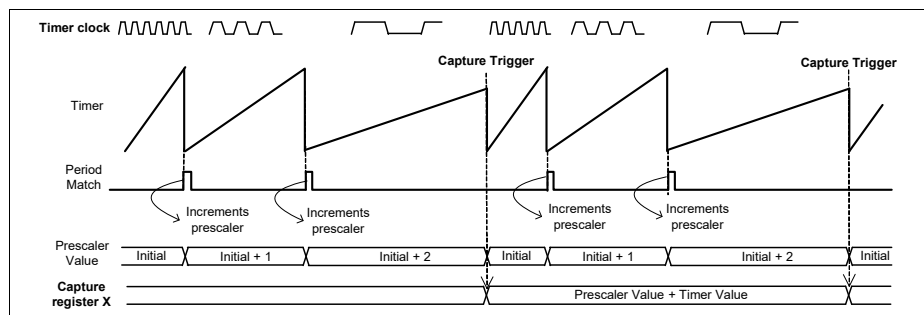
The usage of Capture Register 2 and Capture Register 3 is not possible when the Floating Prescaler function is enabled, $CC8yTC.FPE = 1_B$. This only happens when the Capture Trigger 1 is being used, $CC8yCMD.CAP1S \neq 00_B$. Therefore is not possible to use the Floating Prescaler feature with the capture trigger 1. The usage of the capture trigger 0 is not affected, which means that capture register 0 and capture register 1 can be used with the floating prescaler feature.

Figure 3 Floating Prescaler for Capturing

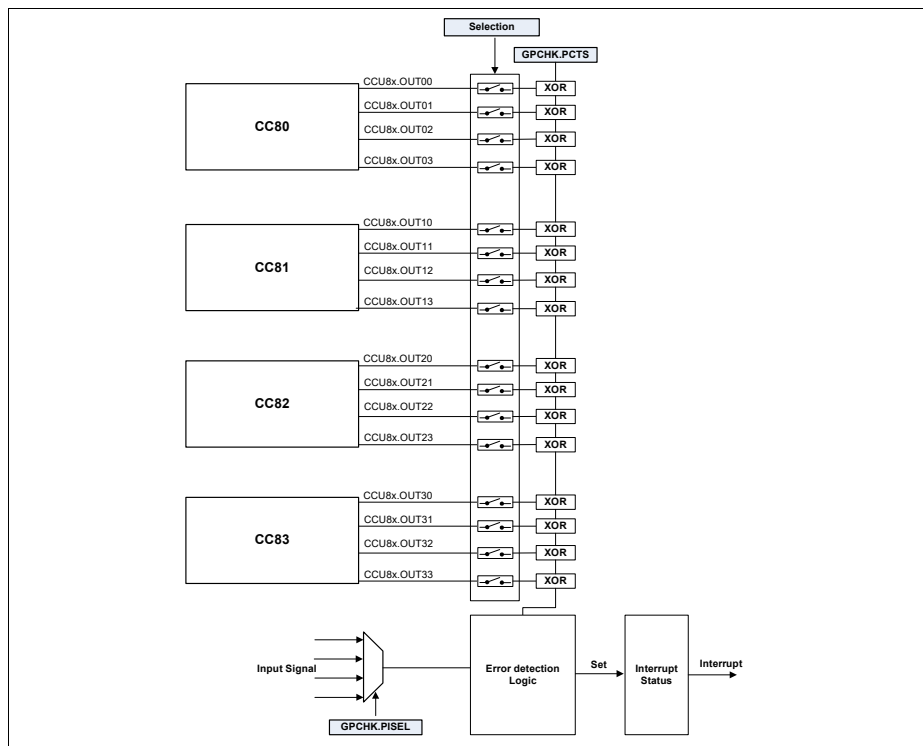
This means that if in the previous PWM cycle an error was detected and one interrupt was triggered, the software needs to read back the status register before the end of the immediately next PWM cycle.

Figure 4 Parity Checker diagram

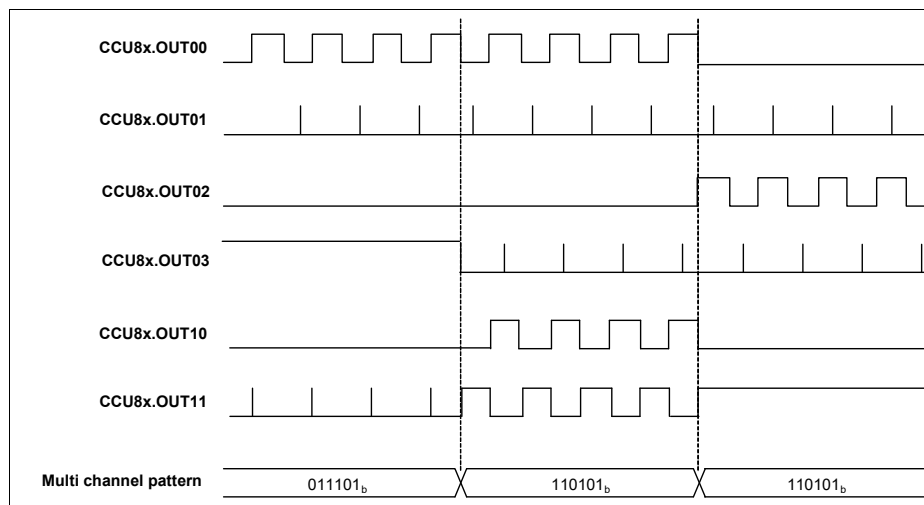
A glitch is present at the PWM outputs whenever the dead time of the specific compare channel is enabled - CC8yDTC.DTE1 and/or CC8yDTC.DTE2 set to 1_B (each compare channel has a separate dead time function) - and the specific multi channel pattern for the channel is 01_B or 10_B.

This glitch only affects the PWM output that is linked to the inverting ST path of each compare channel (non inverting outputs are not affected).

The effect of this glitch can be seen in Figure 3. The duration of the PWM glitch has the same length has the dead time value programmed into the CC8yDC1R.DT1F field (for compare channel 1) or into the CC8yDC1R.DT2F.

Figure 7 PWM output glitch

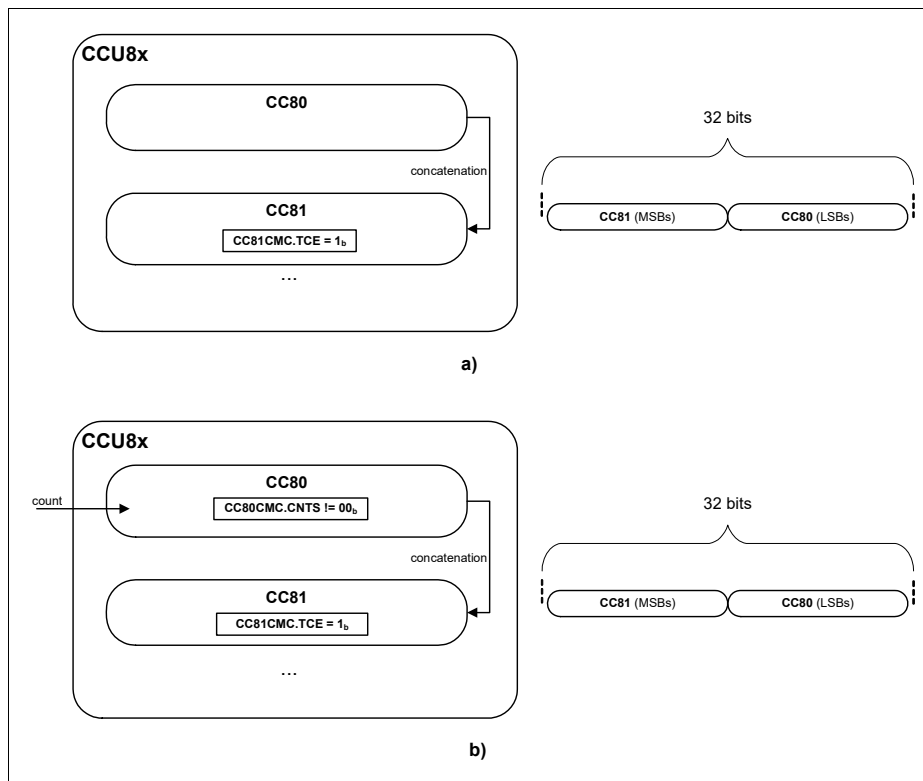
When an external count signal is enabled - by programming the CC8yCMC.CNTS with 01_B , 10_B or 11_B - the concatenation function does not work. One cannot use in parallel the timer concatenation and external count signal features.

Figure 8 CCU8x concatenation feature resource configuration - a) without external count function; b) with external count function

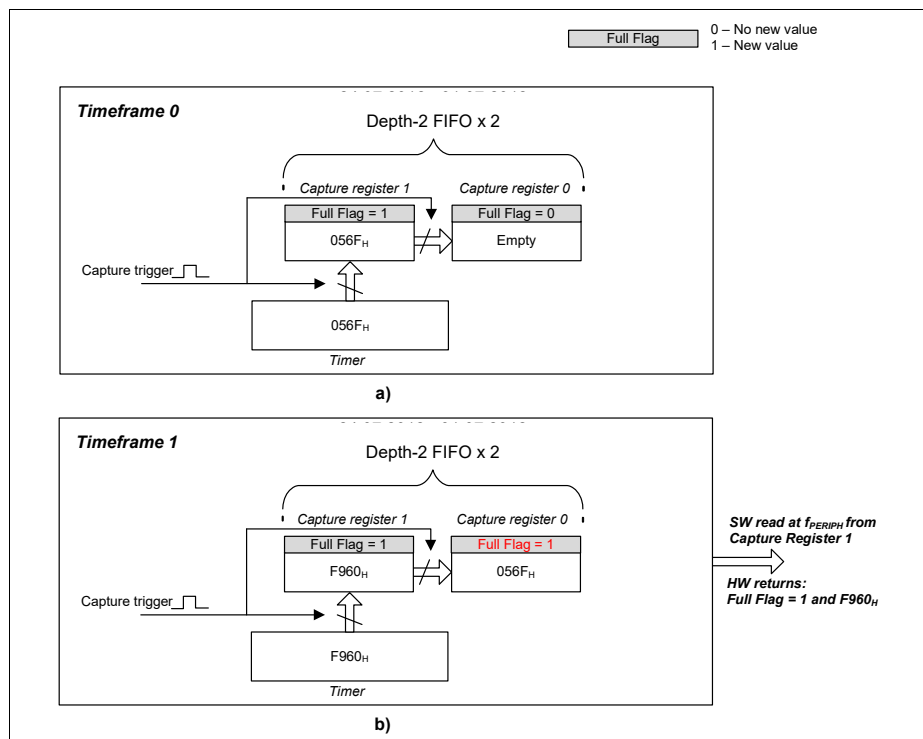
Referring to [Figure 11](#), it can be understood that the proper data is sent to the software when it reads back the capture register 1, nevertheless this same data is shifted to the next capture register (capture register 0) and the full flag of this register is set.

After this if the software reads back capture register 0, a value is going to be returned with a full flag set (indicating that this is a new value - that has not yet been read, which is not true).

Figure 11 Capture shift during read back phase - a) Capture trigger without collision with read back; b) Capture trigger collision with read back

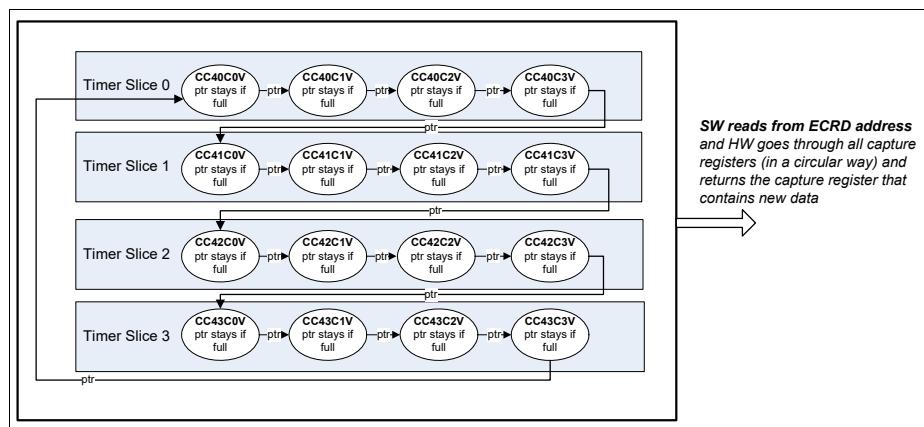
- Timer X has 4 capture registers and is the only Timer set with $ECM = 1_B$. At the moment that the software starts reading the capture registers via the ECRD address, we have already captured two values. The ECRD read back will output CC4xC2V -> CC4xC2V (CC4xC3V value is lost)

- Timer X and Timer Y have 4 capture registers each and they are both configured with $ECM = 1_B$. At the moment that the software starts reading the capture registers via the ECRD address, we have already captured two values on Timer X and 4 on Timer Y. The ECRD read back will output CC4xC0V -> CC4xC1V -> CC4xC2V -> CC4xC3V -> CC4yC2V -> CC4yC2V (CC4yC3V value is lost)

Figure 12 Extended Read Back access - example for CCU4 (CCU8 structure is the same)

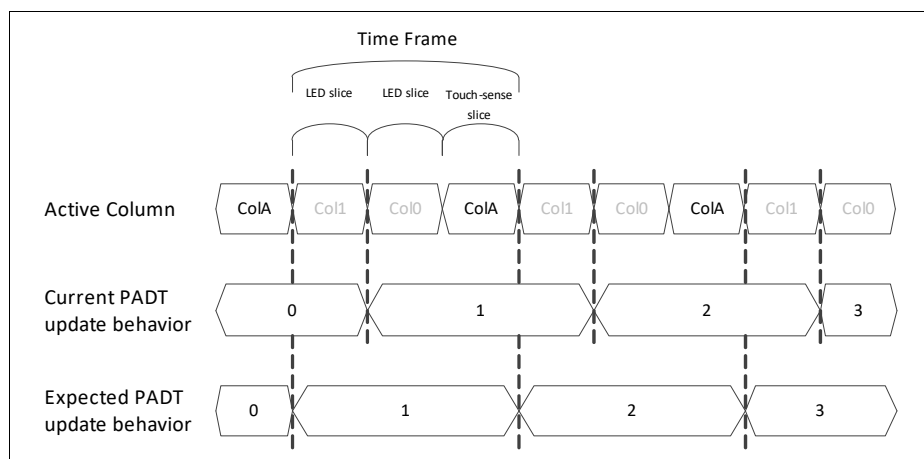
The touch-sense pad turn (PADT) value is updated, not at the end of the touch-sense time slice (ColA), but one time slice later (**Figure 14**).

Figure 14 PADT update behavior

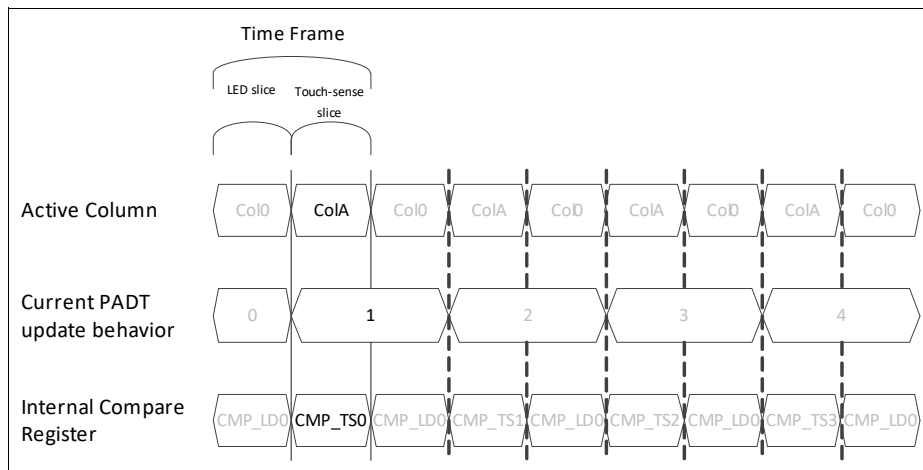
Figure 15 Effect of delay on the update of Internal Compare Register with 1 LED column enabled

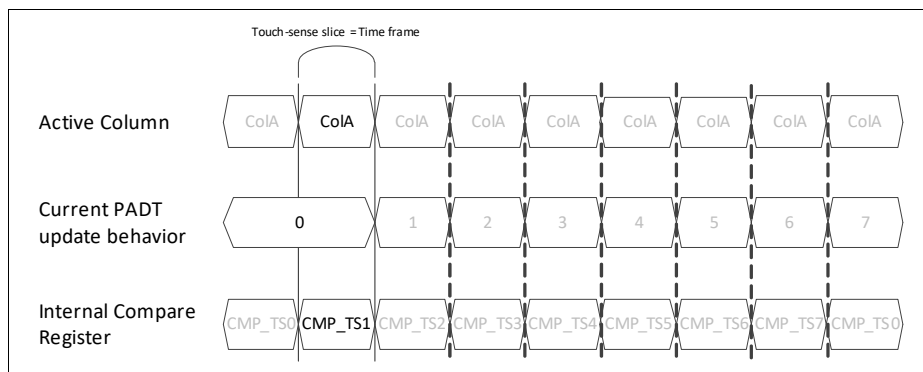
If the number of LED columns enabled is smaller than 2, the delay will affect the activation period of the current active pad. At the beginning of every new Col A, the value of the current PADT's compare register is updated to the internal compare register. However, the delay causes the value of the previous PADT's compare register is updated to the internal compare register instead. This means that the current active pad would be activated with the duration of the previous pad's oscillation window (**Figure 15**). In addition to this, when no LEDs are enabled, pad turn 0 will prevail for one time slice longer before it gets updated (**Figure 16**).

Figure 16 Pad turn 0 prevails for one time slice longer when no LEDs are enabled

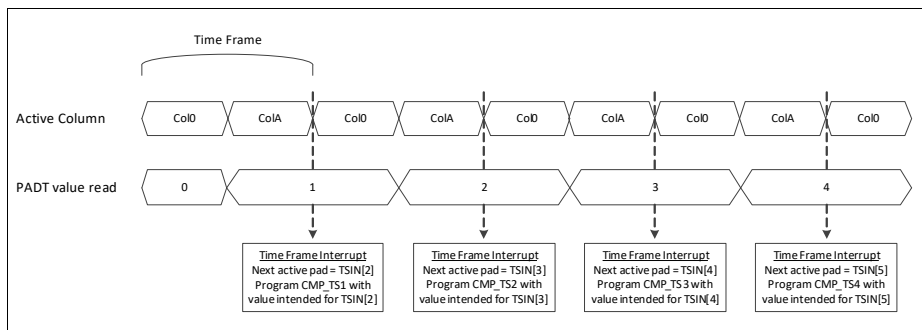
Figure 18 Software workaround demonstration

1. At the end of the time frame interrupt service routine, software can prepare for the next active pad turn by programming the CMP_TS[x-1] bit field with the intended compare value for TSIN[x]. As an example, if the next active pad is TSIN[2], program CMP_TS[1] with the compare value intended for TSIN[2] (**Figure 18**).

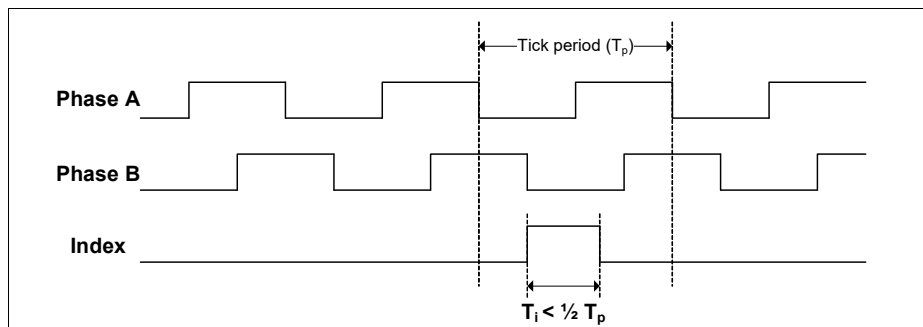
When the index signal is smaller than 1/2 of the tick period, the POSIF module is not able to decode this signal properly, Figure 2 - notice that the reference edge of the index generation in this figure is the falling of Phase B, nevertheless this is an example and depending on the encoder type, this edge may be one of the other three.

Due to this fact it is not possible to use the POSIF to decode these type of signals (index with duration below 1/2 of the tick period).

Figure 20 Different index signal types

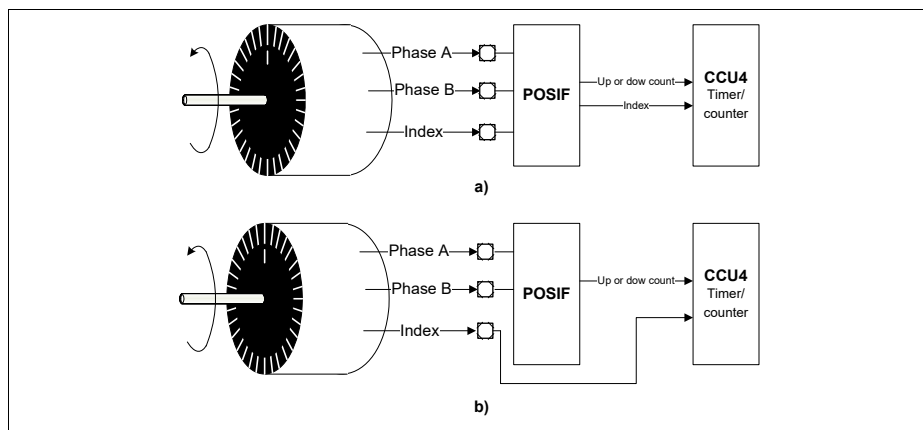
Figure 21 Index usage workaround - a) Non working solution; b) Working solution

To make usage of the Index signal, when the length of this signal is less than 1/2 of the tick period, one should connect it directly to the specific counter/timer. This connection should be done at port level of the device (e.g. connecting the device port to the specific Timer/Counter(s)), Figure 3.

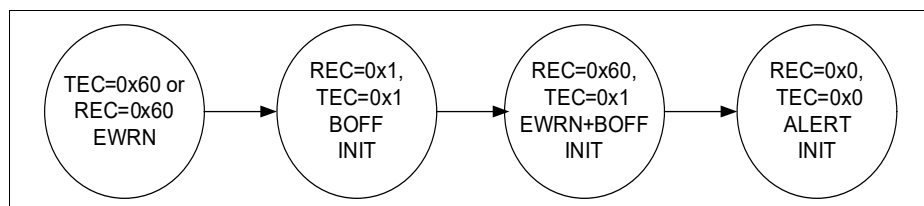
Figure 22 Alert Interrupt Behavior in case of Bus-Off

When the threshold for error warning (EWRN) is reached (default value of Error Warning Level EWRN = 0x60), then the EWRN interrupt is issued. The bus-off (BOFF) status is reached if $TEC > 255$ according to CAN specification, changing the MultiCAN module with REC and TEC to the same value 0x1, setting the INIT bit to 1_B, and issuing the BOFF interrupt. The bus-off recovery phase starts automatically. Every time an idle time is seen, REC is incremented. If REC = 0x60, a combined status EWRN+BOFF is reached. The corresponding interrupt can also be seen as a pre-warning interrupt, that the bus-off recovery phase will be finished soon. When the bus-off recovery phase has finished (128 times idle time have been seen on the bus), EWRN and BOFF are cleared, the ALERT interrupt bit is set and the INIT bit is still set.

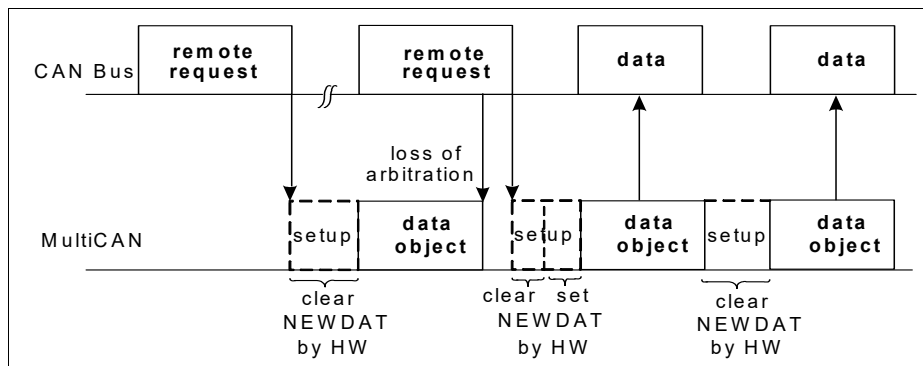
When the appropriate message object (data frame) triggered by the first remote frame wins the arbitration, it will be sent out and `NEWDAT` is not reset. This leads to an additional data frame, that will be sent by this message object (clearing `NEWDAT`).

Figure 23 Loss of Arbitration
